FAMILYGUARD

HOME INSPECTION REPORT

2524 Lincroft Dr. Fort Wayne, IN 46845
Inspection Prepared For: Seller

Date of Inspection: 4/25/2023
Age of House: 27 Years
Weather: Recent Rain

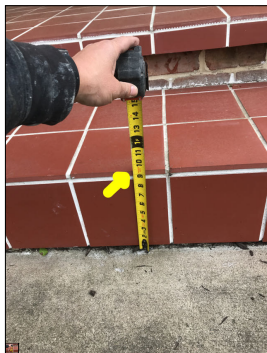
The riser/step is unconventionally high. This is a potential trip hazard. The recommended maximum height for a riser/step is 7 inches.

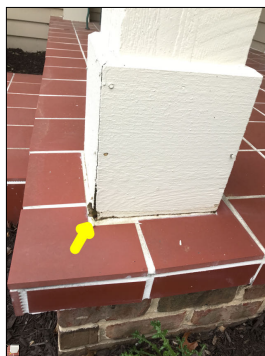
Wood rot damage.

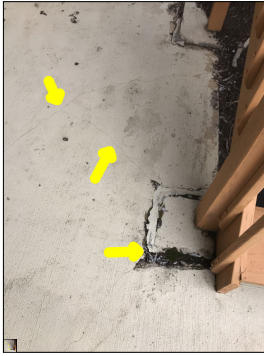
Cracks and deterioration along the patio.

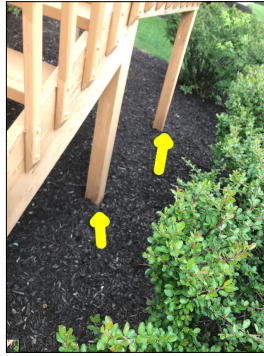
The deck has wood to soil contact. This is not a recommended practice. Water and moisture from the soil/earth can wick up along the deck and the water can be absorbed by the deck. An active or intermittent water source can cause property damage, such as wood rot damage. Also, the wood to soil contact can enable the infestation of wood destroying insects, such as termites or powderpost beetles.

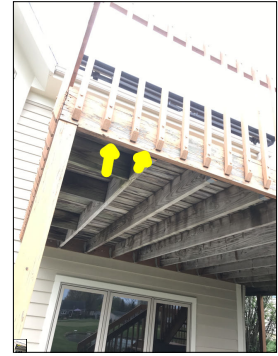
Flaking and peeling along the deck.

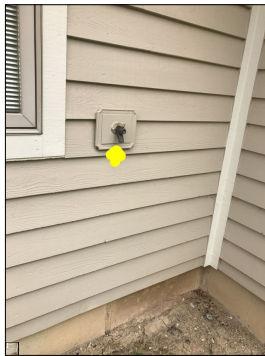
Inoperable hose bib.

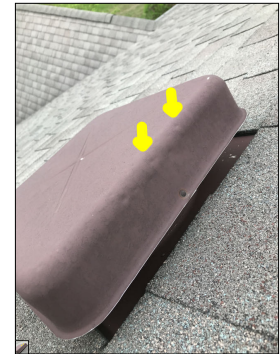
Dents along the roof vents. This is an indication of previous hail damage.

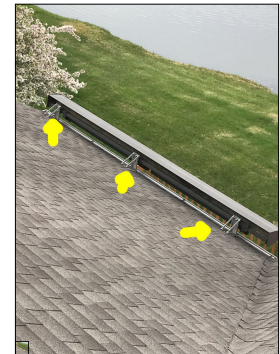
Awning mounted to the roof. While mounting an awning to a roof is a common practice, it is not a recommended practice due to the anchor bolts that penetrate the roof shingles, underlayment and sheathing, thus creating a potential leak point.

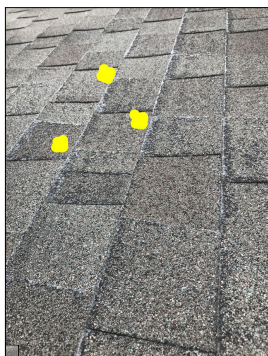
Granule loss along the roof shingles

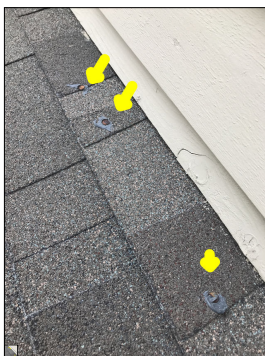
Exposed nailheads/staples. Exposed nailheads/staples are potential leak points.

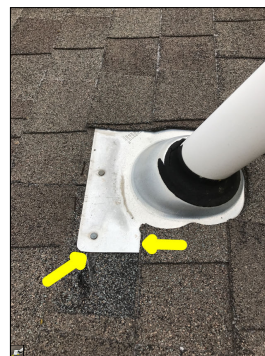
The top shingle layer is missing.

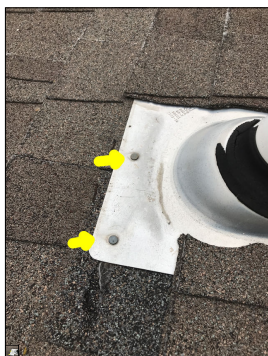
Exposed nailheads/staples. Exposed nailheads/staples are potential leak points.

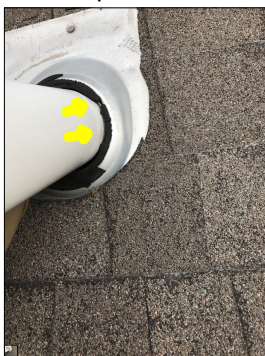
Torn/deteriorated flashing. This is a potential leak point. Water intrusion into the attic and house can cause property damage and mold growth.

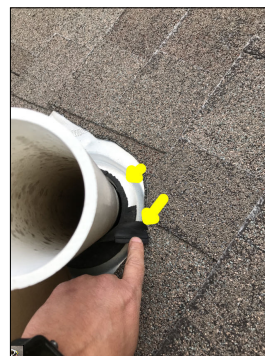
Torn/deteriorated flashing. This is a potential leak point. Water intrusion into the attic and house can cause property damage and mold growth.

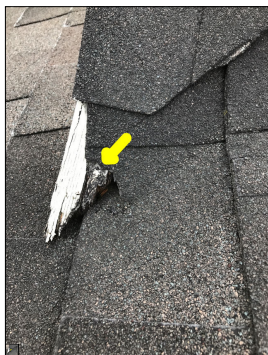
Damaged shingle and wood rot damage.

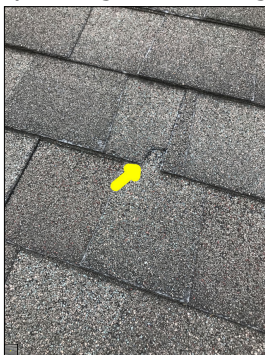
Damaged roof shingles.

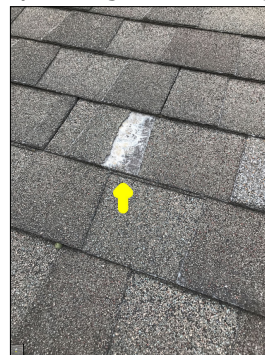
Granule loss along the roof shingles

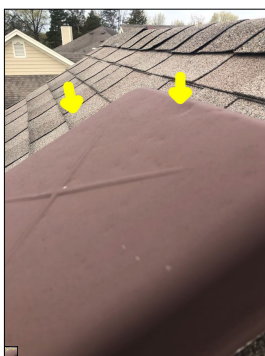
Dents along the roof vents. This is an indication of previous hail damage.

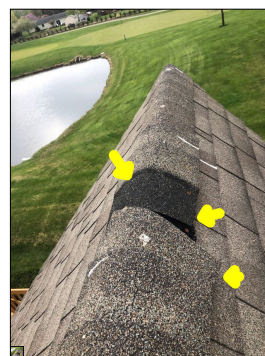
Missing/displaced roof shingle.

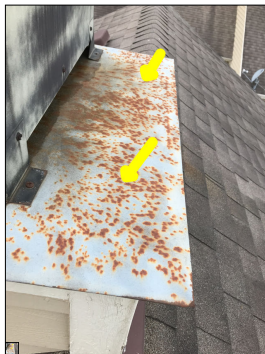
Rust and corrosion along the chimney.
Rust and corrosion can create holes, thus creating leak points.

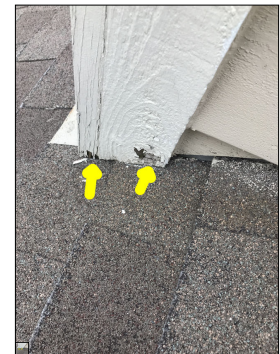
Wood rot damage along the chimney. Wood rot damage can lead to water intrusion into the attic and house. An active or intermittent water source can cause property damage or mold growth.

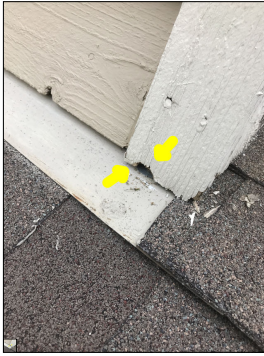
Wood rot damage along the chimney. Wood rot damage can lead to water intrusion into the attic and house. An active or intermittent water source can cause property damage or mold growth.

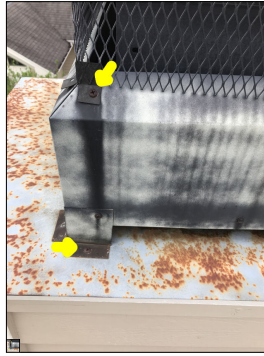
Exposed nails/fasteners along the chimney. Exposed nails/fasteners are potential leak points. Exposed nails/fasteners along the chimney is considered amateur craftsmanship. Amateur craftsmanship is prone to failure and leakage.

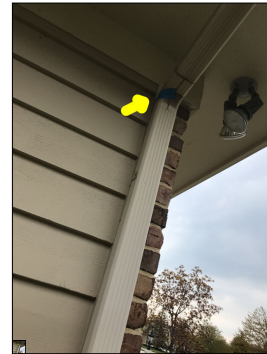
Unconventional tape along the gutter.

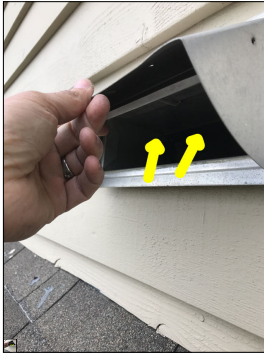
The vent does not have a critter guard.

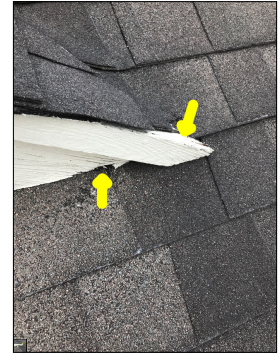
Wood rot damage.

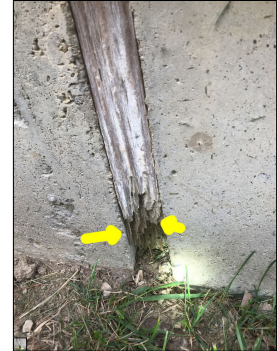
Signs of damage from carpenter ants. Carpenter ants are a wood destroying insect and can cause property damage and structural damage.

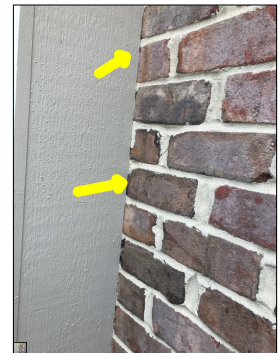
Gaps along the siding.

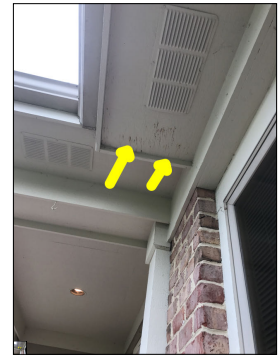
Wood rot damage.

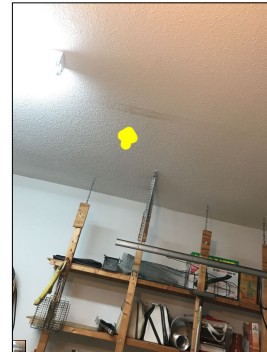
Discoloration along the ceiling and signs of previous water damage. An active or intermittent water source can cause mold growth and property damage.

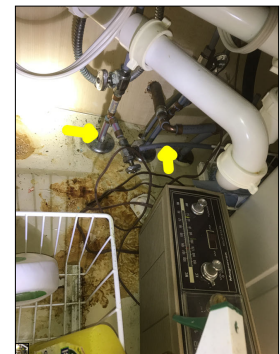
Polybutylene plumbing lines. Polybutylene pipes are prone to failure and no longer meet modern day plumbing standards. Recommend upgrading from polybutylene pipes to modern day plumbing materials, such as PEX or copper. Please note, polybutylene pipes can be concealed behind walls, ceilings, etc.

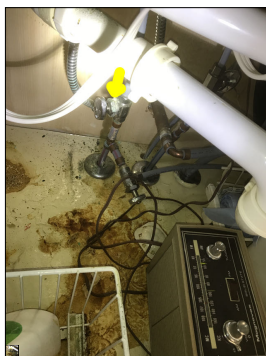
Rust/corrosion along the plumbing pipes.

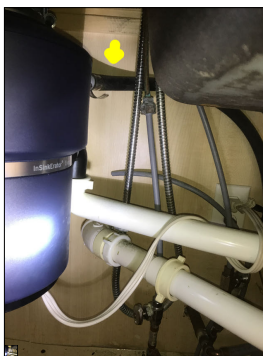
The dishwasher drain line does not have a high loop. A high loop prevents drain water from flowing into the dishwasher and contaminating the clean dishes.

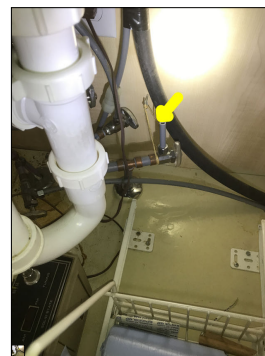
Uncapped water lines. This is not a recommended practice. Water lines that are not being used should be capped. The valve that is closing the line could potentially fail.

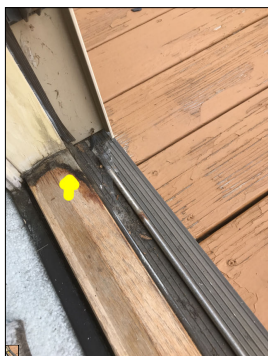
Discoloration along the threshold. An active or intermittent water source can cause discoloration.

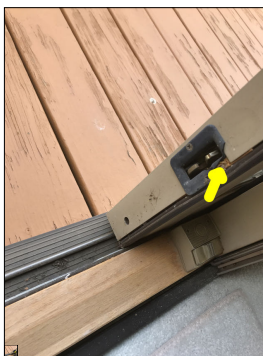
Casing to the latch keeper is damaged.

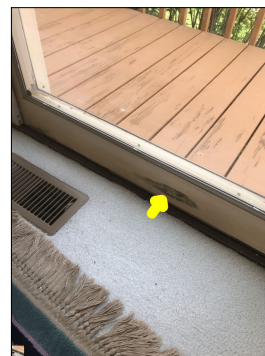
Wood rot damage along the door.

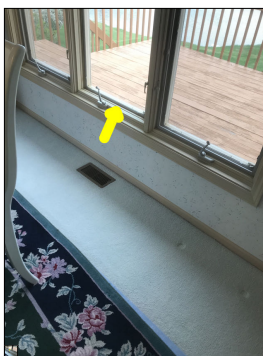
Missing window screens.

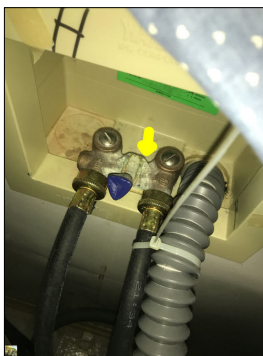
Rust/corrosion along the washer hook up lines.

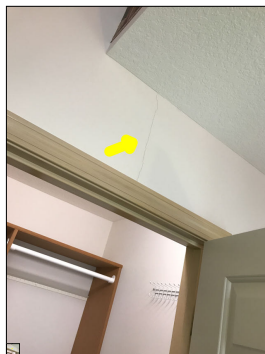
Cracks along the walls.

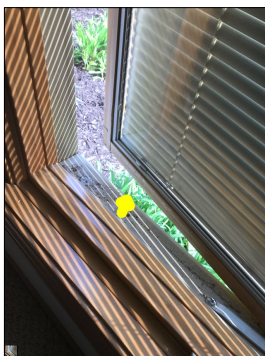
Missing window screens.

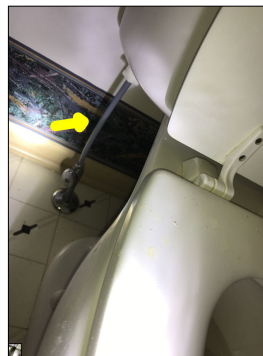
Polybutylene plumbing lines. Polybutylene pipes are prone to failure and no longer meet modern day plumbing standards. Recommend upgrading from polybutylene pipes to modern day plumbing materials, such as PEX or copper.

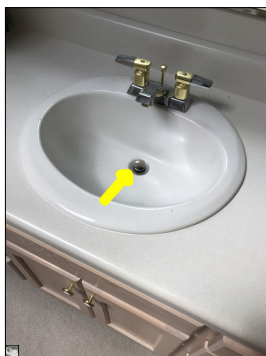
Inoperable drain stopper.

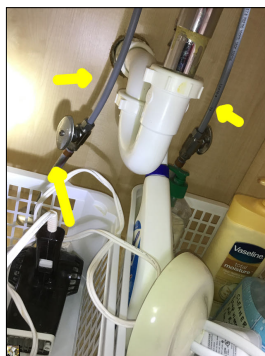
Polybutylene plumbing lines. Polybutylene pipes are prone to failure and no longer meet modern day plumbing standards. Recommend upgrading from polybutylene pipes to modern day plumbing materials, such as PEX or copper. Please note, polybutylene pipes can be concealed behind walls, ceilings, etc.

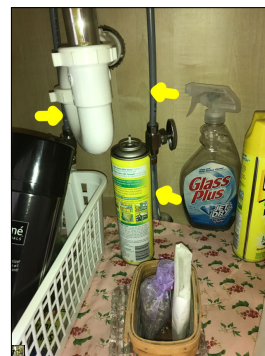
Polybutylene plumbing lines. Polybutylene pipes are prone to failure and no longer meet modern day plumbing standards. Recommend upgrading from polybutylene pipes to modern day plumbing materials, such as PEX or copper. Please note, polybutylene pipes can be concealed behind walls, ceilings, etc.

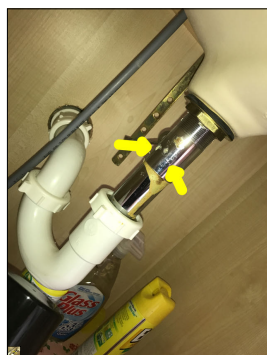
Rust/corrosion along the plumbing pipes.

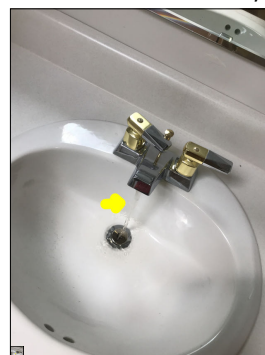
Low water pressure from the hot side compared to the cold side and to the other sink in the bathroom.

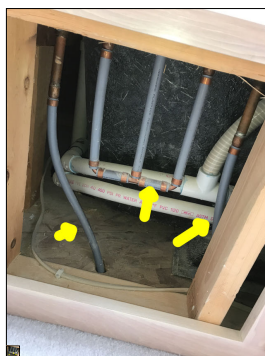
Polybutylene plumbing lines. Polybutylene pipes are prone to failure and no longer meet modern day plumbing standards. Recommend upgrading from polybutylene pipes to modern day plumbing materials, such as PEX or copper. Please note, polybutylene pipes can be concealed behind walls, ceilings, etc.

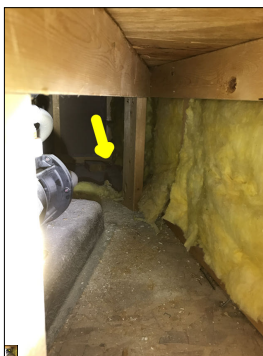
Mice/rodent droppings. Wildlife activity can cause property damage.

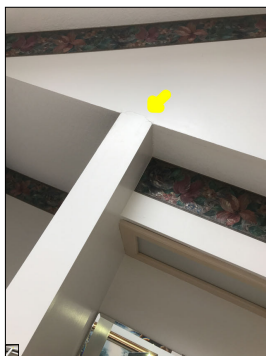
Cracks along the walls.

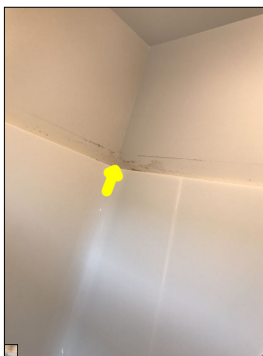
Discoloration along the walls.

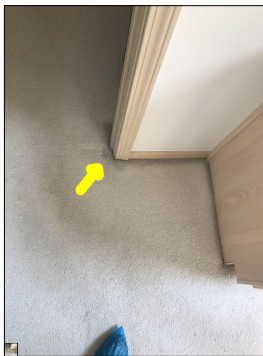
The floor slopes. This is considered abnormal and a defect.

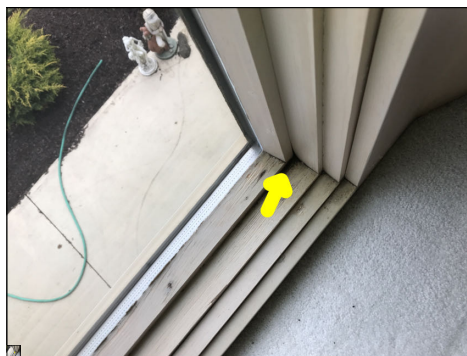
Wood rot damage along the window. These windows probably condensate at times. An active or intermittent water source can cause wood rot damage.

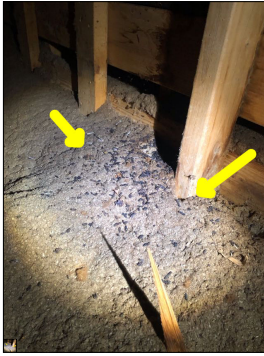
Mice/rodent droppings. Wildlife activity can cause property damage.

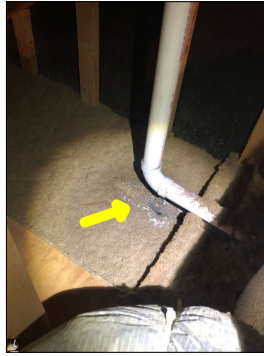
The insulation is hard and discolored. This is an indication of previous water intrusion. After insulation gets wet, the insulation will harden and become stiff. An active or intermittent water source can cause mold growth and property damage. Please note, insulation that gets wet will lose its R-value, which means it becomes less efficient. This is underneath a plumbing vent.

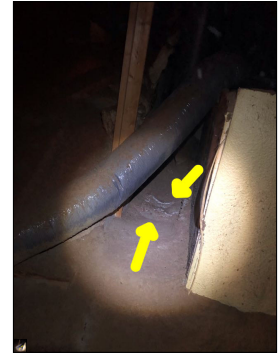
The insulation is hard and discolored. This is an indication of previous water intrusion. After insulation gets wet, the insulation will harden and become stiff. An active or intermittent water source can cause mold growth and property damage. Please note, insulation that gets wet will lose its R-value, which means it becomes less efficient. This is underneath the chimney.

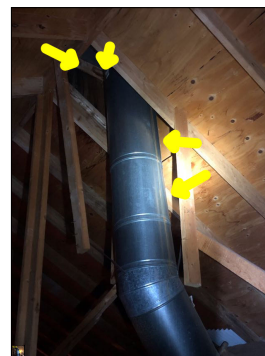
Discoloration/staining along the sheathing and discoloration/staining along the flue.

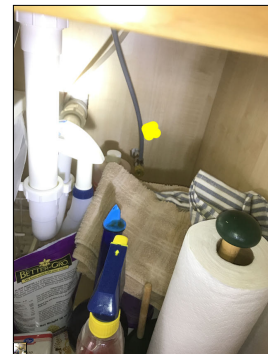
Polybutylene plumbing lines. Polybutylene pipes are prone to failure and no longer meet modern day plumbing standards. Recommend upgrading from polybutylene pipes to modern day plumbing materials, such as PEX or copper. Please note, polybutylene pipes can be concealed behind walls, ceilings, etc.

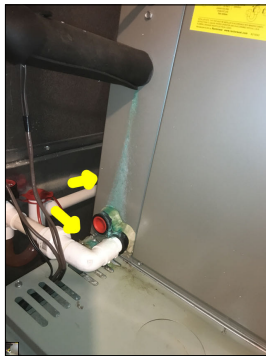
Corrosion and discoloration along the evaporator coil cabinet. This is considered abnormal and a defect.

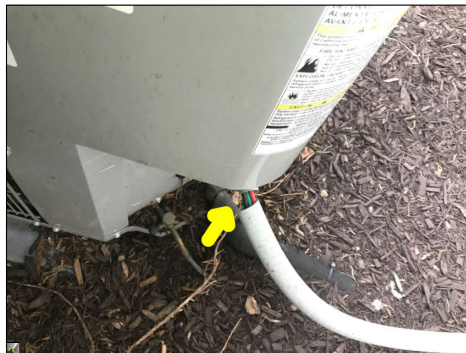
Exposed wires. This is a potential safety hazard. Exposed wires should be wrapped in conduit or placed within an enclosed electrical box.

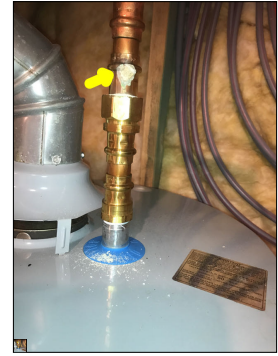
Corrosion along the water supply lines.

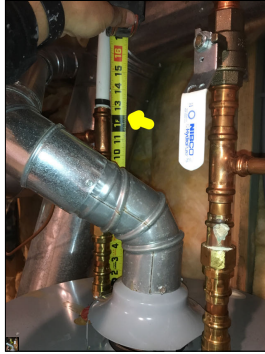
Non-metallic plumbing lines within 18 inches of the water heater. A metallic water supply line, such as copper, should be used for the first 18 inches of water supply lines from the water heater. After the first 18 inches, a transition of plumbing type can be made, such as going from copper to PEX. The rule applies to not only gas water heaters, but also electric, tankless, or closed combustion. Recommend checking with the manufacturer of the water heater to ensure the installation is correct.

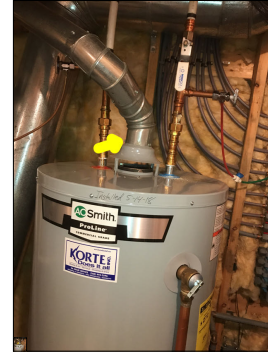
Improper flue. There should be a minimum of twelve inches between the draft hood outlet and the first elbow or connector. The current design of the flue is a potential safety hazard as it could cause the flue to backdraft and release carbon monoxide into the house.

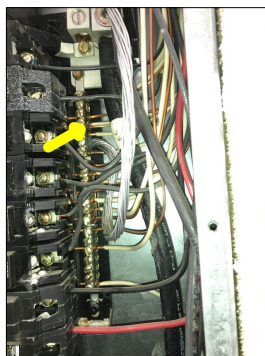
Double tapped neutral wires. Neutral wires should not share a terminal with any other wires, including ground wires. Double tapped neutrals are considered a safety hazard. Double tapped neutral wires do not allow the circuit to be isolated if the circuit needs to be worked on. Also, double tapped neutral wires under the same terminal can become loose, which could lead to arcing, overheating, spark and/or fire.

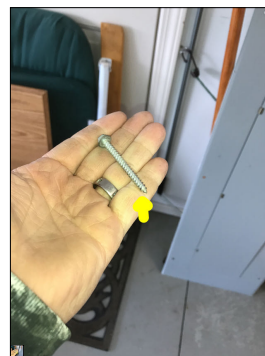
Sharp-end screws used to secure the cover to the circuit breaker panel. This is a potential safety hazard. The screws could potentially penetrate a wire. Flat-end screws should be used when securing a cover to a panel.
