HOME INSPECTION REPORT

Inspector: Alex Bishop
License #: HI01600042

4942 Co Rd 100 E Anderson, IN 46013
Inspection Prepared For: Seller

Date of Inspection: 8/31/2025
Age of House: 55 Years
Weather: Clear

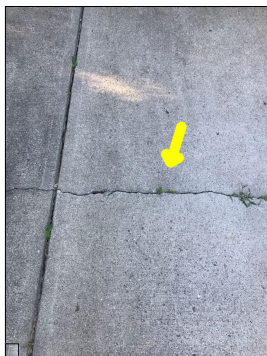
Cracks and deterioration along the driveway.

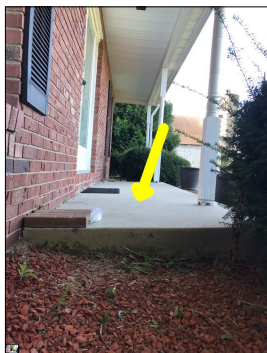
The porch slopes towards the house. This can cause water to flow towards the house, thus potentially causing water intrusion into the house and potential foundation problems due to excessive hydrostatic pressure.

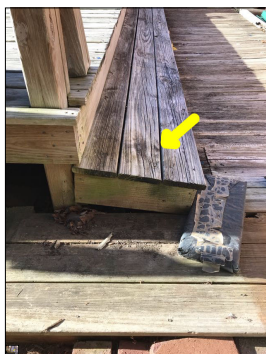
The step is unconventionally sloped. This is a trip hazard.

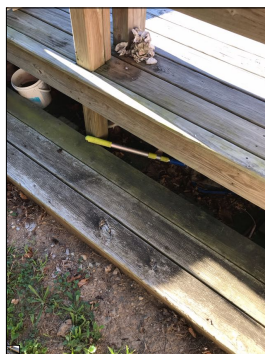
The deck has wood to soil contact. This is not a recommended practice. Water and moisture from the soil/earth can wick up along the deck and the water can be absorbed by the deck. An active or intermittent water source can cause property damage, such as wood rot damage. Also, the wood to soil contact can enable the infestation of wood destroying insects, such as termites or powderpost beetles.

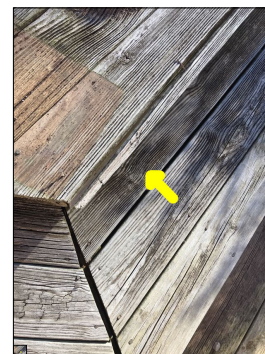
Loose boards along the deck.

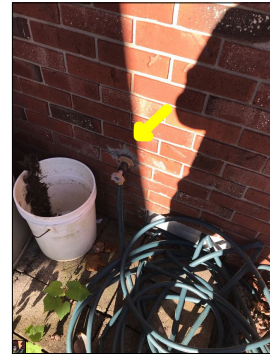
No anti-siphon/frost free valve. The lack of an anti-siphon valve can allow water back flow into the water supply lines, thus contaminating potable water. This is a potential safety hazard. The lack of a frost free valve can allow water to stay within the hose bib, which could potentially freeze during cold months and cause the pipe to rupture. This can cause property damage.

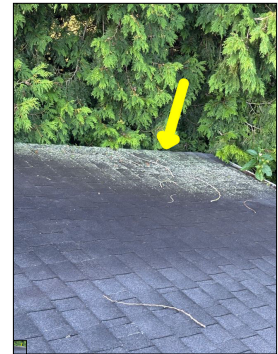
Biological growth along the roof. This is considered a defect. Biological growth has the potential to hold water. Shingles are not designed to hold water, shingles are designed to shed water.

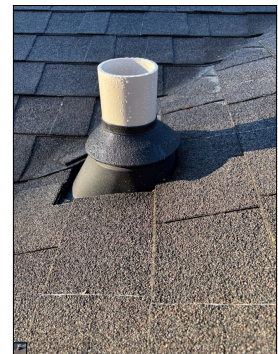
The plumbing vent is unconventionally short. This is considered abnormal and a defect. A short plumbing vent can get covered during heavy snowfall, thus obstructing the vent, which could result in drainage problems with the plumbing system.

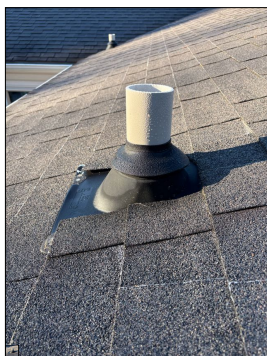
The plumbing vent is unconventionally short. This is considered abnormal and a defect. A short plumbing vent can get covered during heavy snowfall, thus obstructing the vent, which could result in drainage problems with the plumbing system.

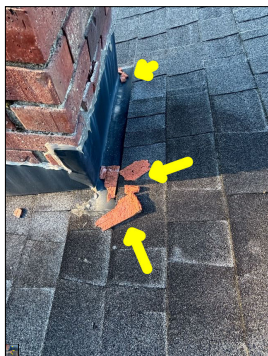
Loose/detached brick from the chimney observed along the roof.

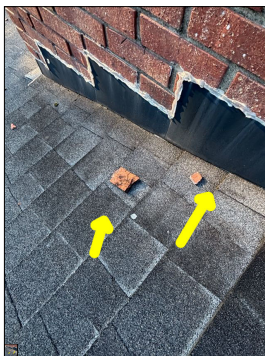
Loose/detached brick from the chimney observed along the roof.

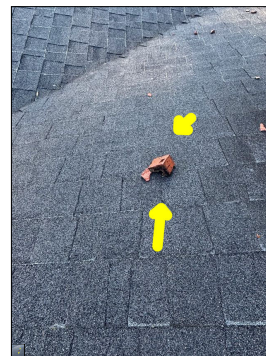
Loose/detached brick from the chimney observed along the roof.

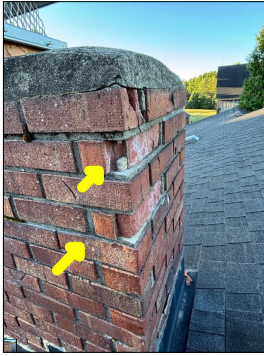
Deterioration and cracking along the chimney. Deterioration and cracks are potential leak points.

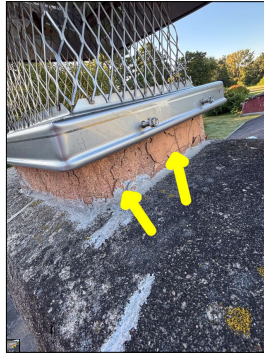
Cracks along the clay tile. Cracks along the clay tiles are a potential safety hazard. Cracked tiles can cause the chimney to not draft properly, thus potentially causing carbon monoxide to enter the house or potentially cause a fire.

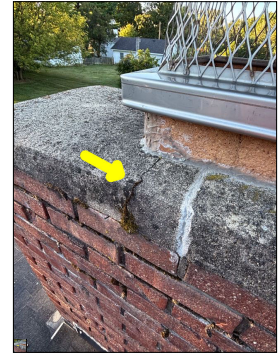
Cracks along the chimney. Cracks are considered defects and potential leak points.

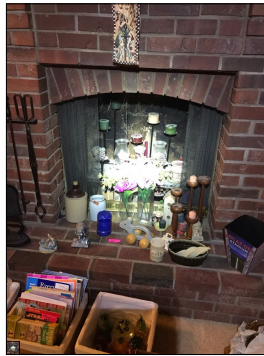
Decor within the fireplace. This is an indication that the fireplace has not been used for its original purpose for an extended period of time. Before using the fireplace for its intended purpose, recommended licensed chimney professional further evaluate and make necessary repairs to ensure the fireplace is operable and is in good working condition.

- Needs cleaning/serviced
- Before using the fireplace, it is recommended that a licensed chimney/fireplace professional further evaluate to ensure the fireplace is in good working condition and is safe for usage.

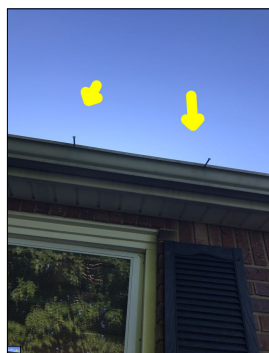
Loose gutter spikes.

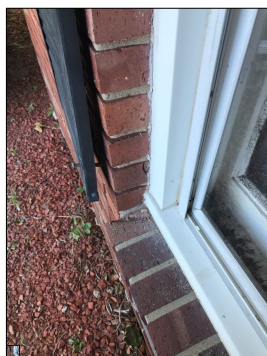
Loose shutters.

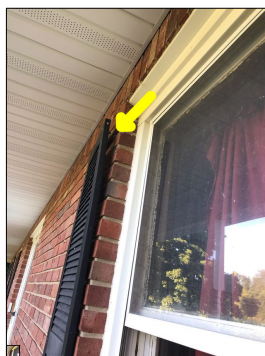
Loose/detached shutters.

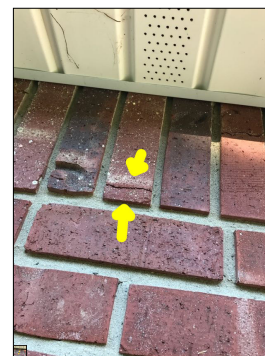
Cracks along the siding.

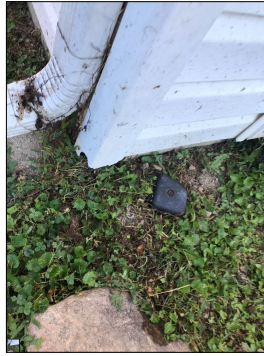
Damaged siding.

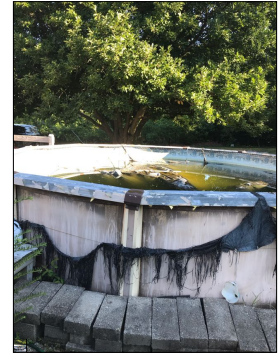
Swimming pool observed. The swimming pool's current condition is rated poor as it has been neglected for an extended period of time.

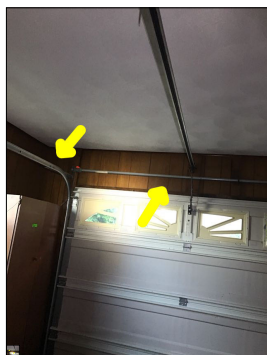
There is not a torsion spring or extension springs along the overhead doors. This is considered abnormal and a safety hazard.

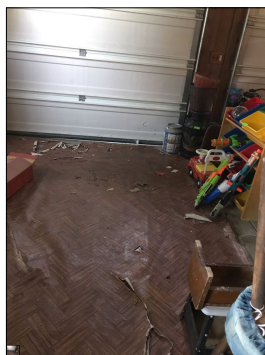
Daylight can be seen from the interior. This is an entry point for moisture, insects, mice, rodents, etc.

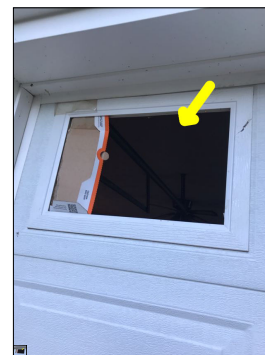
Missing window.

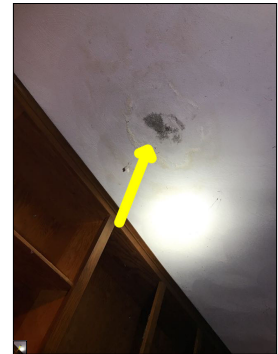
Mold like substance. An active or intermittent water source can cause mold growth and property damage.

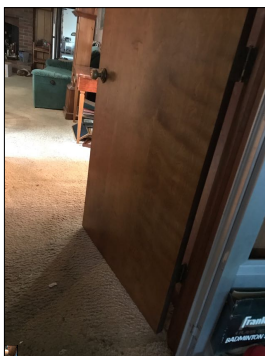
The door that separates the interior of the house from the garage is not a proper fire rated door. This is a potential safety hazard.

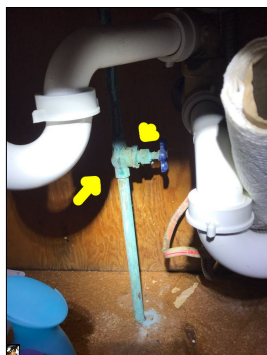
Rust/corrosion along the plumbing pipes.

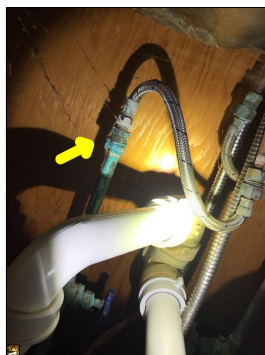
Rust/corrosion along the plumbing pipes.

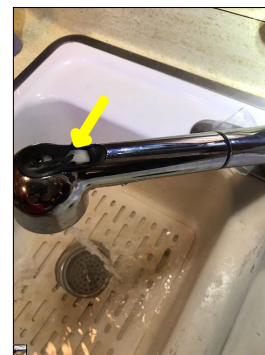
The button pad is deteriorated.

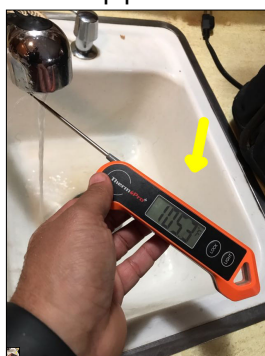
Temperature reading of the hot water during the time of the inspection. The approximate temperature of the hot water was 105 degrees Fahrenheit.

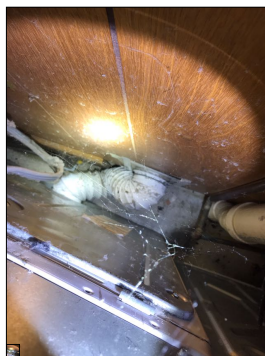
The dryer ductwork is plastic. This is not a recommended practice and is considered a safety hazard. The plastic can overheat and melt, thus creating a fire. Metal ductwork is the recommended material to use for dryer exhaust. It is also recommended for the exhaust ductwork to be insulated in non climate controlled areas, such as an attic, to prevent condensation from forming along the ductwork. An active or intermittent water source can cause mold growth and property damage.

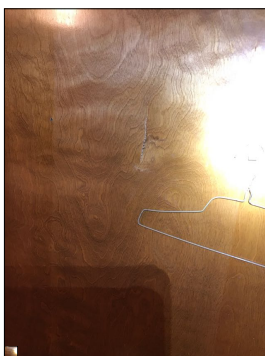
Damage/dents along the door.

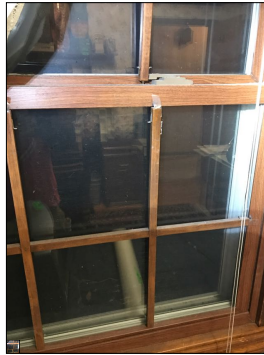
The window grids are loose/detached.

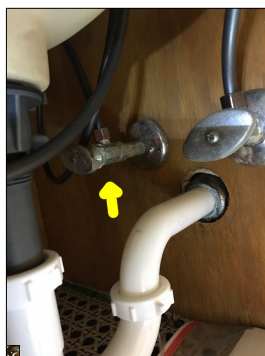
Rust/corrosion along the plumbing pipes.

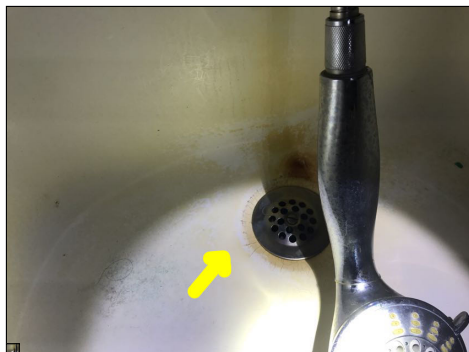
Cracks along the bathtub.

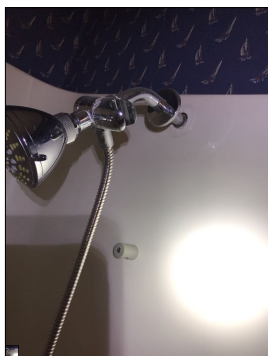
The showerhead is loose.

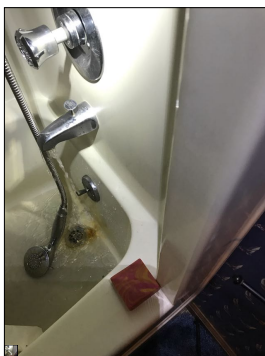
The bathtub faucet leaks while the showerhead is in operation. This is considered a defect. A properly functioning diverter will not allow any water through the bathtub faucet while the showerhead is in operation.

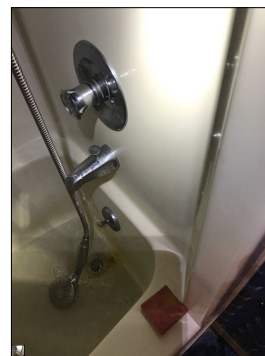
The diverter rod does not drop when the showerhead is turned off. This is considered abnormal and a defect. Unless the diverter rod is manually disengaged when turning the showerhead off, the next person to turn the bathtub faucet on will receive water from the showerhead.

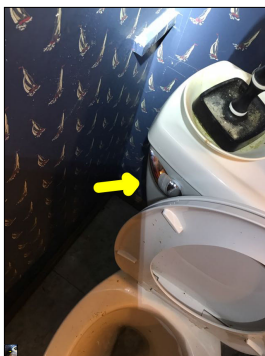
The handle is unconventionally loose.

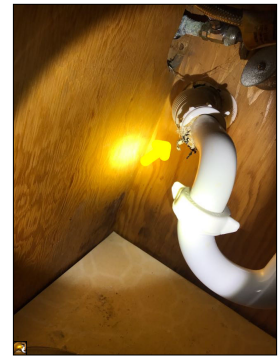
Grime along the **PVC** plumbing pipes. Grime along PVC pipes is considered abnormal and an indication of a developing leak or an intermittent leak.

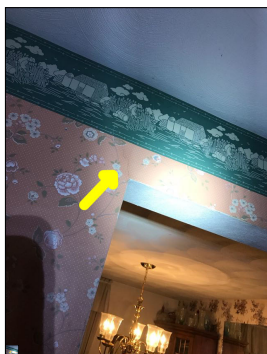
Cracks along the walls.

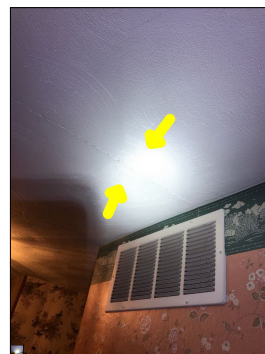
Cracks along the ceiling.

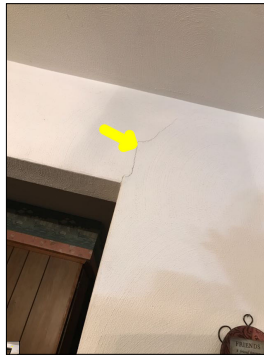
Cracks along the walls.

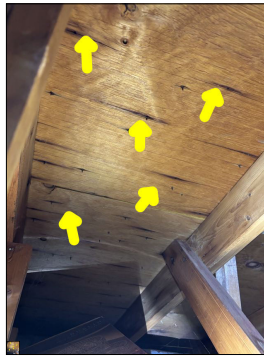
Black discoloration around the roofing nails and black discoloration around previous holes from prior roof shingles. The black discoloration is a potential mold like substance. This is caused by an active or intermittent water source. In most cases, the discoloration is caused by inadequate attic ventilation. An active or intermittent water source can cause mold growth and property damage.

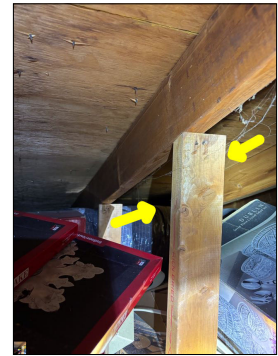
Apparent added supports/webbing observed in the attic. This is an indication of previous structural repairs.

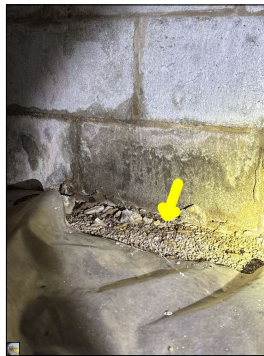
The crawl space has a gravel floor that exposes the earth. Gravel floors are not recommended. A gravel floor can allow the intrusion of moisture, insects, wood destroying insects, radon, mice, and rodents. An active or intermittent water source can cause mold growth and property damage, such as wood rot damage. It is recommended that the crawl space be properly encapsulated.

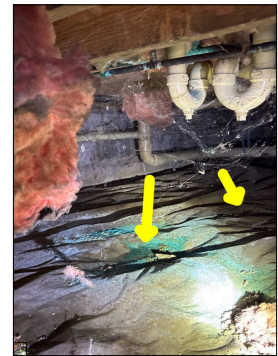
Standing water in the crawl space. This is considered a defect. An active or intermittent water source can cause mold growth and property damage, such as wood rot and structural damage. Also, areas that are exposed to water, moisture and dampness are prone to infestation and damage from wood destroying insects, such as termites and powder post beetles. Please note, due to the areas of standing water, the crawl space could not be fully and properly inspected. Costly repairs should be anticipated with crawl spaces that have water intrusion. It is beyond the scope of a general home inspection to enter areas of standing water, entering areas with standing water is a potential safety hazard. The water could have an electrical charge to it, the water could be waste/sewage from plumbing pipes, the water could be infested with bacteria, etc.

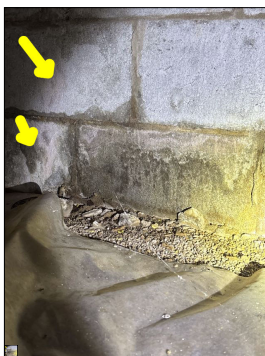
Efflorescence along the walls. Efflorescence is considered a defect and an indication that moisture/water is getting through the walls. An active or intermittent water source can cause mold growth and property damage.

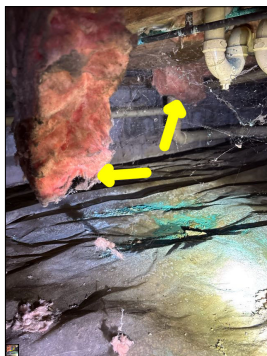
Torn and displaced insulation. This is considered abnormal and a defect.

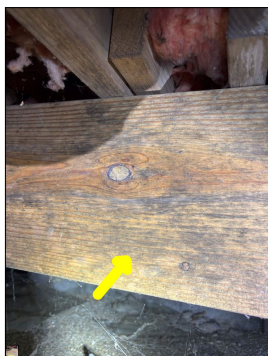
Mold like substance along the floor joists. An active or intermittent water source can cause mold growth and property damage.

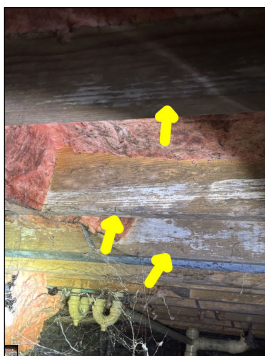
Mold like substance along the floor joists. An active or intermittent water source can cause mold growth and property damage.

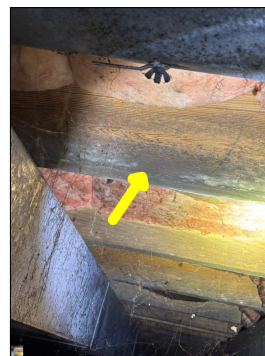
Mold like substance along the floor joists. An active or intermittent water source can cause mold growth and property damage.

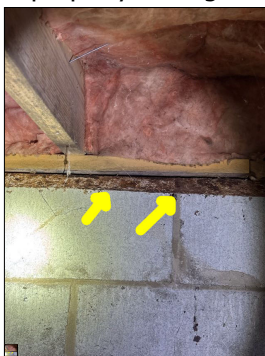
Rust/corrosion along the metal plate against the sill. This is an indication that the crawl space has an active or intermittent water source. An active or intermittent water source can cause mold growth and property damage, such as wood rot, rust, and corrosion.

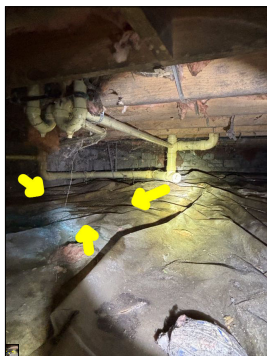
Moisture and dampness observed underneath the plumbing lines. The water source could potentially be from a leaking pipe or from ground water. Recommend general contractor further evaluate and make necessary repairs.

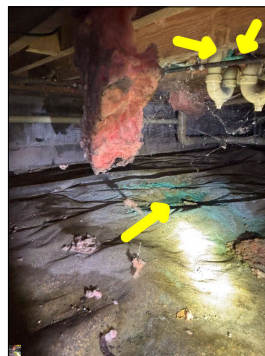
Rust and corrosion along the plumbing pipes.

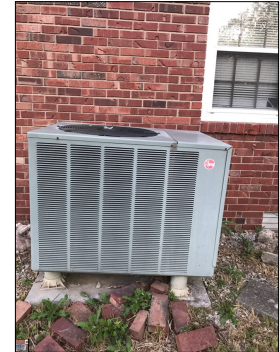
The condenser is not level. Refrigerant within an air conditioner also acts as a lubricant. When the condenser is leaning, some internal components may not get properly lubricated, thus shortening the lifespan of the condenser.

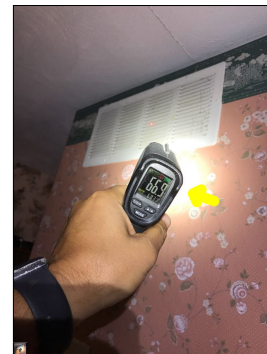
The photo identifies the temperature of the return air while the air conditioner was in operation. The approximate temperature of the return air was 66 degrees Fahrenheit.

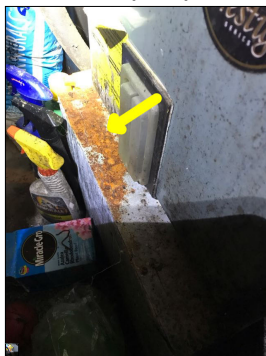
Rust and corrosion along the HVAC ductwork. This is considered a defect. An active or intermittent water source can cause rust and corrosion and property damage.

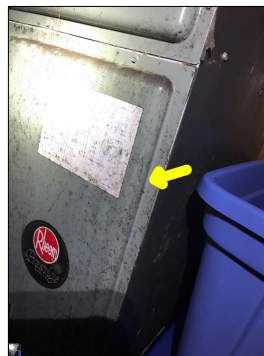
Mold like substance along the furnace. An active or intermittent water source can cause mold growth and property damage.

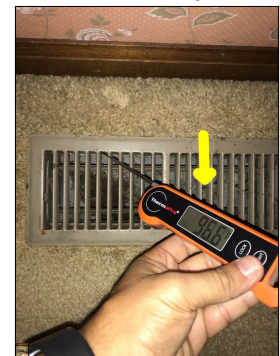
The photo identifies the temperature of the supply air while the heat pump was in operation. The approximate temperature of the supply air was 96 degrees Fahrenheit.

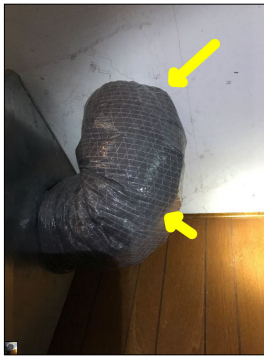
Flex HVAC ductwork routed through the ceiling. This is considered abnormal and a fire hazard.

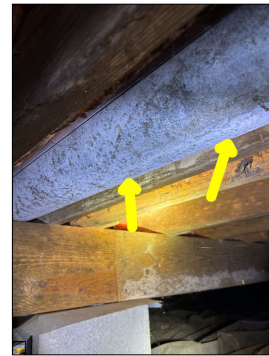
The HVAC ductwork lacks insulation. This is not a recommended practice. The lack of insulation along the ductwork can allow moisture and condensation to form along the ductwork. An active or intermittent water source can cause the ductwork to rust and corrode. A water source can also cause mold growth and property damage. This is located in the crawl space.

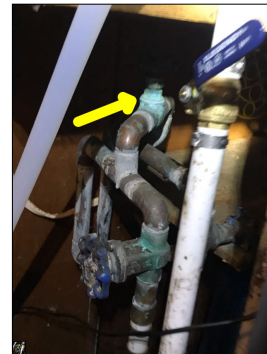
Corrosion and rust along the water lines.

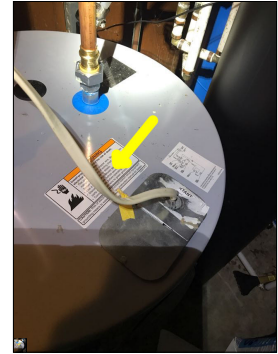
The wires are not wrapped in conduit. This is considered abnormal, amateur craftsmanship and a potential safety hazard. Wires should be wrapped in conduit to protect both humans and the electrical wiring. Wires that lack conduit can potentially get pulled, become loose, or damaged, thus creating shock hazards and/or fire hazards.

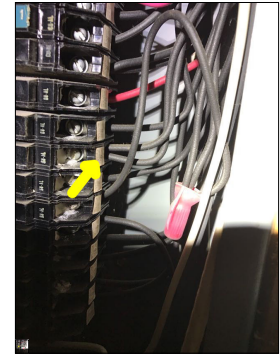
Double tapped circuit breaker. Two conductors inserted into a single circuit breaker that is rated for one conductor could become loose over time which could lead to overheating, arcing, spark and possible fire.

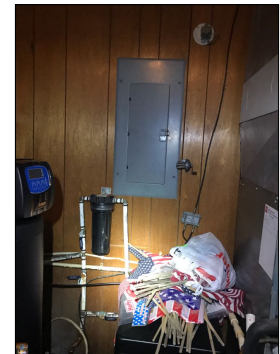
Inadequate clearance around the circuit breaker panel. The lack of proper clearance is a potential safety hazard. Circuit breaker panels should have at minimum, 3 feet depth measured from front edge of the panel, 30 inches minimum width or width of equipment if > 30 inches, working space height of 6 feet, 6 inches or height of equipment, whichever is greater. Required working space must extend to the ground, panel door must be operable to at least 90 degrees.
