Property Inspection Report

Steven Mix HI01600075
Shamrock Home Inspections LLC

4015 Wedgewood Drive
Inspection Prepared For: Steve Weiss
Agent: Heidi Haiflich - NE Group Realty

Date of Inspection: 4/4/2025
Year Built: 1962 Size: 1960
Weather: Sunny 40 degrees

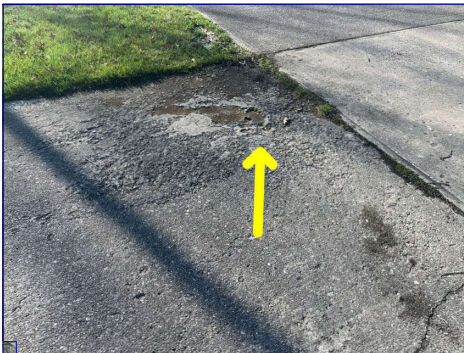
The driveway has areas of spalling. Spalling is a common surface imperfection. In most cases, the defect does not affect the slab's service life if untreated. Recommend a professional contractor repair to help prevent additional damage.

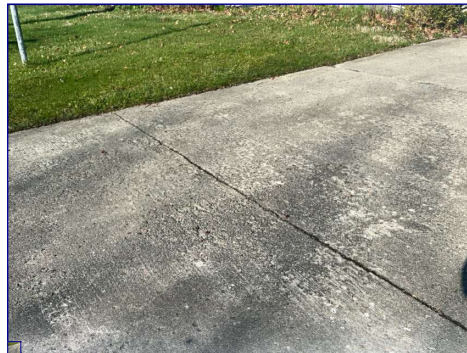
The driveway is cracked. Recommend sealing the cracks to help prevent additional damage. Consult a professional contractor as needed.

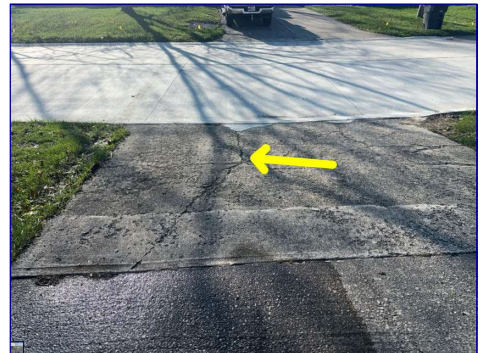
The driveway has areas of spalling. Spalling is a common surface imperfection. In most cases, the defect does not affect the slab's service life if untreated. Recommend a professional contractor repair to help prevent additional damage.

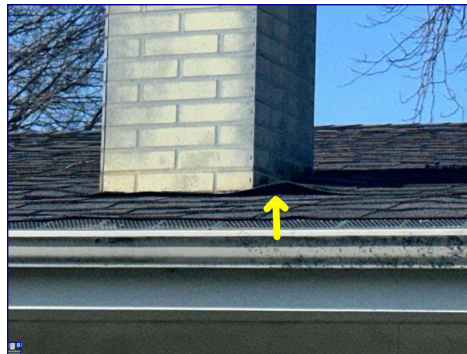
The roof flashing has pulled away from the roof - recommend a licensed roofer repair.

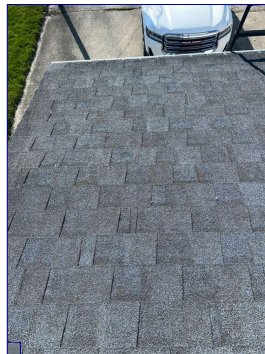
A number of roof shingles are missing granules. Recommend a licensed roofer evaluate and repair/replace shingles as needed.

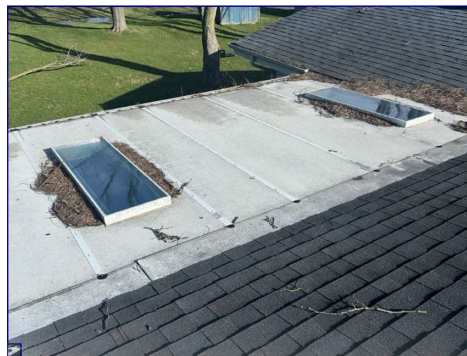
The Skylight

- The skylight has evidence of leaking insulated glass. Recommend a professional contractor repair or replace the glass as needed.

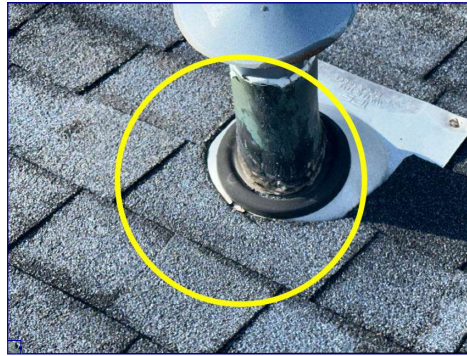
One or more plumbing vent flashing was sunken, which can allow water/ice build-up and cause premature failure and leaking of the plumbing vent. Recommend a professional roofing contractor repair or replace the roof pipe flashing.

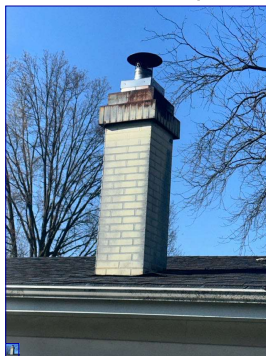
The chimney cap is rusted. Monitor and consult a licensed chimney sweep as needed.

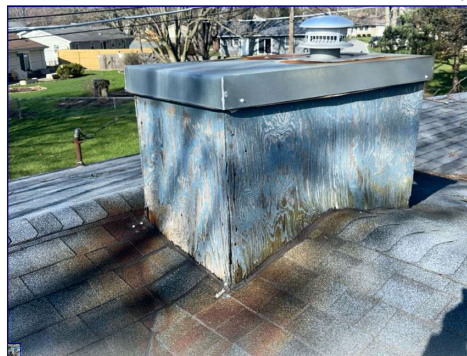
The Chimney Chase has been covered with wood. But is showing a lot of rust stains coming out under onto roof. Recommend monitoring for repair.

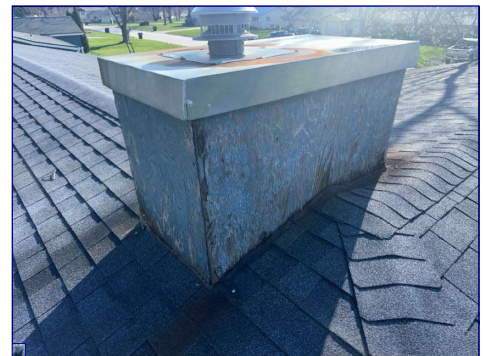
Chimney Chase has some deterioration around bottom edge of wood frame. Recommend monitoring for replacement.

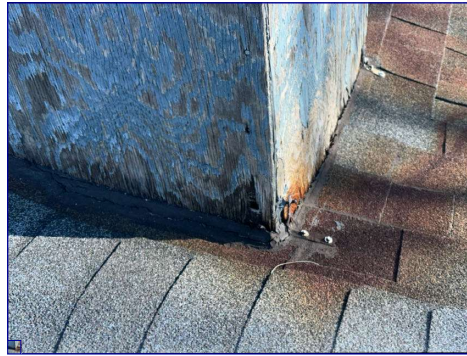
The Chimney Chase has holes in wood covering. Recommend replacing.

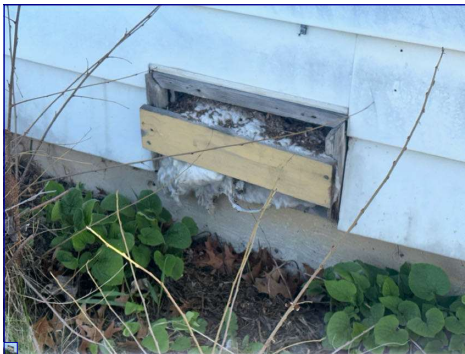
There is some loose and/or missing exterior trim, recommend repair. Consult a professional contractor as needed.

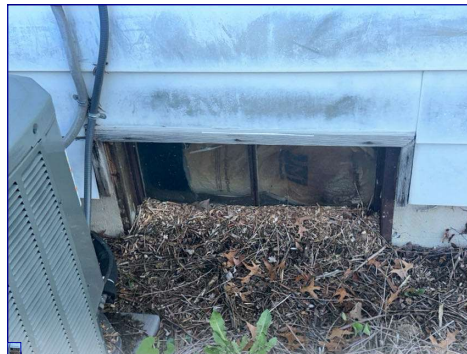
The exterior trim was in need of normal painting maintenance. Recommend a professional painter repair/paint the exterior trim.

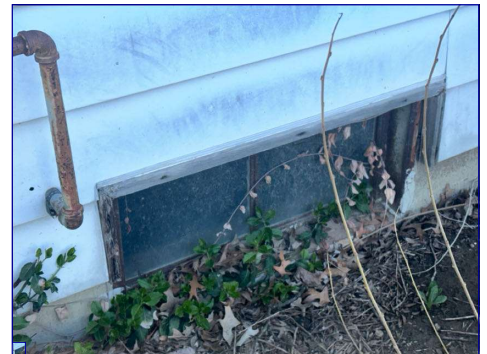
Some of the trim was damaged. Recommend repair or replacement of damaged exterior trim by a licensed contractor.

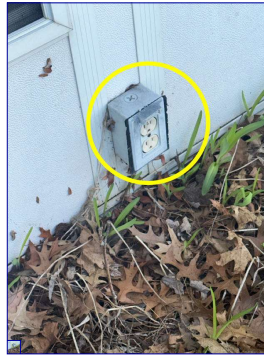
One or more exterior electrical receptacle cover plates were missing or damaged. Recommend a licensed electrician repair.

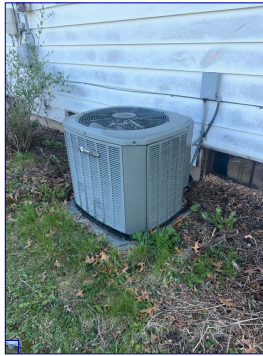
The air conditioner was not operated due to the outside temperature. The unit should not be operated when the outside temperature is less than 60 degrees. Recommend a licensed HVAC contractor clean and check the a/c performance before using.

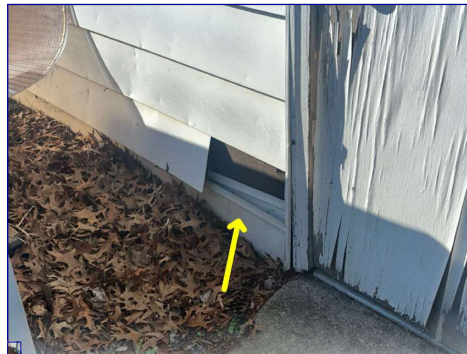
The exterior siding was loose or missing in one or more areas. Recommend a professional contractor secure to prevent damage.

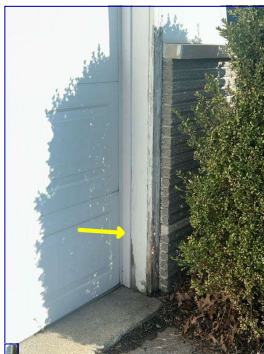
The garage exterior trim needed routine painting maintenance. Recommend a professional painter repair/paint the exterior trim.

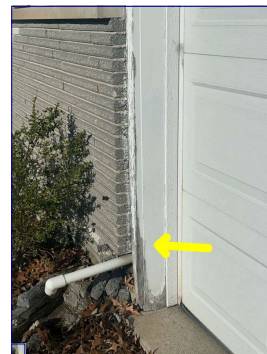
The garage exterior trim needed routine painting maintenance. Recommend a professional painter repair/paint the exterior trim.

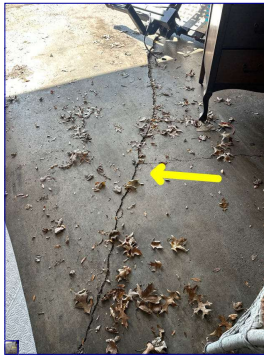
The garage floor has large settling cracks. Recommend further evaluation by a qualified contractor.

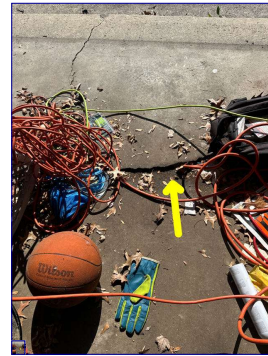
The garage floor has large settling cracks. Recommend further evaluation by a qualified contractor.

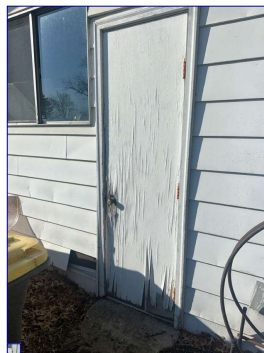
The garage service door is weathered and damaged. Recommend replacement.

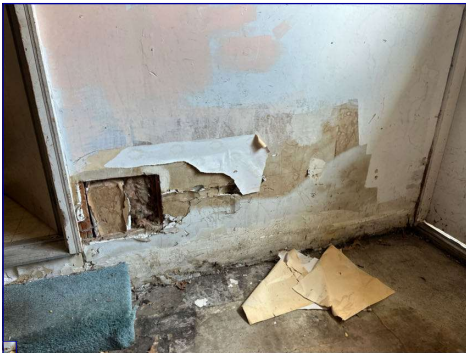
One or more holes or damage was present at the garage firewall. Consult a professional contractor as needed for repair.

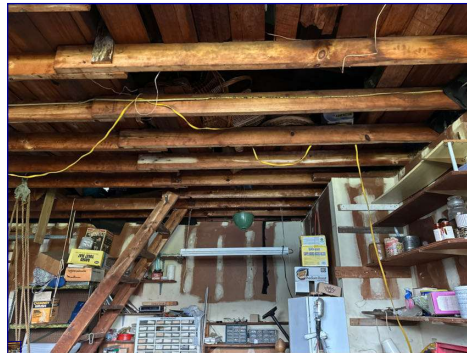
The firewall between the garage and living area is not present - Potential Safety Hazard. Recommend a licensed contractor install a firewall.

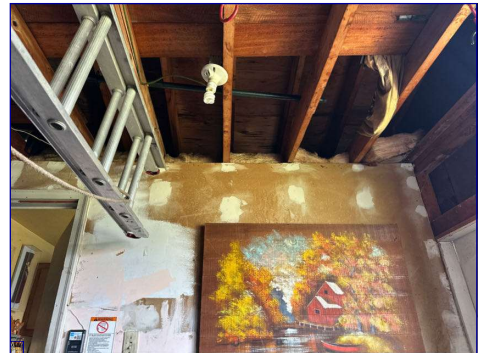
The firewall between the garage and living area is not present - Potential Safety Hazard. Recommend a licensed contractor install a firewall.

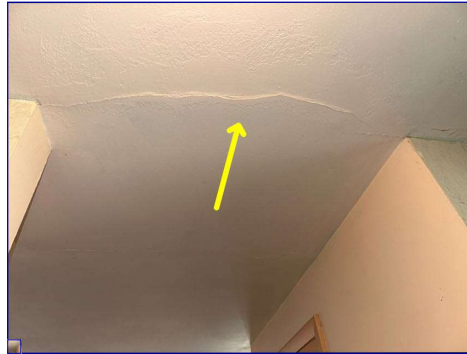
There are typical cracks on the walls/ceilings. Monitor and repair as needed.

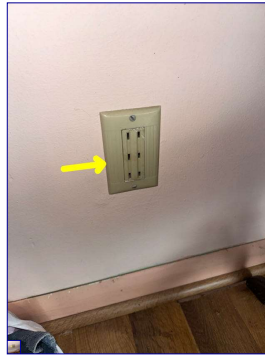
This type of receptacle is not accepted in today's standards. Safety concern having open ground with three plugs. Recommendation is upgrading receptacles by a licensed electrician.

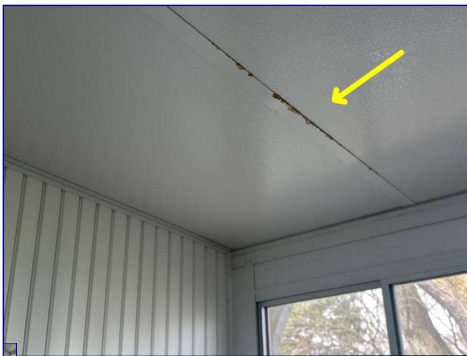
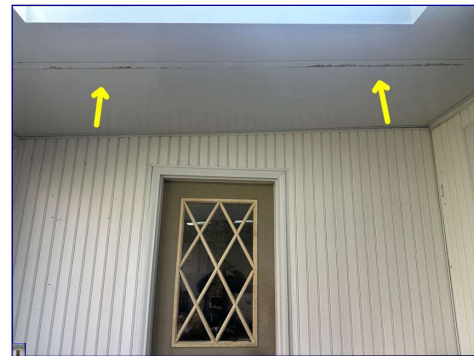
There is staining on the room ceiling. There was no current moisture at the time of the inspection. Monitor and repair as needed.

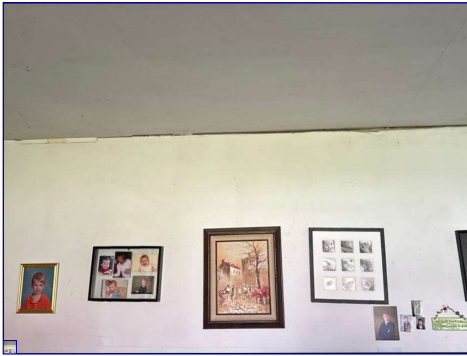
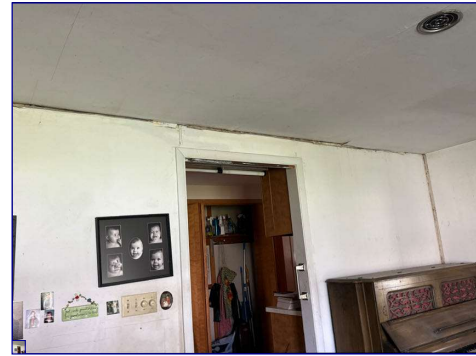
There is staining on the room ceiling. There was no current moisture at the time of the inspection. Monitor and repair as needed.

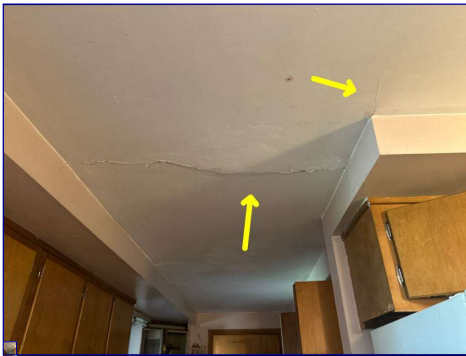
Typical cracking present in the kitchen walls/ceiling.
Recommend monitoring and repair as needed.

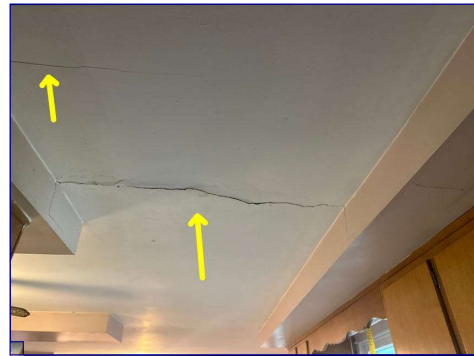
Typical cracking present in the kitchen walls/ceiling.
Recommend monitoring and repair as needed.

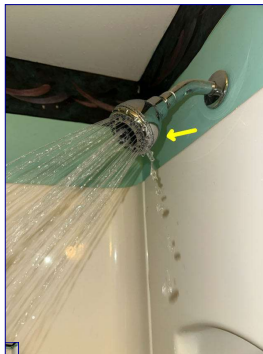
The showerhead is leaking. Recommend a licensed plumber replace as needed.

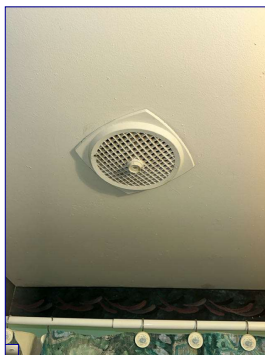
The exhaust fan was noisy in the bathroom. Recommend a professional contractor evaluate and repair or replace as needed.

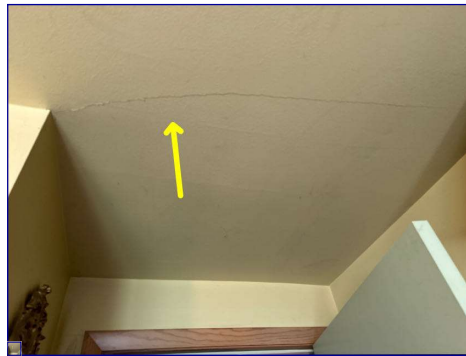
There are typical cracks on the walls/ceilings. Consult with a professional contractor to repair as needed.

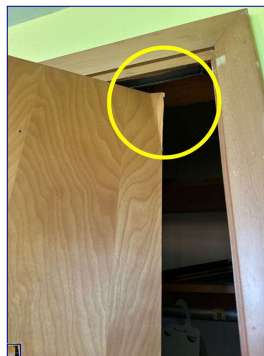
Closet door guide was damaged/missing. Closet door guides will help prevent damage to the closet doors. Recommend installing closet door guides.

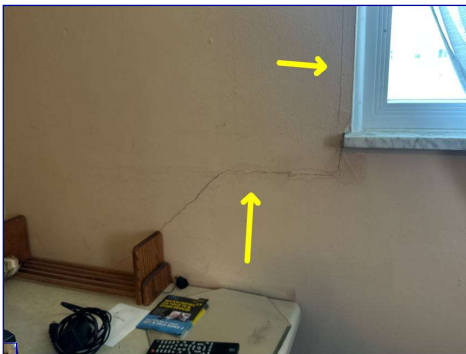
There are typical cracks on the walls/ceilings. Consult with a professional contractor to repair as needed.

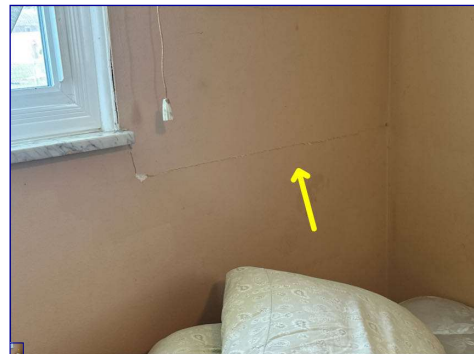
There are typical cracks on the walls/ceilings. Consult with a professional contractor to repair as needed.

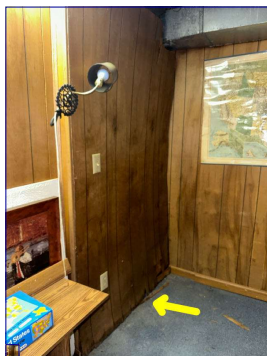
Basement wall is showing moisture at the bottom of paneling causing warping. Recommend further evaluation from a qualified contractor to determine repair.

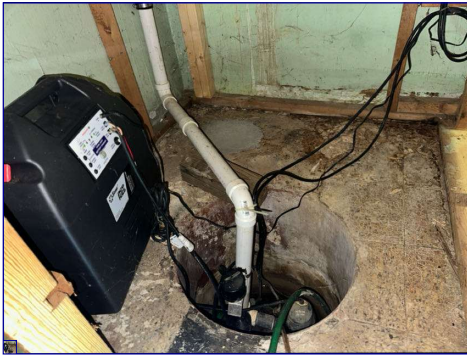
Backup system appears to not be working. Recommend further evaluation by a licensed contractor.

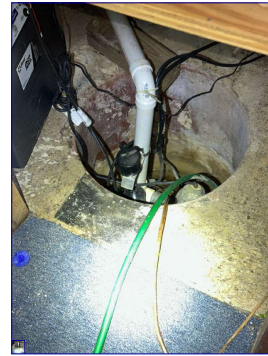
The sump pump was not working properly when tested. Recommend replacing the sump pump. Consult a licensed plumber as needed.

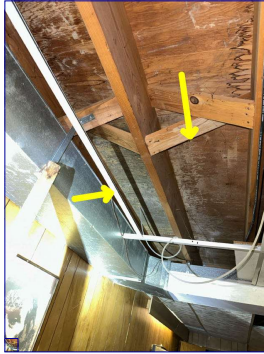
There is an organic growth like substance noticed in the basement at the subfloor. Recommend a professional environmental company test and remediate as needed.

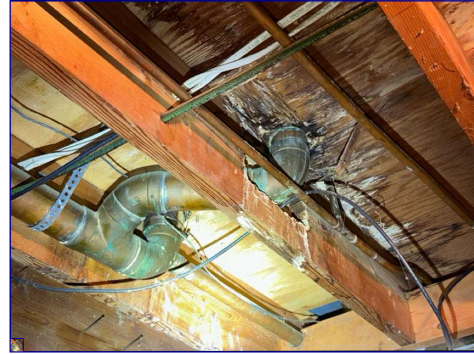
There was previous moisture staining in one or more areas as seen at the basement subfloor. No current moisture was detected. Recommend monitoring and consulting a licensed contractor as needed.

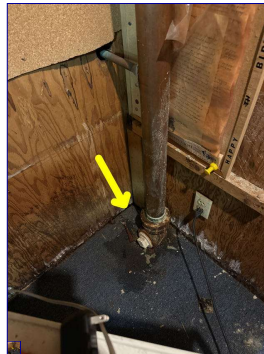
The visible drain/waste piping appears to be leaking. Recommend repair by a licensed plumber.
