# **FAMILYGUARD**

## **HOME INSPECTION REPORT**

**5622 Sawmill Woods Blvd. Fort Wayne, IN 46835**  
**Inspection Prepared For: Seller**

**Date of Inspection: 8/5/2025**  
**Age of House: 20 Years**  
**Weather: Clear**

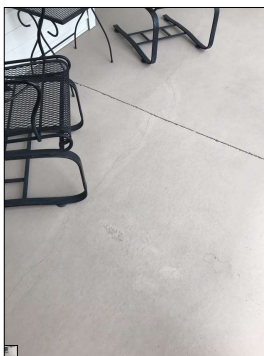
## 4. Patio/Deck

Marginal

Cracks and deterioration along the patio.

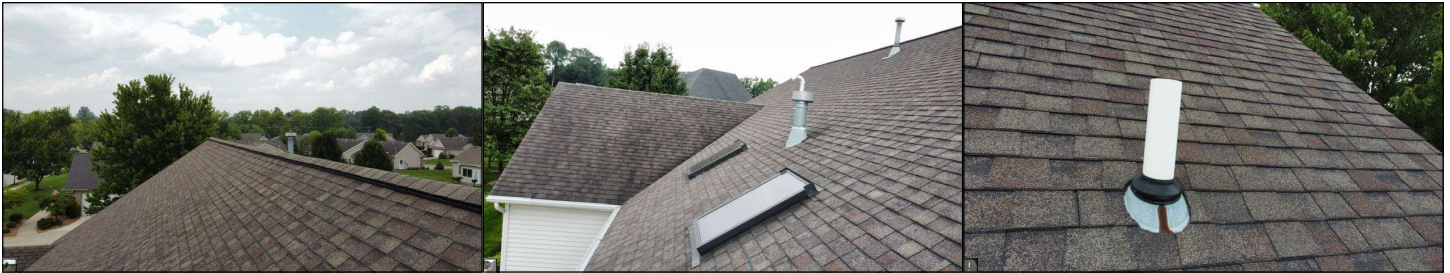
## 5. Condition

General photo of the roof.

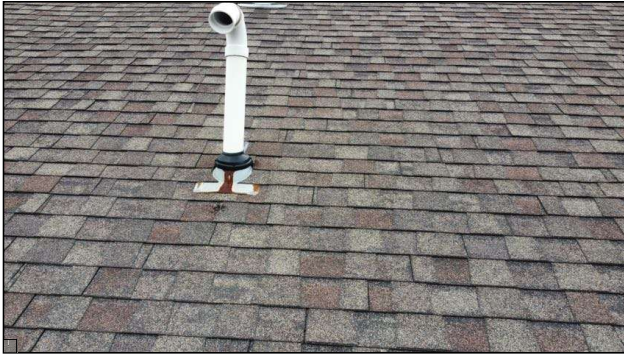
Rust and corrosion along the flashing. Rust and corrosion can create holes in the flashing, thus creating potential leak points.

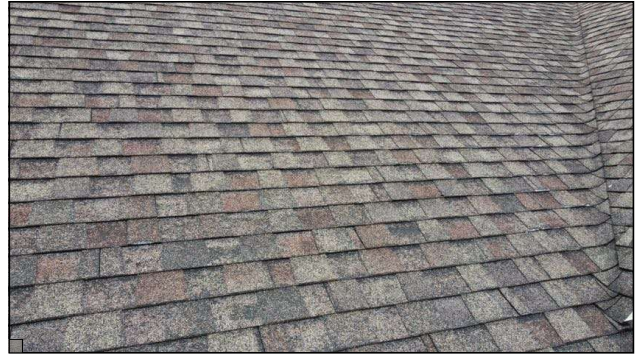
Granule loss along the roof shingles

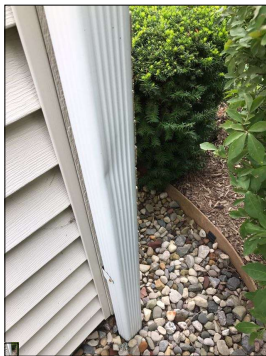
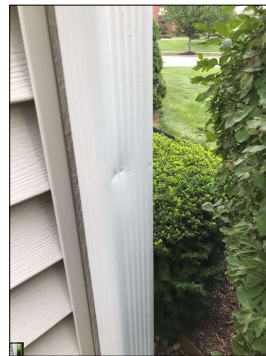
### 1. Gutters

Marginal

Dents/damage along the gutter system.

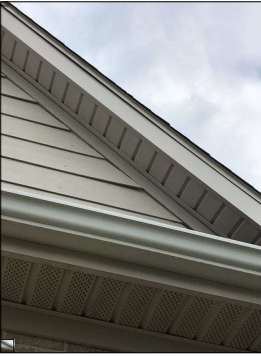
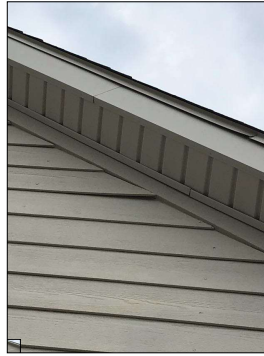
- Cracks and holes in siding, loose/detached siding, gaps in siding and missing siding have the potential to allow water/moisture, insects, bats, mice, wood destroying insects, pests, and rodents into the framing of a house. The intrusion of water/moisture, insects, bats, mice, wood destroying insects, pests, and rodents has the potential to cause damage to a house, such as wood rot, mold, property damage and structural damage.

Warped panels.

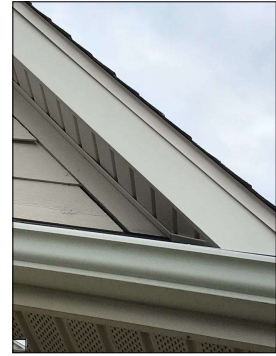
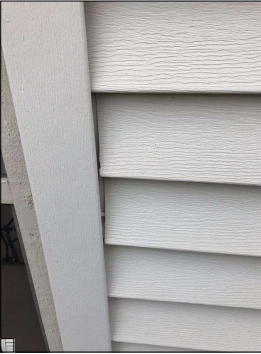
Gaps along the siding.

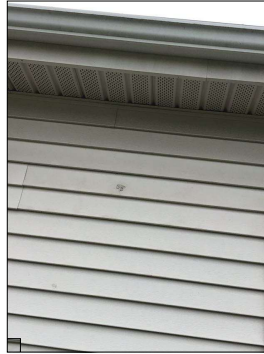
Discoloration along the siding.

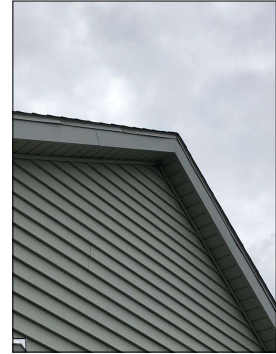
Wasp nest observed. Wasps can cause property damage and potentially sting those dwelling around the house.

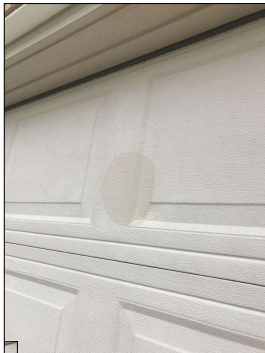
## 1. Overhead Door(s)

Discoloration along the overhead garage door.

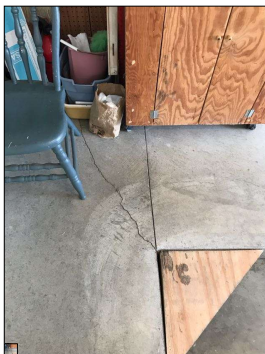
## 4. Floor/Slab

Cracks and deterioration along the floor.

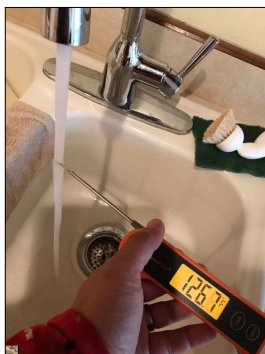
Temperature reading of the hot water during the time of the inspection. The approximate temperature of the hot water was 126 degrees Fahrenheit.

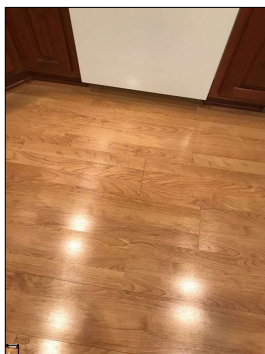
#### 4. Walls/Ceiling

The floor is unconventionally wavy. This is considered abnormal and a defect.

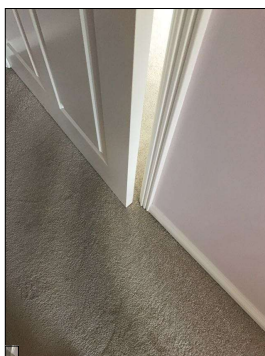
## 4. Doors

The door drags the floor during operation.

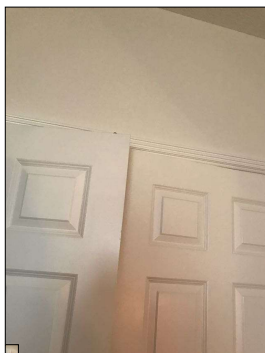
## 5. Doors

The doors are difficult to latch.

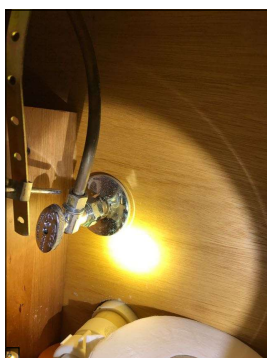
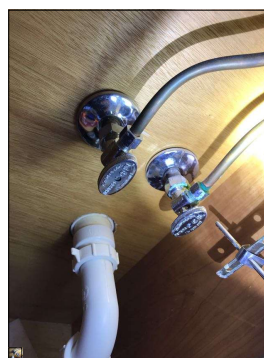
## 2. Sinks/Plumbing

Rust/corrosion along the plumbing pipes.

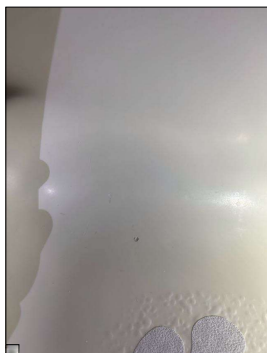
### 3. Shower/Bathtub

Chips along the bathtub. Chips are considered defects and are potential leak points.

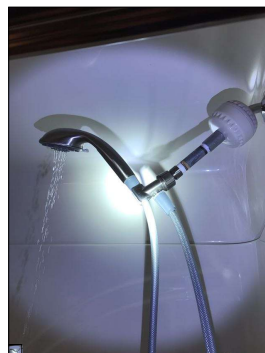
The water pressure is unconventionally low.

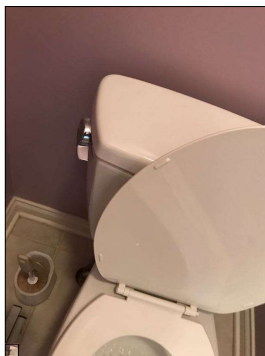
### 4. Toilet

The lever has to be held down for a few seconds for the toilet to flush. This is considered abnormal and a defect. A toilet should properly flush by simply pressing down on the lever and then releasing from the lever.

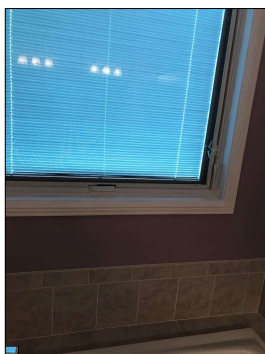
## 8. Windows

- Inoperable

Inoperable window. The window appears to be stuck. Please note, a properly functioning window should be able to easily open.

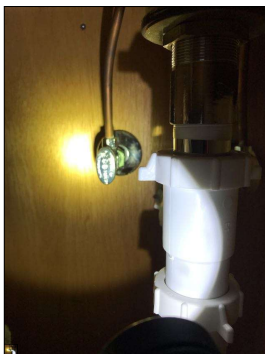
## 2. Sinks/Plumbing

- Limited visibility underneath the sink
- Rust/corrosion

Rust/corrosion along the plumbing pipes.

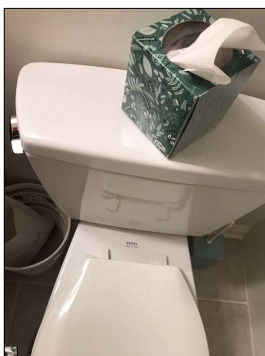
## 4. Toilet

The tank is loose. This is considered a defect. A properly installed tank should not have any movement.

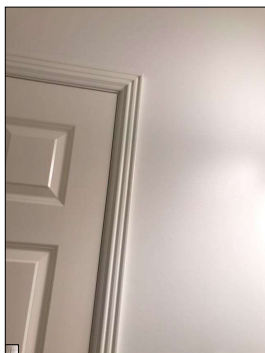
## 7. Doors

The door rubs the frame during operation.

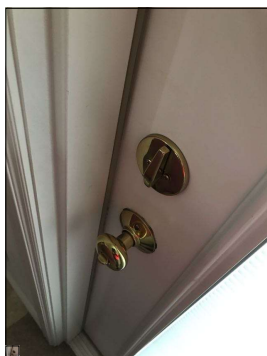
The deadbolt and lock are unconventionally loose.

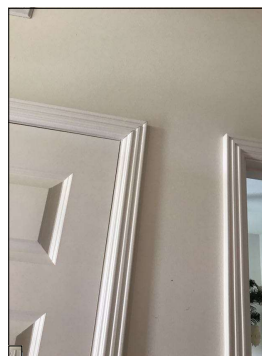
The door rubs the frame during operation.

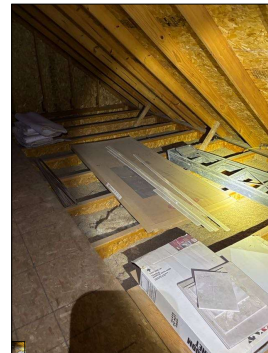
Debris and clutter within the attic.

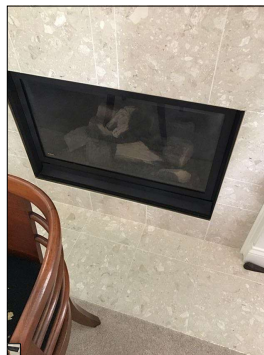
## 4. Fireplace

The fireplace is a gas fireplace. There is no apparent electronic ignition. It is beyond the scope of a general home inspection to light fuel burning appliances. Doing so could cause property damage. Recommend a licensed chimney/fireplace professional further evaluate to make sure the fireplace is in good working condition and is safe to use.

- Not tested
- Before using the fireplace, it is recommended that a licensed chimney/fireplace professional further evaluate to ensure the fireplace is in good working condition and is safe for usage.

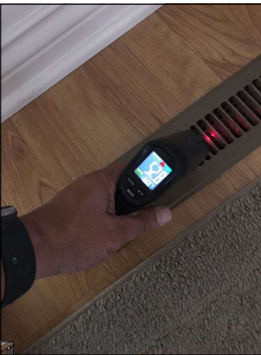
- The temperature drop for the air conditioning was approximately 12 degrees Fahrenheit.

The photo identifies the temperature of the supply air while the air conditioner was in operation. The approximate temperature of the supply air was 52 degrees Fahrenheit.

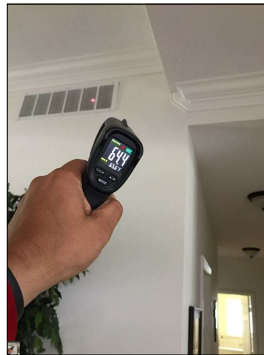
The photo identifies the temperature of the return air while the air conditioner was in operation. The approximate temperature of the return air was 64 degrees Fahrenheit.

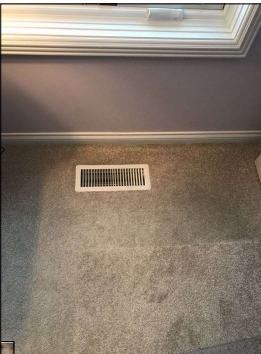
Please note, the house has sub slab HVAC ductwork. Sub slab ductwork can potentially allow water intrusion from the ground. Ground water entering into the ductwork can cause air quality problems and can hinder the performance of the heating and cooling systems. Also, sub slab ductwork can potentially increase indoor radon levels, allow the intrusion of insects, allow the intrusion of wood destroying insects and the intrusion of mice and other rodents.

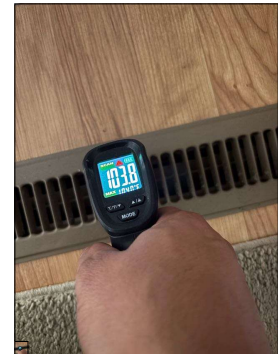
- The temperature rise for the furnace was approximately 20 degrees Fahrenheit.

The photo identifies the temperature of the supply air while the furnace was in operation. The approximate temperature of the supply air was 103 degrees Fahrenheit.

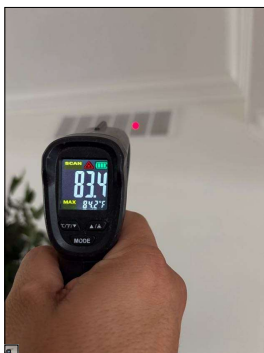
The photo identifies the temperature of the return air while the furnace was in operation. The approximate temperature of the return air was 83 degrees Fahrenheit.
