# **FAMILYGUARD**

## **HOME INSPECTION REPORT**

**5707 Chester Blvd. Fort Wayne, IN 46819**  
**Inspection Prepared For: Seller**

**Date of Inspection: 10/5/2025**  
**Age of House: 69 Years**  
**Weather: Clear**

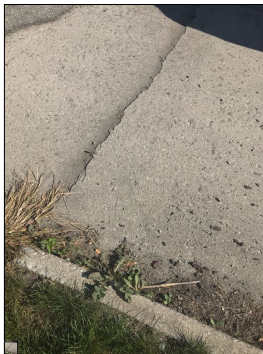
Cracks and deterioration along the driveway.

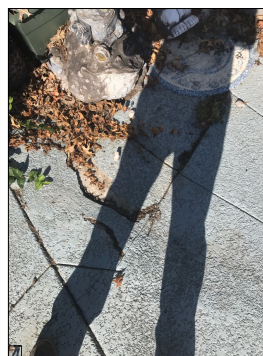
Cracks and deterioration along the service walks.

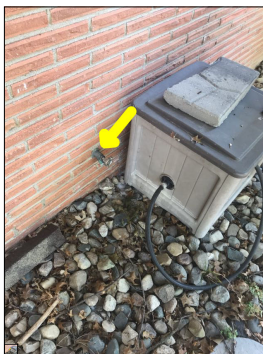
No anti-siphon/frost free valve. The lack of an anti-siphon valve can allow water back flow into the water supply lines, thus contaminating potable water. This is a potential safety hazard. The lack of a frost free valve can allow water to stay within the hose bib, which could potentially freeze during cold months and cause the pipe to rupture. This can cause property damage.

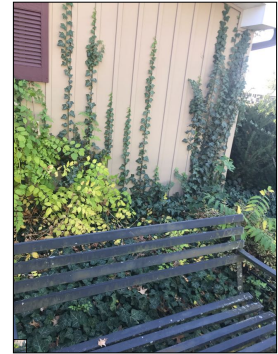
Vegetation against the siding/in proximity of the siding. This is not a recommended practice. Vegetation has the potential to harbor insects, wood destroying insects, rodents and hold moisture. Insects, wood destroying insects, rodents and moisture have the potential to create future problems for a house, such as structural damage, pest infestation and wood rot damage.

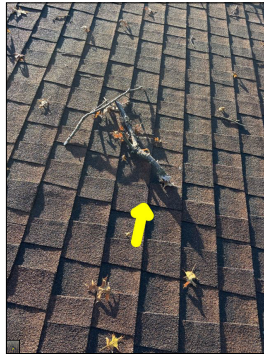
Tree branches observed along the roof. Falling tree branches can cause damage to the roof system, thus resulting in water intrusion into the attic/house.

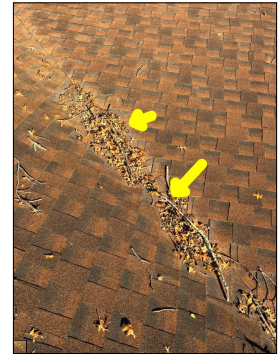
Debris along the roof. Excessive debris along the roof can restrict the ability of the roof to shed water, thus creating potential leak points.

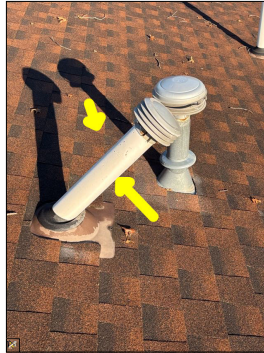
Flue is unconventionally crooked and not plumb. This is considered abnormal and amateur craftsmanship. Amateur craftsmanship is prone to failure.

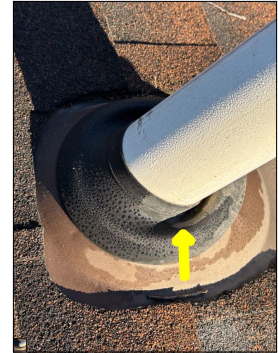
The rubber flashing is concave. This is considered a defect. The concave flashing will act as a trap for water and hold water and snow, thus creating a potential leak point. Flashing is not designed to hold water, flashing is designed to shed water.

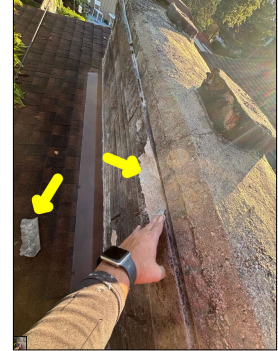
Deterioration and cracking along the chimney. Deterioration and cracks are potential leak points.

- Recommend chimney professional further evaluate and make necessary repairs
- Before using the fireplace, it is recommended that a licensed chimney/fireplace professional further evaluate to ensure the fireplace is in good working condition and is safe for usage.

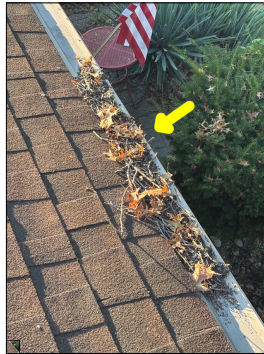
The gutter system is dirty and needs to be cleaned. A dirty gutter system can cause excessive water to accumulate around the house, thus potentially causing water intrusion into the house or potential foundation problems due to excessive hydrostatic pressure. Also, a dirty gutter system can cause excessive water to flow along the siding which could allow water to get behind the siding. An active or intermittent water intrusion source can cause mold growth and property damage.

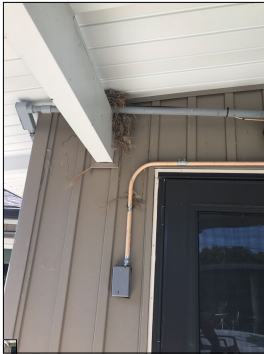
Bird's nest. Wildlife activity can cause property damage.

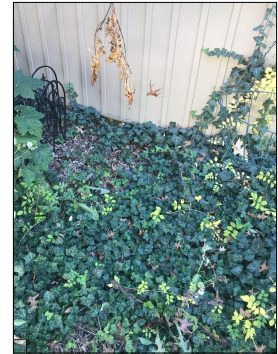
The siding is in proximity to the ground. Siding should have at least 6 to 8 inches of clearance above the ground. Maintaining proper clearances reduces access to wood structures behind the siding and helps preserve the house. The proper clearances help restrict access from wood destroying insects and/or moisture/water that might find its way behind the siding.

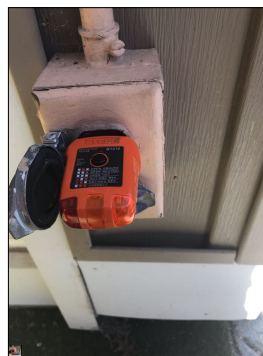
Open ground receptacles.

- Non **GFCI** protected
- Recommend licensed electrician further evaluate and make necessary repairs.

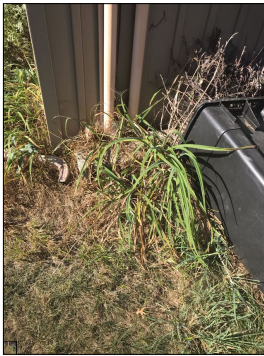
The siding is in proximity to the ground. Siding should have at least 6 to 8 inches of clearance above the ground. Maintaining proper clearances reduces access to wood structures behind the siding and helps preserve the house. The proper clearances help restrict access from wood destroying insects and/or moisture/water that might find its way behind the siding.

- Limited visibility and accessibility due to excessive vegetation
- Cracks/gaps/holes
- Recommend general contractor further evaluate and make necessary repairs

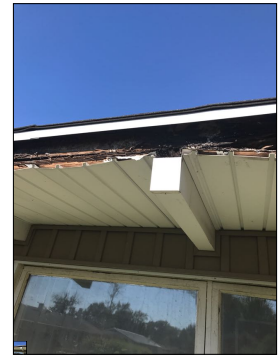
Wood rot damage.

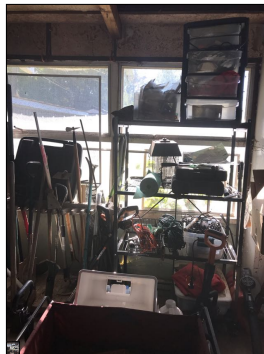
Aged windows.

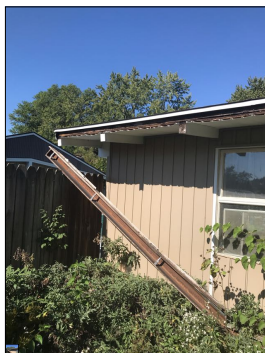
| Garage | | |
|---|---|---|
| Page 12 Item: 12 | Gutters | • Partially detached gutter system and damage along the gutter system. |

Damaged gutter system.

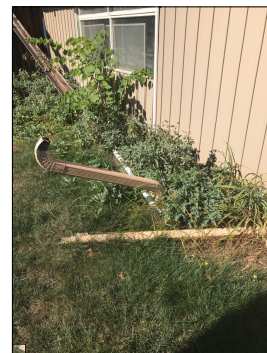
Damaged gutter system.

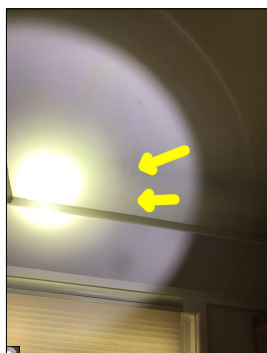
Discoloration along the ceiling and signs of previous water damage. An active or intermittent water source can cause mold growth and property damage.

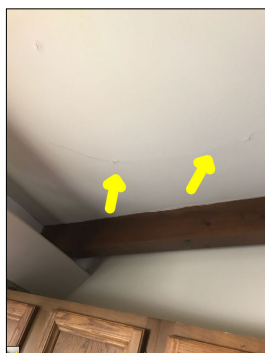
Cracks along the ceiling and nail pops.

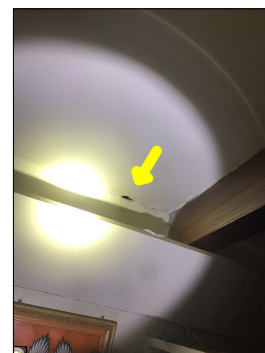
Damage along the ceiling and signs of previous water damage.

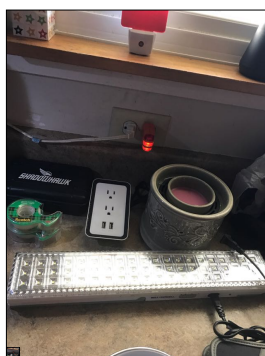
Non GFCI protected receptacles.

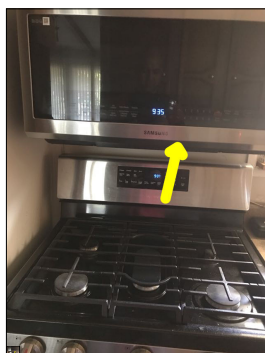
The microwave is unconventionally close to the burners. This is considered abnormal and amateur craftsmanship. This is also a potential fire hazard.

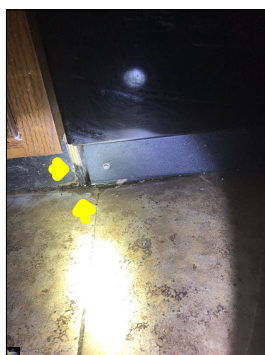
Moisture observed underneath the dishwasher and a mold like substance. An active or intermittent water source can cause mold growth and property damage.

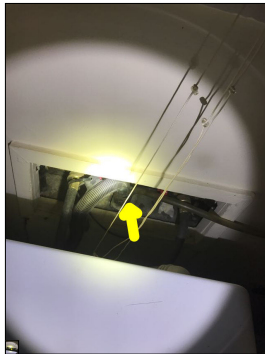
Aged copper drain pipes. Copper pipes make good water supply lines, however, they are not as effective for drain pipes. This is because copper drain pipes are thin walled, which means they are not very robust. Also, some cleaning products and house hold products are acidic which causes copper pipes to corrode. Also, urine is acidic, which can also cause copper pipes to corrode. Due to the age of copper drain pipes, repairs should be anticipated and possible replacement of copper drain pipes should be anticipated.

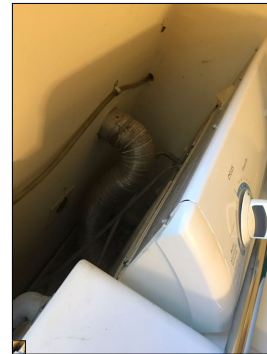
There is no an apparent fuel shut off valve behind the dryer. This is considered abnormal, amateur craftsmanship and a potential safety hazard.

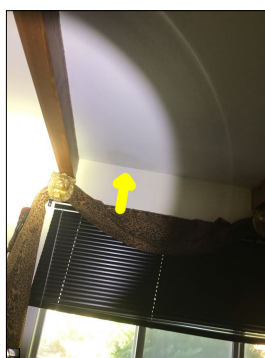
There is a contrast of texture/color along the ceiling. This is considered abnormal, amateur craftsmanship and an indication that previous repairs were made to the ceiling.

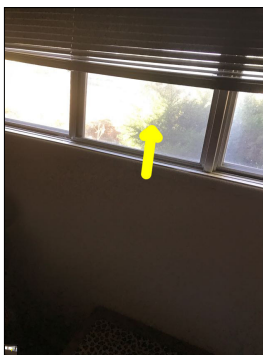
Aged windows.

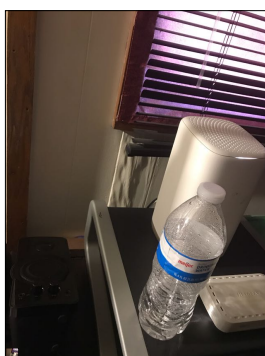
Bubbling along the wall underneath the window. This could potentially be a sign of previous water damage.

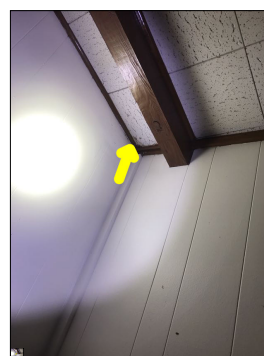
Discoloration along the ceiling and signs of previous water damage. An active or intermittent water source can cause mold growth and property damage.

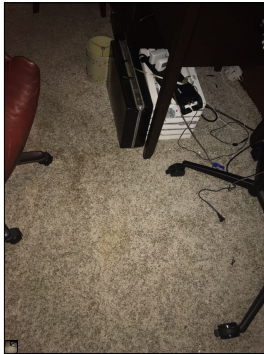
Uneven surfaces along the floor. Uneven surfaces are a potential trip hazard.

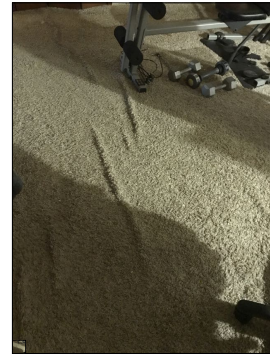
Loose carpet

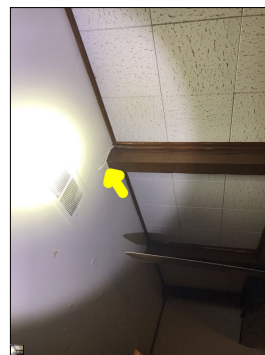
The wires are not wrapped in conduit. This is considered abnormal, amateur craftsmanship and a potential safety hazard. Wires should be wrapped in conduit to protect both humans and the electrical wiring. Wires that lack conduit can potentially get pulled, become loose, or damaged, thus creating shock hazards and/or fire hazards.

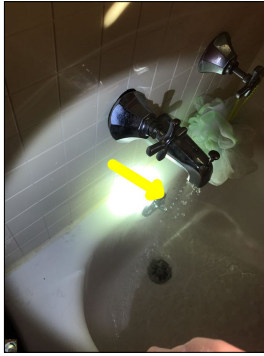
The bathtub faucet leaks while the showerhead is in operation. This is considered a defect. A properly functioning diverter will not allow any water through the bathtub faucet while the showerhead is in operation.

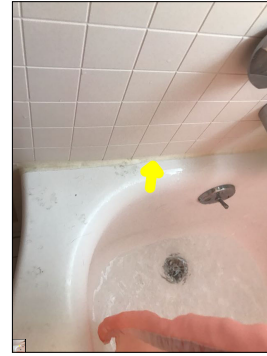
Unconventional beads of caulk along the shower/bath. This is considered amateur craftsmanship. The beads of caulk will discolor and deteriorate with time and potentially mold. The caulk will require regular maintenance to prevent water from getting underneath the caulk and behind the shower/bath wall. A properly installed shower/bath will have edges that overlap and the overlapped edges will properly shed water and create liquid tight seams. Beads of caulk can actually trap water and allow water to get behind the shower/bathtub wall and within the wall cavities, thus causing potential mold growth and property damage.

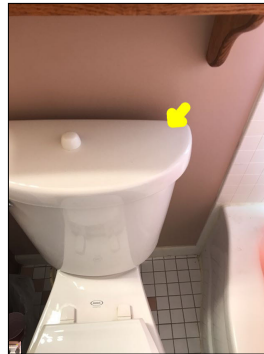
The tank is loose. This is considered a defect. A properly installed tank should not have any movement.

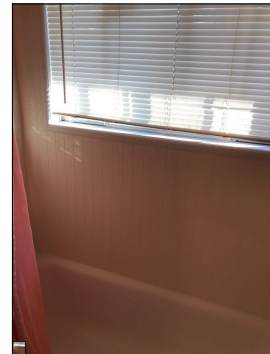
There is a window located in the bathtub/shower. This is not a recommended practice. Some window materials can absorb water, thus causing mold growth and property damage, such as wood rot. Also, the window can potentially allow water to get behind the wall cavity, thus potentially causing mold growth and property damage.

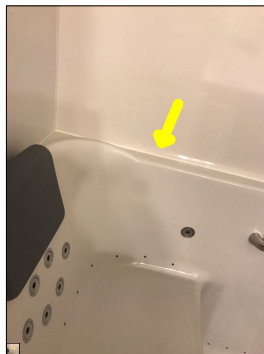
Unconventional beads of caulk along the shower/bath. This is considered amateur craftsmanship. The beads of caulk will discolor and deteriorate with time and potentially mold. The caulk will require regular maintenance to prevent water from getting underneath the caulk and behind the shower/bath wall. A properly installed shower/bath will have edges that overlap and the overlapped edges will properly shed water and create liquid tight seams. Beads of caulk can actually trap water and allow water to get behind the shower/bathtub wall and within the wall cavities, thus causing potential mold growth and property damage.

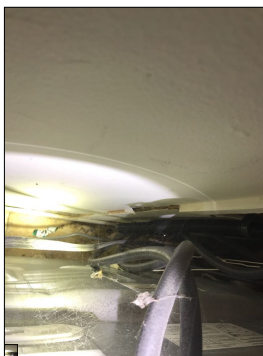
Damage observed along the wall behind the washer.

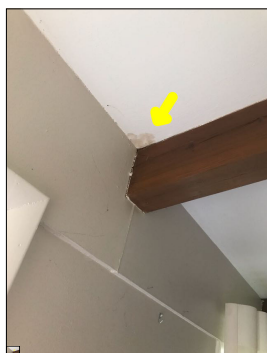
Discoloration along the ceiling and signs of previous water damage. An active or intermittent water source can cause mold growth and property damage.

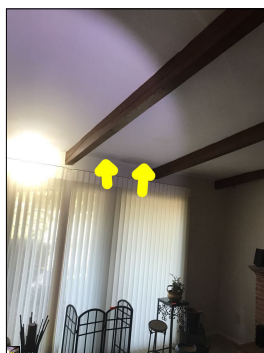
There is a contrast of texture/color along the ceiling. This is considered abnormal, amateur craftsmanship and an indication that previous repairs were made to the ceiling.

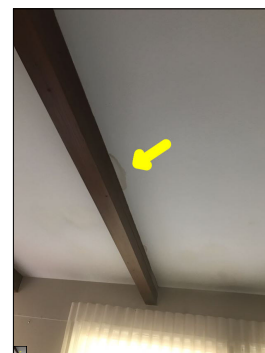
Discoloration along the ceiling and signs of previous water damage. An active or intermittent water source can cause mold growth and property damage.

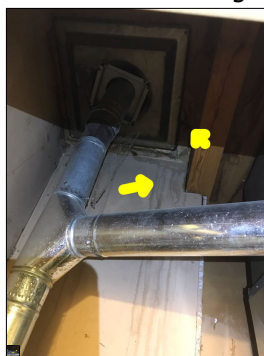
Discoloration along the ceiling/wall and signs of previous water damage. An active or intermittent water source can cause mold growth and property damage.

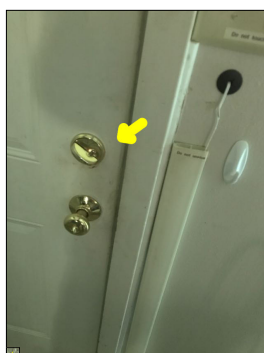
The deadbolt rubs the strike plate during operation. This is considered a defect. The strike plate should move smoothly during operation.

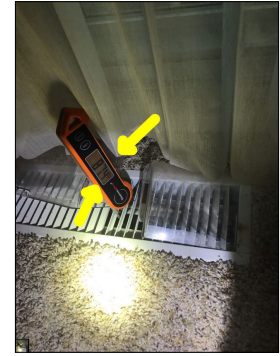
| Garage | | |
|---|---|---|
| Page 38 Item: 3 | Heating System | • The approximate temperature of the supply air was 87 degrees Fahrenheit. This is considered unconventionally low and does not meet the industry standards. Forced air heat should have a supply temperature of approximately 115+ degrees. Several supply vents were checked against the furnace and all other supply vents had a similar supply temperature. Due to the abnormalities, recommend licensed HVAC technician further evaluate and make necessary repairs. Please note, the furnace was in operation for over 10 minutes before temperature readings were conducted. |

- The approximate temperature of the supply air was 87 degrees Fahrenheit. This is considered unconventionally low and does not meet the industry standards. Forced air heat should have a supply temperature of approximately 115+ degrees. Several supply vents were checked against the furnace and all other supply vents had a similar supply temperature. Due to the abnormalities, recommend licensed HVAC technician further evaluate and make necessary repairs. Please note, the furnace was in operation for over 10 minutes before temperature readings were conducted.

The photo identifies the temperature of the supply air while the furnace was in operation. The approximate temperature of the supply air was 87 degrees Fahrenheit. This is considered unconventionally low and does not meet the industry standards. Forced air heat should have a supply temperature of approximately 115+ degrees.

- Recommend licensed HVAC technician further evaluate and make necessary repairs

Several supply vents were checked against the furnace and all other supply vents had a similar supply temperature as in the photo. Due to the abnormalities, recommend licensed HVAC technician further evaluate and make necessary repairs. Please note, the furnace was in operation for over 10 minutes before temperature readings were conducted.

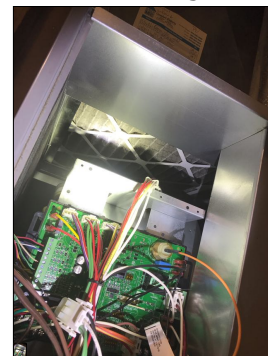
The filter is dirty and needs to be replaced. A dirty filter can restrict airflow, thus potentially causing defects with the heating system. Also, a dirty filter can create poor indoor air quality within the house.

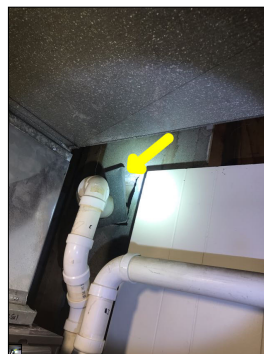
Unconventional block displaced. This appears to be part of the chimney.

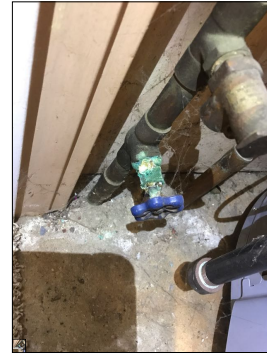
Corrosion along the apparent main water shut off valve.

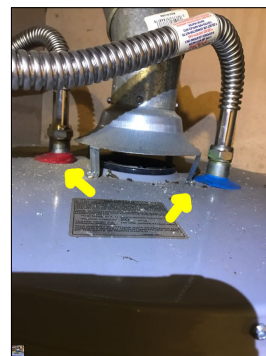
The plastic rings adjacent to the water heater flue are melted. This is an indication that the water heater is backdrafting. This is a potential safety hazard as it can release carbon monoxide into the house.

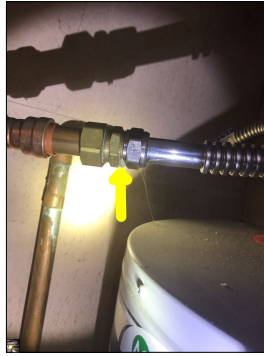
Corrosion along the water supply lines.

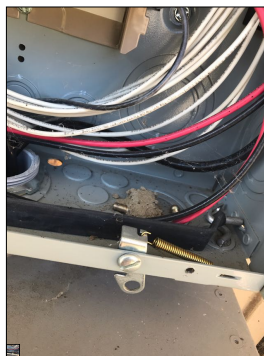
Apparent wasp nest within the electrical panel. Wildlife activity can cause property damage.

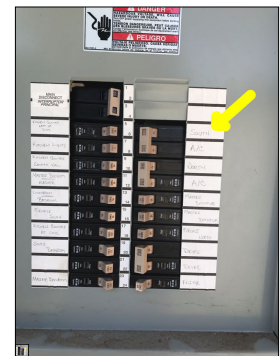
The air conditioning (A/C) circuit breaker is oversized according to the data plate on the condenser. This is a potential safety hazard. According to the data plates for both AC units, the breakers should not exceed 25 amps. The current breaker for one of the units is 30 amps.

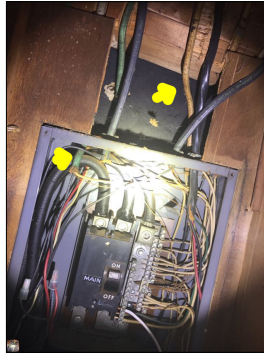
Cloth sheathing wiring observed. Cloth sheathing wiring is considered aged wiring. The cloth sheathing can become brittle due to age, thus causing wires to be exposed, which can cause spark, arcing and or fire. Also, cloth sheathing can potentially have asbestos in it. Asbestos is a potential safety hazard.

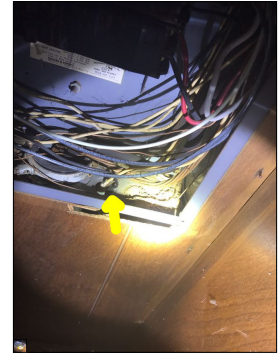
Wires routed through the knockout without a bushing or clamp. This is considered a safety hazard as the metal edge of the knockout could penetrate the wires, thus causing spark and a fire.

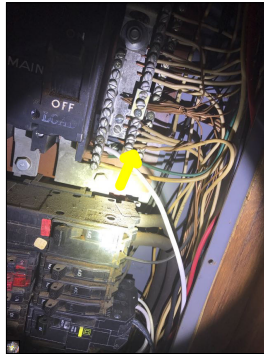
Double tapped neutral wires. Neutral wires should not share a terminal with any other wires, including ground wires. Double tapped neutrals are considered a safety hazard. Double tapped neutral wires do not allow the circuit to be isolated if the circuit needs to be worked on. Also, double tapped neutral wires under the same terminal can become loose, which could lead to arcing, overheating, spark and/or fire.
