FAMILYGUARD

HOME INSPECTION REPORT

1780 S 11th St. Albion, IN 46701
Inspection Prepared For: Seller

Date of Inspection: 12/5/2025
Age of House: 53 Years
Weather: Recent Snow

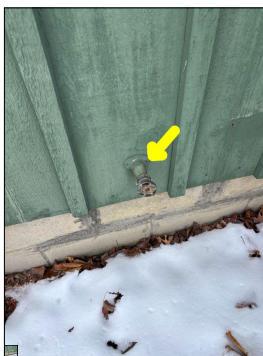
- No anti-siphon/frost free valve

No anti-siphon/frost free valve. The lack of an anti-siphon valve can allow water back flow into the water supply lines, thus contaminating potable water. This is a potential safety hazard. The lack of a frost free valve can allow water to stay within the hose bib, which could potentially freeze during cold months and cause the pipe to rupture. This can cause property damage.

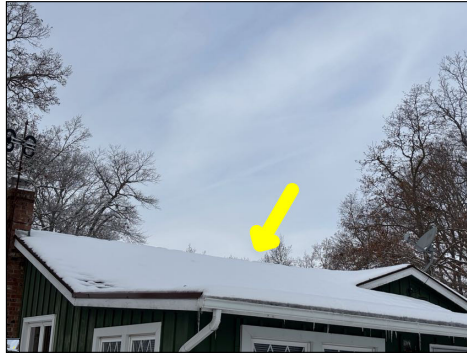
Snow and ice along the roof. Visibility and accessibility were restricted . The roof could not be properly inspected due to the snow and ice.

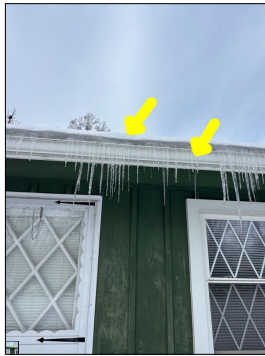
Ice within the gutter system. Ice in the gutter system can cause ice damming, which can cause water intrusion within the eaves and into the house. An active or intermittent water source can cause property damage and mold growth. Also, ice can become heavy. The weight of the ice can pull down the gutter system, thus causing property damage.

- Recommend general contractor further evaluate and make necessary repairs
- A defective gutter/drainage system can cause excessive water to accumulate around the house, thus potentially causing water intrusion into the house or potential foundation problems due to excessive hydrostatic pressure. Also, a defective gutter/drainage system can cause excessive water to flow along the exterior walls, which could allow water to get behind the siding, soffit and fascia. An active or intermittent water intrusion source can cause mold growth and property damage.

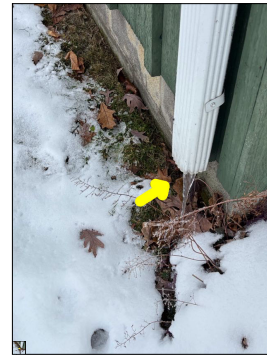
Missing downspout elbows.

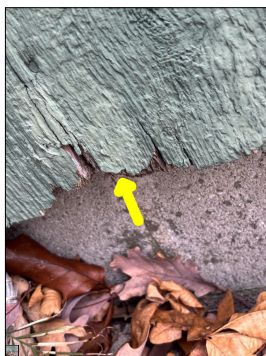
Deterioration along the siding.

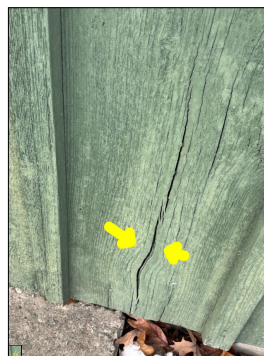
Splits along the siding.

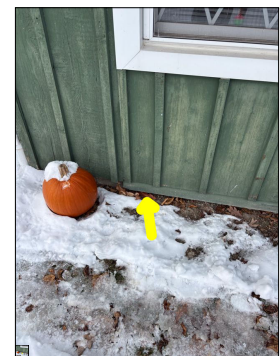
The siding is in proximity to the ground. Siding should have at least 6 to 8 inches of clearance above the ground. Maintaining proper clearances reduces access to wood structures behind the siding and helps preserve the house. The proper clearances help restrict access from wood destroying insects and/or moisture/water that might find its way behind the siding.

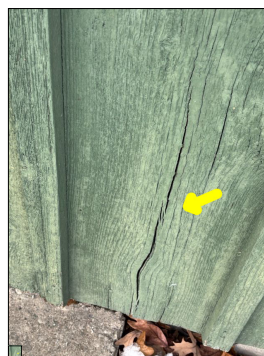
The siding color has faded with age.

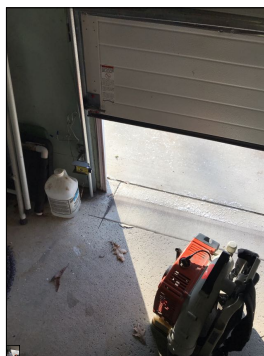
The photo eye sensors are too high. This is a potential safety hazard. The photo eye sensors should be between four and six inches from the floor.

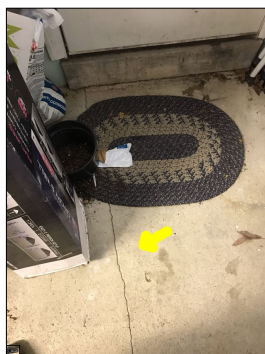
Cracks along the floor.

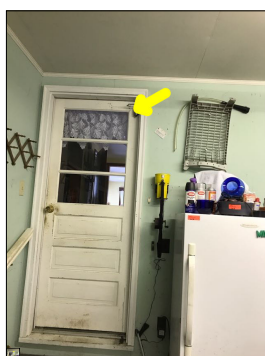
The door that separates the interior of the house from the garage is not a proper fire rated door. This is a potential safety hazard.

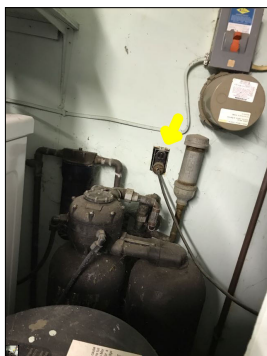
Missing receptacle cover.

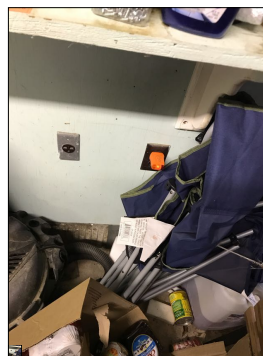
Open ground receptacles.

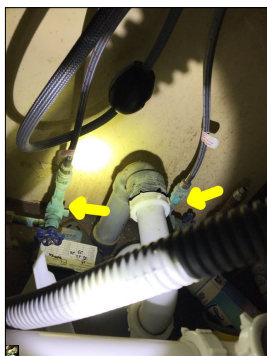
Rust/corrosion along the plumbing pipes.

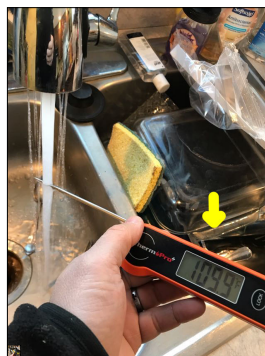
Temperature reading of the hot water during the time of the inspection. The approximate temperature of the hot water was 109 degrees Fahrenheit.

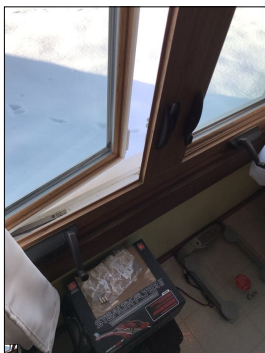
Missing window screens.

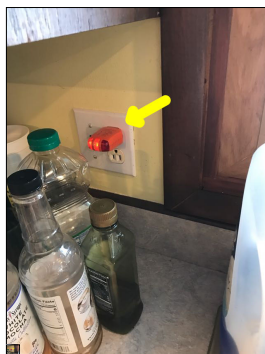
Non GFCI protected receptacles.

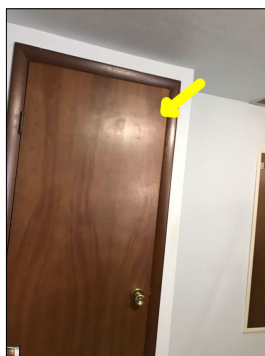
The door rubs the frame during operation.

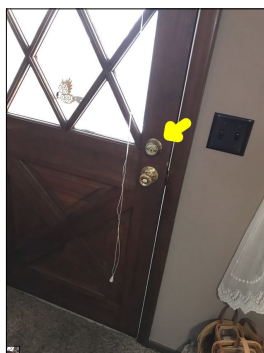
Double-keyed deadbolt lock. Double-keyed deadbolts are considered a safety hazard as they could create restricted egress.

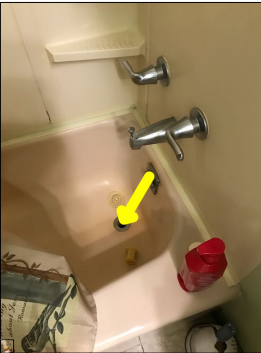
Missing drain stopper.

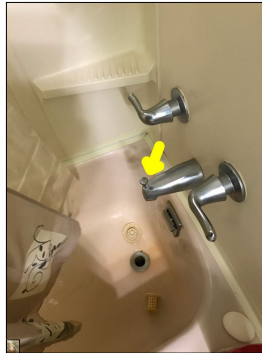
The diverter rod is stuck. It's currently in a position where only the showerhead works.

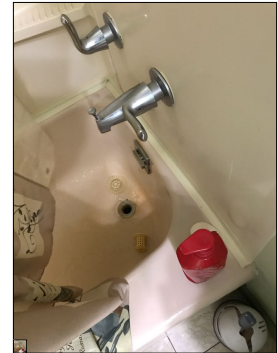
The bathtub faucet leaks while the showerhead is in operation. This is considered a defect. A properly functioning diverter will not allow any water through the bathtub faucet while the showerhead is in operation.

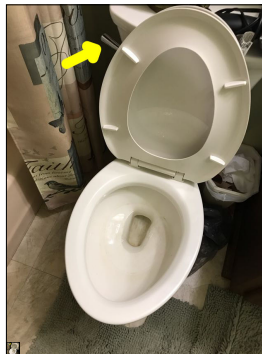
The lever has to be held down for a few seconds for the toilet to flush. This is considered abnormal and a defect. A toilet should properly flush by simply pressing down on the lever and then releasing from the lever.

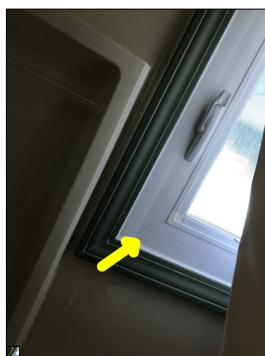
There is a window located in the bathtub/shower. This is not a recommended practice. Some window materials can absorb water, thus causing mold growth and property damage, such as wood rot. Also, the window can potentially allow water to get behind the wall cavity, thus potentially causing mold growth and property damage.

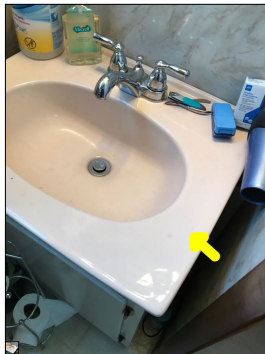
The sink is loose.

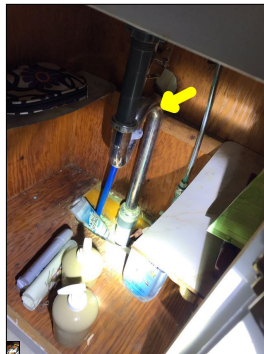
S-trap underneath the sink. S-traps no longer meet modern day plumbing standards. S-traps have the potential to siphon and become dry, thus creating the potential to allow sewer gases into the house. S-traps have the potential to make a knocking/gurgling sound when draining.

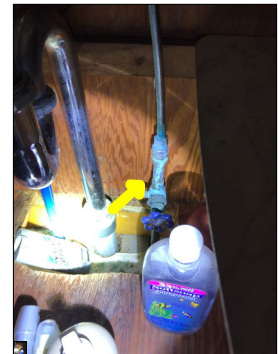
Rust/corrosion along the plumbing pipes.

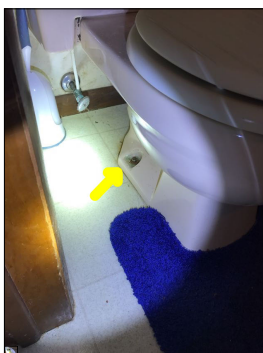
Rust and corrosion along the toilet anchor bolts. This is considered a defect and the rust and corrosion can cause the toilet to become loose and potentially leak.

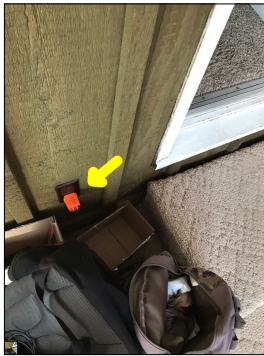
The receptacle is inoperable.

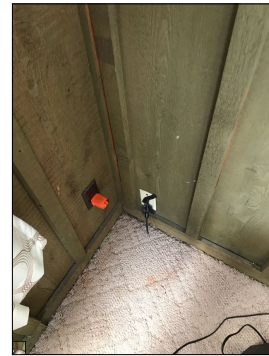
The receptacle is inoperable.

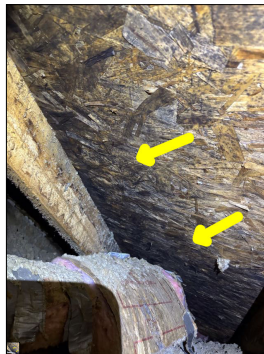
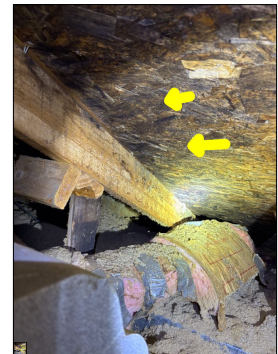
Attic/Structure/Framing/Insulation		
Page 24 Item: 6	Sheathing/Framing	• Mold like substance along the sheathing/framing. An active or intermittent water source can cause mold growth and property damage, such as wood rot damage.
Crawl Space		
Page 26 Item: 6	Beams/Subfloor/Joists/Columns	• Mold like substance along the subfloor and floor joists. An active or intermittent water source can cause mold growth and property damage.

- **Mold like substance along the sheathing/framing. An active or intermittent water source can cause mold growth and property damage, such as wood rot damage.**

Mold like substance along the sheathing/framing. An active or intermittent water source can cause mold growth and property damage, such as wood rot damage.

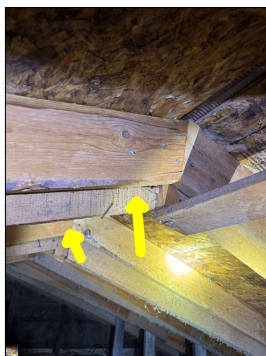
Sistered trusses observed in the attic. This is an indication of previous structural repairs.

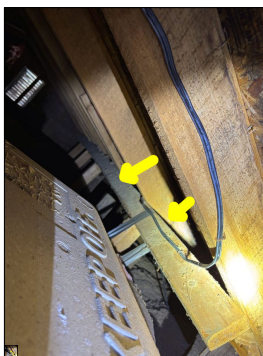
Added supports/webbing observed in the attic. This is an indication of previous structural repairs

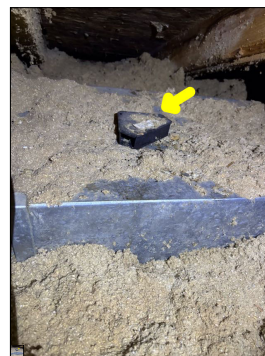
Pest control. Wildlife activity can cause property damage.

- Signs of wildlife activity
- Debris within the insulation
- Recommend exterminator further evaluate and make necessary treatments

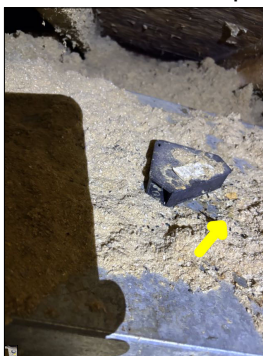
Mice/rodent droppings. Wildlife activity can cause property damage.

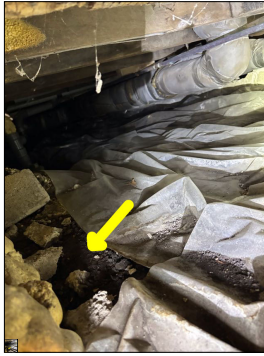
The crawl space has a dirt floor. Dirt floors are not recommended. A dirt floor can allow the intrusion of moisture, insects, wood destroying insects, radon, mice, and rodents. An active or intermittent water source can cause mold growth and property damage, such as wood rot damage. It is recommended that the crawl space be properly encapsulated.

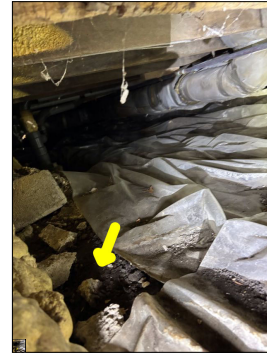
Moisture/dampness observed. This is considered a defect. An active or intermittent water source can cause mold growth and property damage.

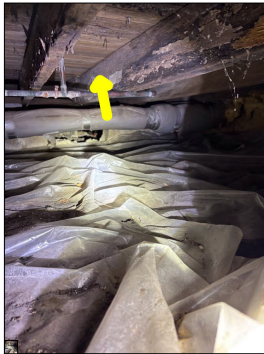
There is no insulation along the subfloor. This is not a recommend practice. The lack of insulation does not meet the industry standard. An insulated subfloor can help maintain desired room temperatures within the above living areas, thus reducing utility expenses with heating and cooling.

- Recommend properly encapsulating the crawl space
- Recommend general contractor further evaluate and make necessary repairs

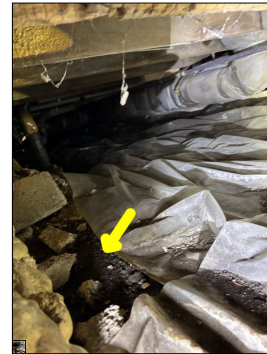
The vapor barrier is not properly installed. The vapor barrier should be sealed along the foundation walls and sealed along any columns to prevent moisture intrusion from the ground. An active or intermittent water source can cause mold growth and property damage.

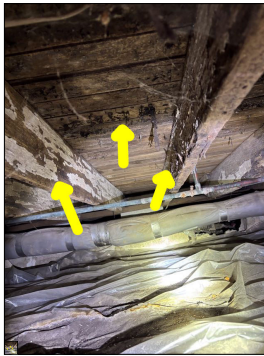
• Mold like substance along the subfloor and floor joists. An active or intermittent water source can cause mold growth and property damage.

Mold like substance along the subfloor and floor joist. An active or intermittent water source can cause mold growth and property damage.

- Limited visibility
- Mold like substance
- Recommend general contractor further evaluate and make necessary repairs

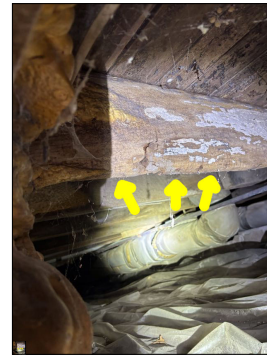
Wood rot damage observed. Wood rot is caused by a wood-decaying fungi.

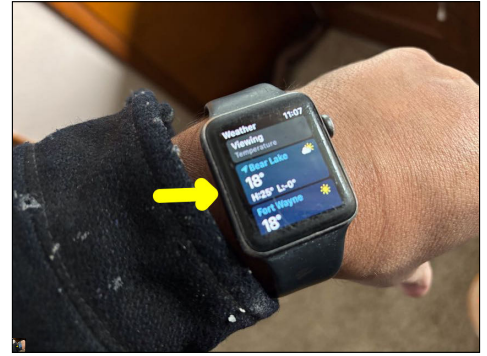
The outdoor temperature during the time of the inspection was approximately 18 degrees Fahrenheit. Due to the cold weather conditions during the time of the inspection. The performance level and working condition of the air conditioner could not be determined.

- Needs cleaning/serviced
- No current service record
- Service recommended

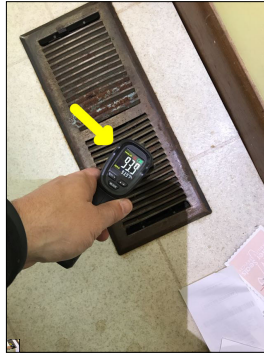
The photo identifies the temperature of the supply air while the heat pump was in operation. The approximate temperature of the supply air was 93 degrees Fahrenheit.

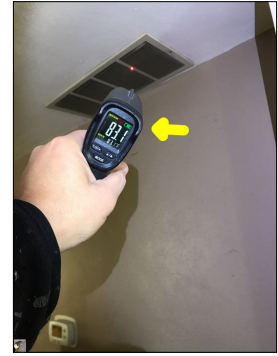
The photo identifies the temperature of the return air while the heat pump was in operation. The approximate temperature of the return air was 83 degrees Fahrenheit.

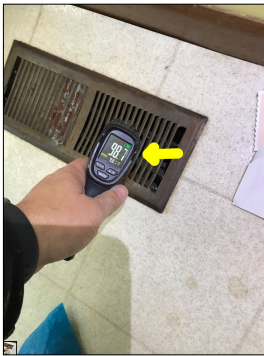
The photo identifies the temperature of the supply air while the furnace was in operation. The approximate temperature of the supply air was 98 degrees Fahrenheit.

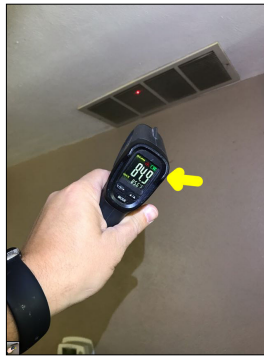
The photo identifies the temperature of the return air while the furnace was in operation. The approximate temperature of the return air was 84 degrees Fahrenheit.

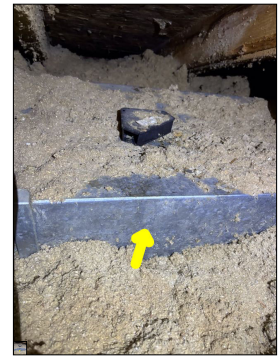
The HVAC ductwork lacks insulation. This is not a recommended practice. The lack of insulation along the ductwork can allow moisture and condensation to form along the ductwork. An active or intermittent water source can cause the ductwork to rust and corrode. A water source can also cause mold growth and property damage. This is located in the attic.

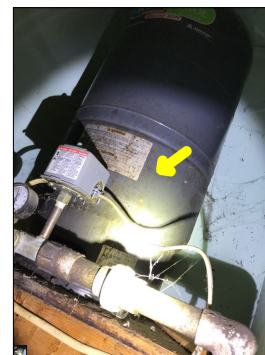
Mold like substance along the pressure tank. An active or intermittent water source can cause mold growth and property damage.

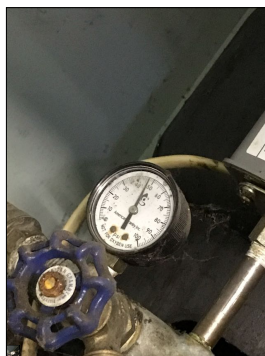
The well pressure was approximately 45 PSI during the inspection.

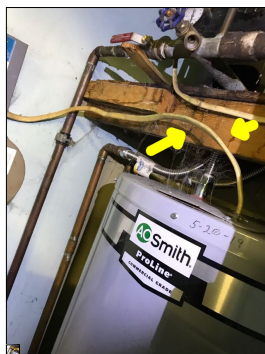
The wires are not wrapped in conduit. This is considered abnormal, amateur craftsmanship and a potential safety hazard. Wires should be wrapped in conduit to protect both humans and the electrical wiring. Wires that lack conduit can potentially get pulled, become loose, or damaged, thus creating shock hazards and/or fire hazards.

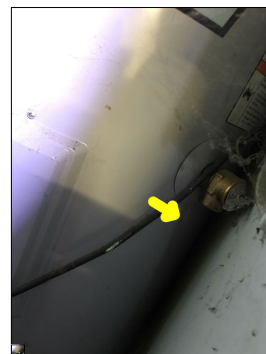
The temperature and pressure relief valve extension is missing. This is a potential safety hazard.

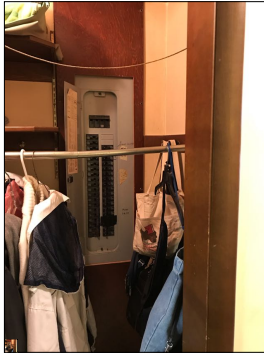
Inadequate clearance around the circuit breaker panel. The lack of proper clearance is a potential safety hazard. Circuit breaker panels should have at minimum, 3 feet depth measured from front edge of the panel, 30 inches minimum width or width of equipment if > 30 inches, working space height of 6 feet, 6 inches or height of equipment, whichever is greater. Required working space must extend to the ground, panel door must be operable to at least 90 degrees.

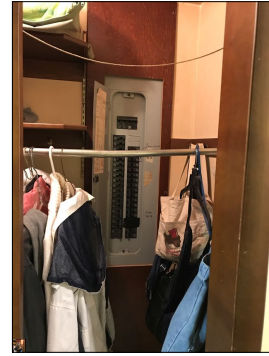
The circuit breaker panel is inaccessible due to personal items, clutter, etc. Also, the panel has some decorative wooden casing around the panel. It is beyond the scope of a general home inspection to move personal property. Doing so could potentially cause property damage. Electrical systems, wire type, electrical components, etc. behind the panel cover could not be inspected. It is the responsibility of the seller and the listing agent to ensure all major systems and components are readily accessible during a home inspection.
