HOME INSPECTION REPORT

615 Whitelock St. Huntington, IN 46750
Inspection Prepared For: Seller

Date of Inspection: 12/13/2025
Age of House: 125 Years
Weather: Cold & Dry

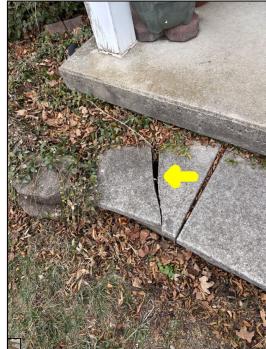
Cracks and deterioration along the service walks.

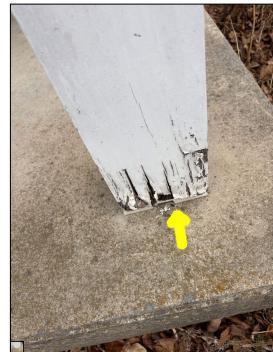
Wood rot damage along the columns.

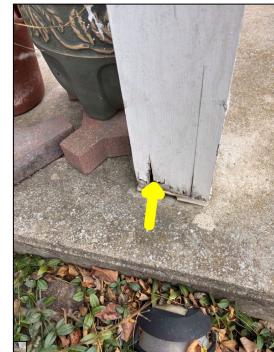
Wood rot damage along the columns.

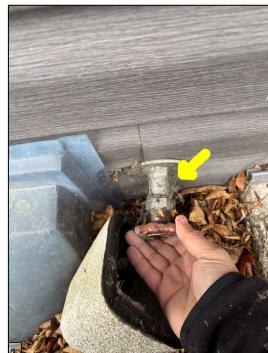
Inoperable hose bib.

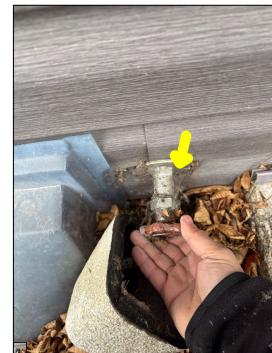
No anti-siphon/frost free valve. The lack of an anti-siphon valve can allow water back flow into the water supply lines, thus contaminating potable water. This is a potential safety hazard. The lack of a frost free valve can allow water to stay within the hose bib, which could potentially freeze during cold months and cause the pipe to rupture. This can cause property damage.

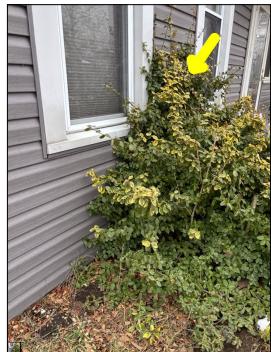
Vegetation against the siding/in proximity of the siding. This is not a recommended practice. Vegetation has the potential to harbor insects, wood destroying insects, rodents and hold moisture. Insects, wood destroying insects, rodents and moisture have the potential to create future problems for a house, such as structural damage, pest infestation and wood rot damage.

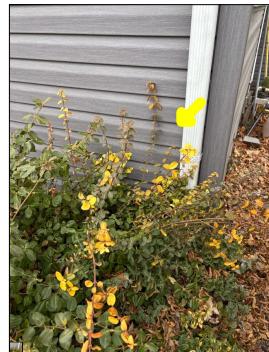
Vegetation against the siding/in proximity of the siding. This is not a recommended practice. Vegetation has the potential to harbor insects, wood destroying insects, rodents and hold moisture. Insects, wood destroying insects, rodents and moisture have the potential to create future problems for a house, such as structural damage, pest infestation and wood rot damage.

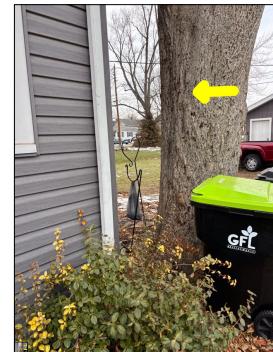
Tree adjacent to the house. Tree roots can cause foundation problems and can create structural damage to the foundation. Also, trees that are next to the house can potentially fall on the house, potentially causing bodily harm and damage to the house.

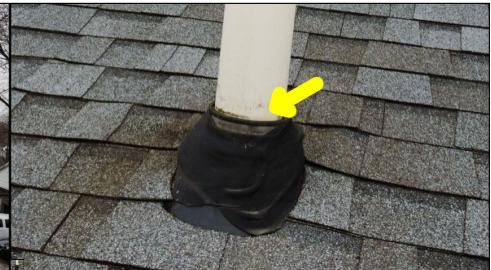
Unconventional rubber coupler observed along the vent pipe and unconventional flashing. This is considered abnormal and a potential leak point.

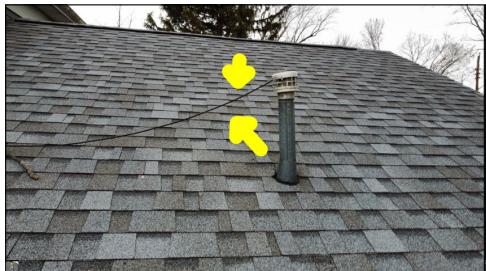
Unconventional cord routed along the flue. This is abnormal and a potential fire hazard.

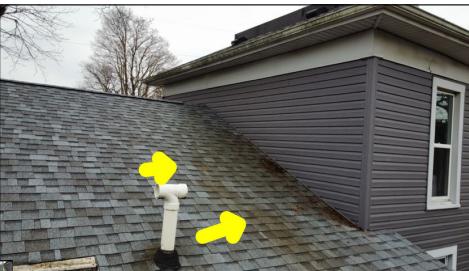
Discoloration along the roof.

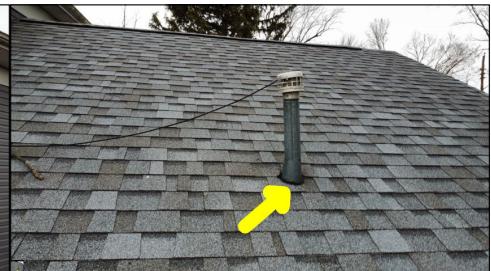
Unconventional application of sealant along the roof. This is considered abnormal and amateur craftsmanship. Amateur craftsmanship is prone to failure and leakage.

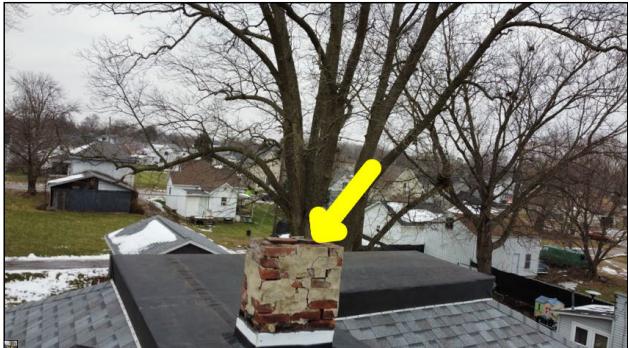
The chimney does not have a rain cap/spark arrestor. A rain cap/spark arrestor keeps rain water, small animals and pests from getting within the chimney. A spark arrestor prevents the emission of flammable debris from combustion sources. Spark arrestors help prevent surrounding objects from catching on fire, such as a tree or roof.

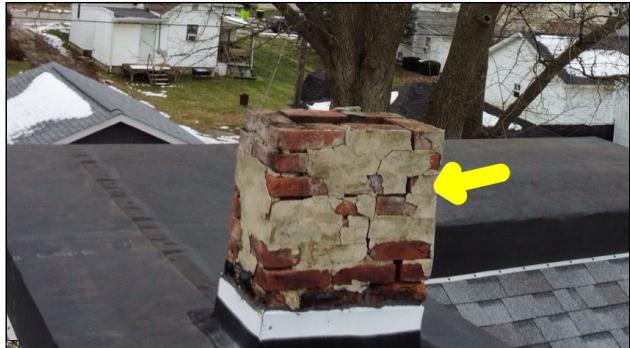
Deterioration and cracking along the brick.

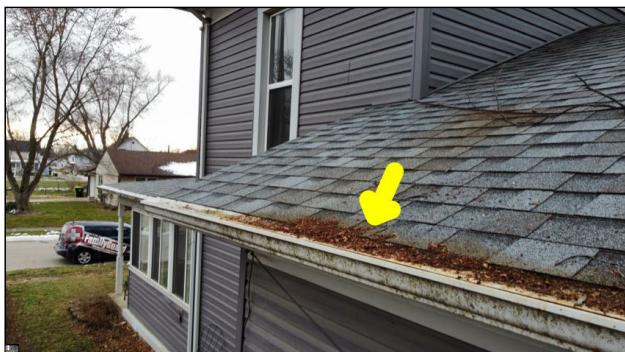
The gutter system is dirty and needs to be cleaned. A dirty gutter system can cause excessive water to accumulate around the house, thus potentially causing water intrusion into the house or potential foundation problems due to excessive hydrostatic pressure. Also, a dirty gutter system can cause excessive water to flow along the siding which could allow water to get behind the siding. An active or intermittent water intrusion source can cause mold growth and property damage.

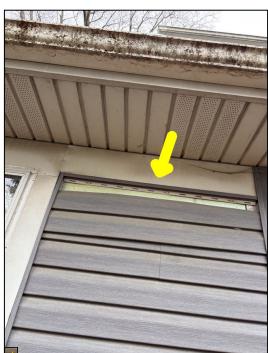
Loose/detached siding.

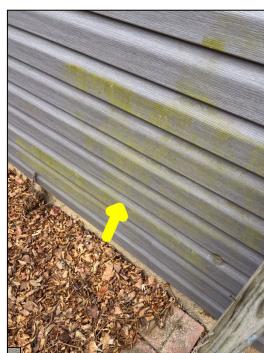
Discoloration along the siding.

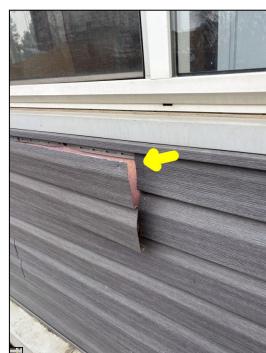
Loose/detached siding.

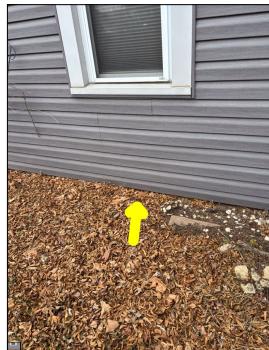
The siding is in proximity to the ground. Siding should have at least 6 to 8 inches of clearance above the ground. Maintaining proper clearances reduces access to wood structures behind the siding and helps preserve the house. The proper clearances help restrict access from wood destroying insects and/or moisture/water that might find its way behind the siding.

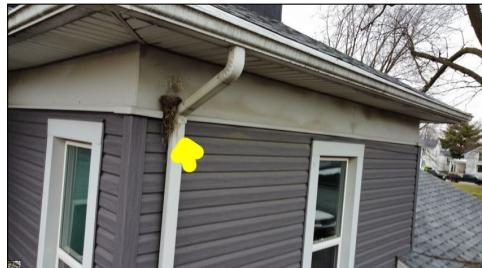
Bird's nest. Wildlife activity can cause property damage.

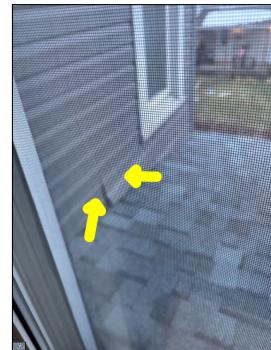
Loose/detached siding.

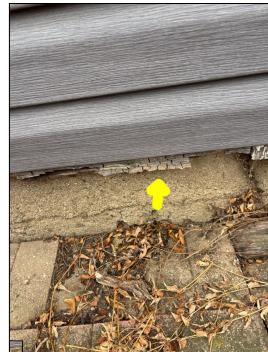
Wood rot damage.

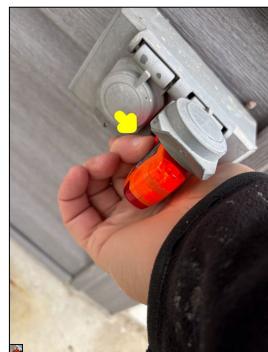
Non **GFCI** protected receptacles.

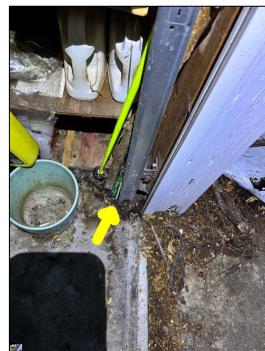
No photo eye sensors. The lack of photo eye sensors is a potential safety hazard.

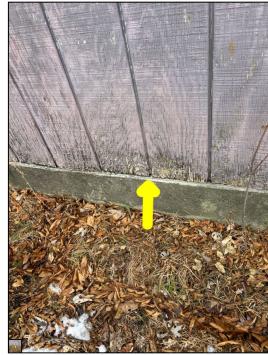
Deterioration along the siding.

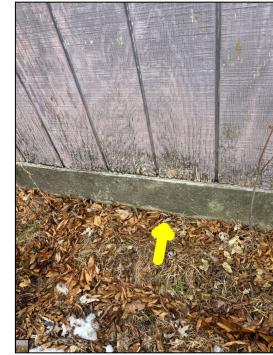
The siding is in proximity to the ground. Siding should have at least 6 to 8 inches of clearance above the ground. Maintaining proper clearances reduces access to wood structures behind the siding and helps preserve the house. The proper clearances help restrict access from wood destroying insects and/or moisture/water that might find its way behind the siding.

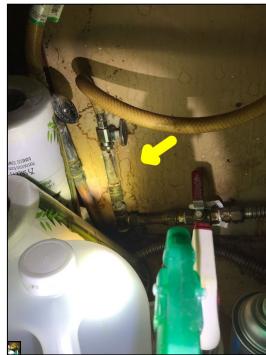
Discoloration observed underneath the sink along the wall. An active or intermittent water source can cause discoloration, mold, and property damage.

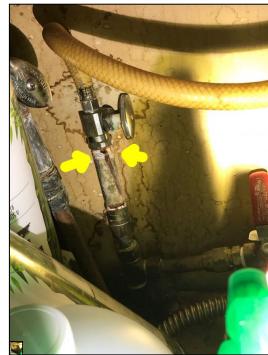
Rust/corrosion along the plumbing pipes.

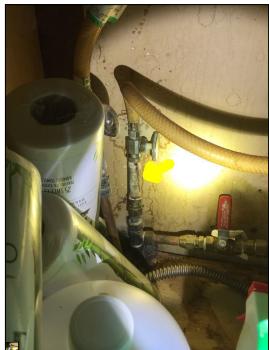
Aged galvanized water lines/pipes. Galvanized pipes no longer meet modern day plumbing standards. Galvanized pipes are prone to corroding from the inside out. Galvanized pipes are towards the end of their life expectancy. Repairs or replacement to galvanized pipes should be anticipated.

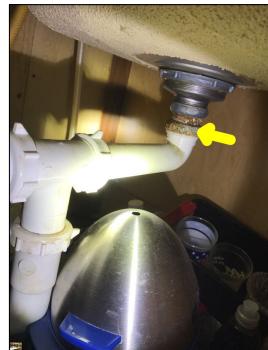
Active plumbing leak. An active or intermittent water source can cause mold growth and property damage.

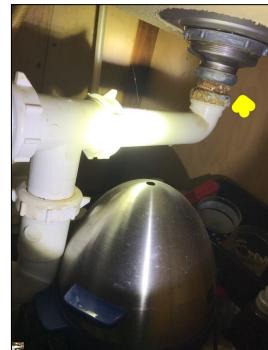
Rust/corrosion along the plumbing pipes.

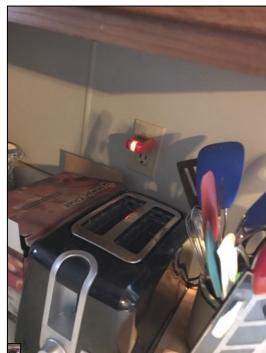
Open ground receptacles.

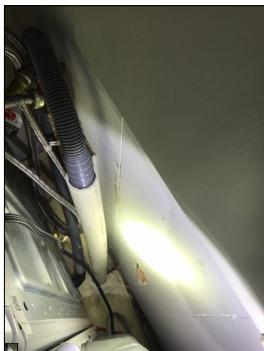
The drain line from the washing machine does not have a proper P-trap. The lack of a proper P-trap can potentially allow sewer gases into the house. Sewer gases are a potential safety hazard.

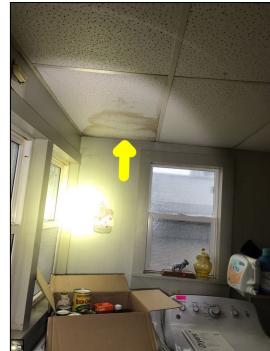
Discoloration along the ceiling. Discoloration along the ceiling is considered abnormal and a defect. An active or intermittent water source can cause discoloration, mold growth and property damage.

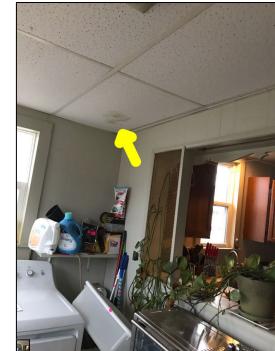
Discoloration along the ceiling. Discoloration along the ceiling is considered abnormal and a defect. An active or intermittent water source can cause discoloration, mold growth and property damage.

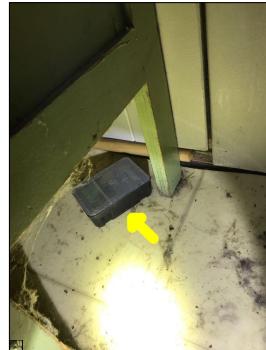
Pest control observed. Wildlife activity can cause property damage.

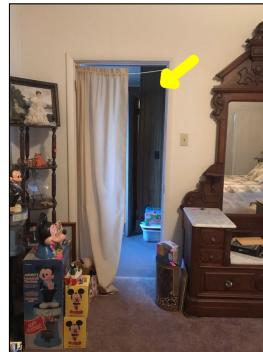
Missing doors.

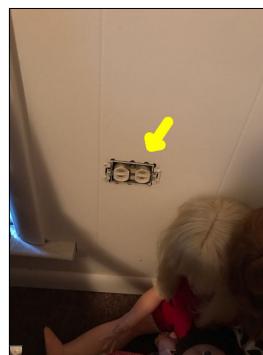
Two prong receptacles. Two prong receptacles are not grounded. Also, missing switch cover.

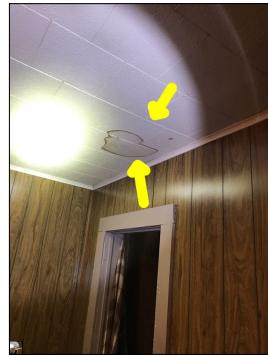
Discoloration along the ceiling and signs of previous water damage. An active or intermittent water source can cause mold growth and property damage.

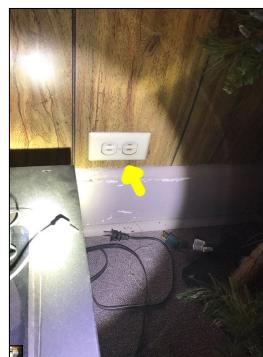
Two prong receptacles. Two prong receptacles are not grounded.

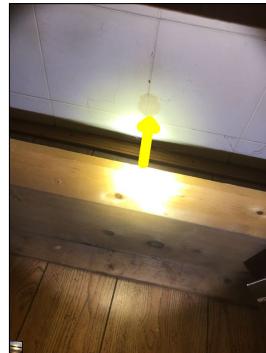
Discoloration along the ceiling. Discoloration along the ceiling is considered abnormal and a defect. An active or intermittent water source can cause discoloration, mold growth and property damage.

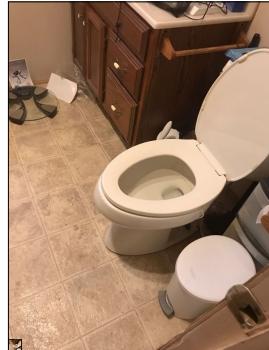
The toilet continuously calls for water. This is considered abnormal and a defect.

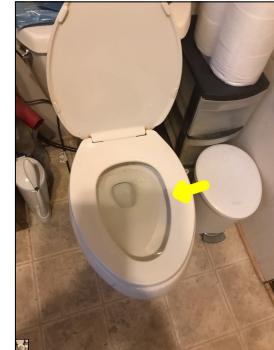
The toilet is loose. The toilet rocks back and forth. A toilet should not have any movement and be fully anchored and secured to the floor.

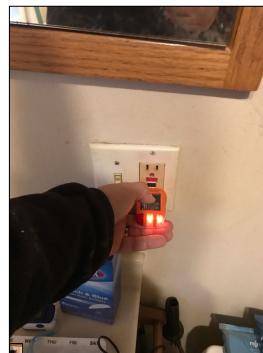
Inoperable GFCI

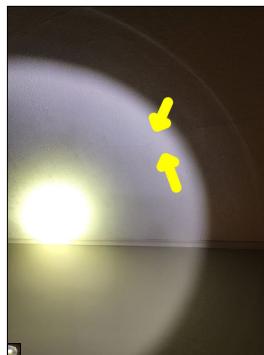
Cracks along the ceiling.

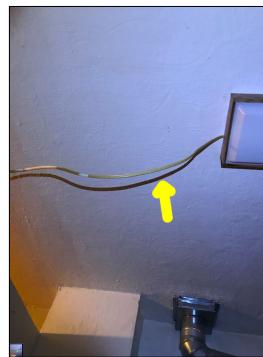
Loose electrical wires.

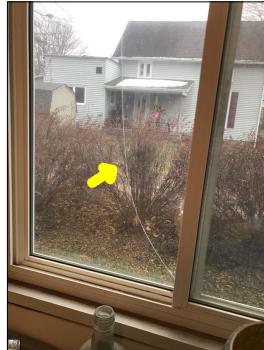
Cracked glass.

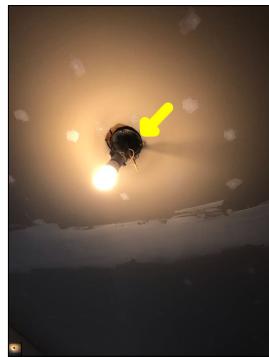
Exposed wires. This is a potential safety hazard.

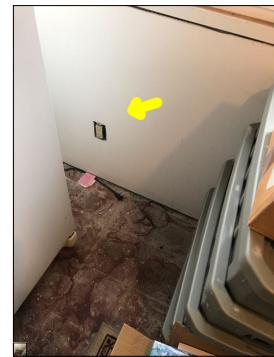
Missing receptacle cover.

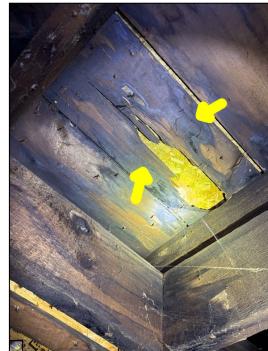
Discoloration and deterioration along the sheathing. An active or intermittent water source can cause discoloration, mold growth and property damage.

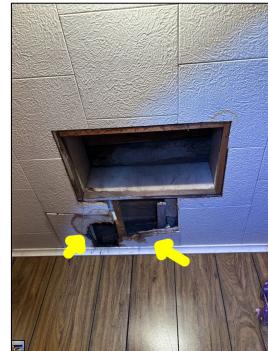
Discoloration and signs of previous water damage. An active or intermittent water source can cause mold growth or property damage.

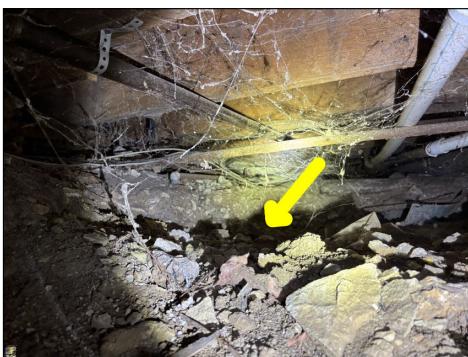
The crawl space has a dirt floor. Dirt floors are not recommended. A dirt floor can allow the intrusion of moisture, insects, wood destroying insects, radon, mice, and rodents. An active or intermittent water source can cause mold growth and property damage, such as wood rot damage. It is recommended that the crawl space be properly encapsulated.

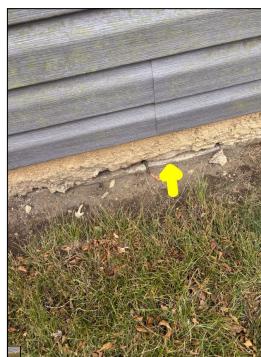
Crack along the foundation. Cracks are considered a defect. Cracks should be repaired/sealed to prevent the intrusion of moisture, insects, wood destroying insects, mice, and radon.

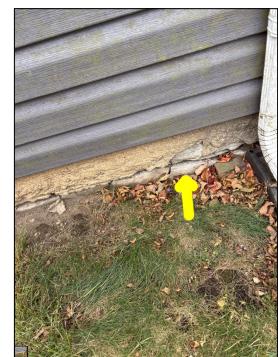
Crack along the foundation wall. Cracks are considered a defect.

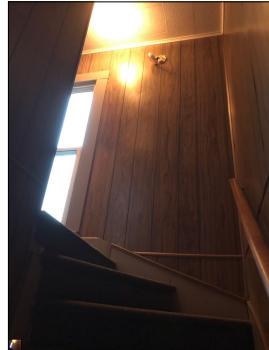
There is no apparent 3-way switch for the stairs. The lack of a 3-way switch to operate a stairwell light is a potential safety hazard.

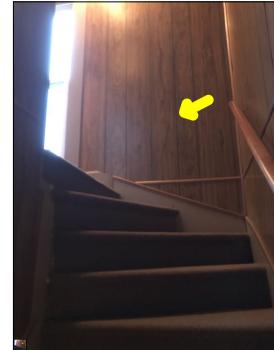
Missing handrail.

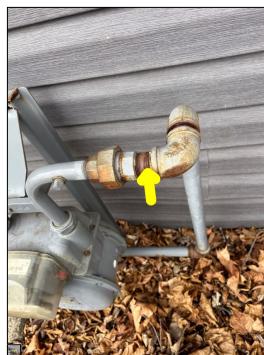
Rust and corrosion along the fuel lines. Rust and corrosion can create holes along the fuel lines, thus creating a fuel leak.

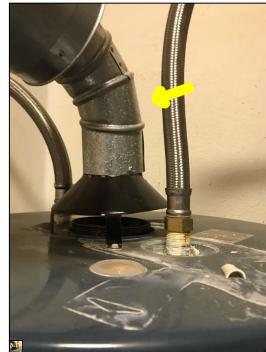
Improper flue. There should be a minimum of twelve inches between the draft hood outlet and the first elbow or connector. The current design of the flue is a potential safety hazard as it could cause the flue to backdraft and release carbon monoxide into the house.

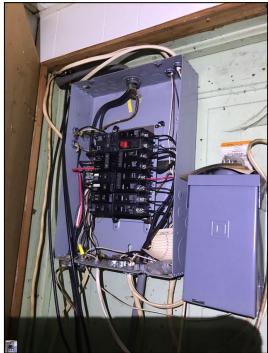
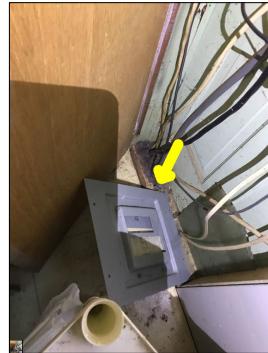
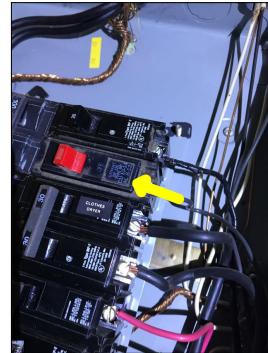
The cover is detached.

Electrical panel/circuit breaker manufacturer mismatch within the circuit breaker panel. The defect is because not all busbars are the same size and have the same dimensions. A circuit breaker from another manufacturer might not properly fit the busbar, thus creating a poor/loose connection.

- Recommend licensed electrician further evaluate and make necessary repairs
- Circuit breaker panels less than 200 amps might not be able to meet modern day electrical demands.

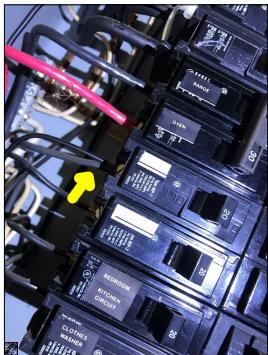
Double tapped circuit breaker. Two conductors inserted into a single circuit breaker that is rated for one conductor could become loose over time which could lead to overheating, arcing, spark and possible fire.

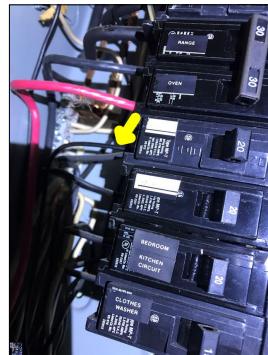
Oversized circuit breaker. An oversized circuit breaker is a potential safety hazard. An oversized circuit breaker will potentially fail to trip when the circuit experiences an overload or overheating, thus creating arcing, spark and/or fire.

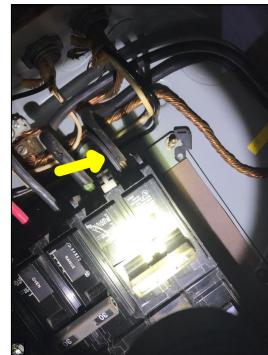
Oversized circuit breaker. An oversized circuit breaker is a potential safety hazard. An oversized circuit breaker will potentially fail to trip when the circuit experiences an overload or overheating, thus creating arcing, spark and/or fire.
