# **FAMILYGUARD**

## **HOME INSPECTION REPORT**

**3185 S. Golden Lake Rd. Pleasant Lake, IN 46779**  
**Inspection Prepared For: Seller**

**Date of Inspection: 6/25/2026**  
**Age of House: 38 Years**  
**Weather: Clear**

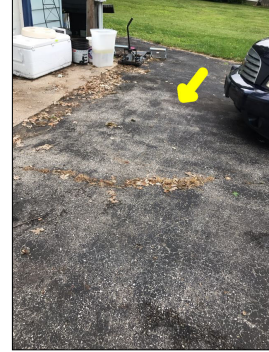
Cracks and deterioration along the driveway.

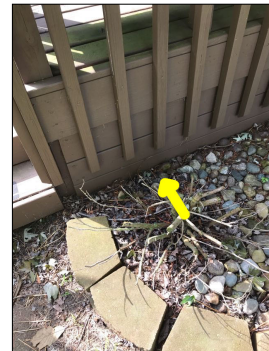
Uneven surfaces along the deck. The step is sloped. Also, the riser/step is unconventionally high. This is a potential trip hazard. The recommended maximum height for a riser/step is 7 inches.

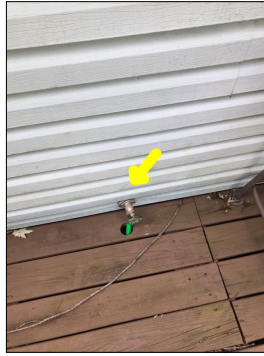
No anti-siphon/frost free valve. The lack of an anti-siphon valve can allow water back flow into the water supply lines, thus contaminating potable water. This is a potential safety hazard. The lack of a frost free valve can allow water to stay within the hose bib, which could potentially freeze during cold months and cause the pipe to rupture. This can cause property damage. Also, the hose bib is loose.

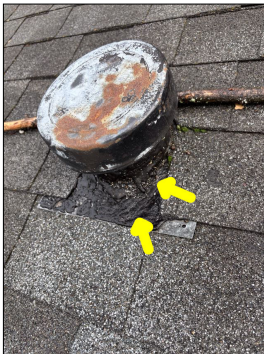
Unconventional application of sealant along the roof. This is considered abnormal and amateur craftsmanship. Amateur craftsmanship is prone to failure and leakage.

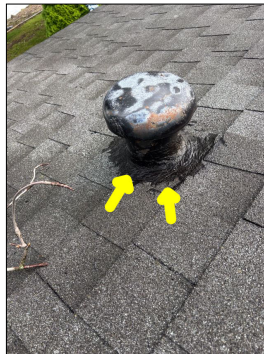
Unconventional application of sealant along the roof. This is considered abnormal and amateur craftsmanship. Amateur craftsmanship is prone to failure and leakage.

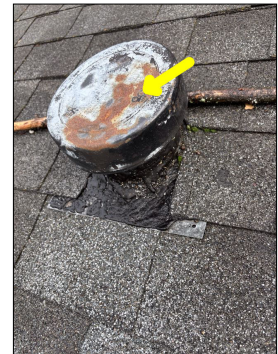
Unconventional application of sealant along the roof. This is considered abnormal and amateur craftsmanship. Amateur craftsmanship is prone to failure and leakage.

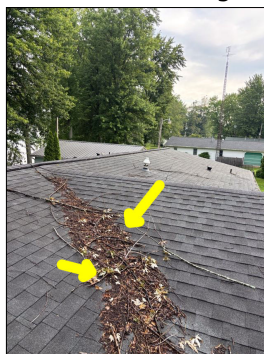
Tree branches observed along the roof. Falling tree branches can cause damage to the roof system, thus resulting in water intrusion into the attic/house.

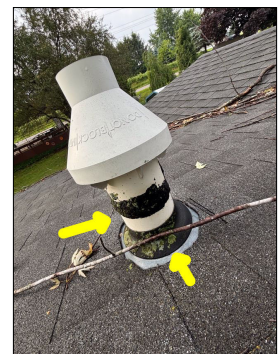
Debris along the roof. Excessive debris along the roof can restrict the ability of the roof to shed water, thus creating potential leak points.

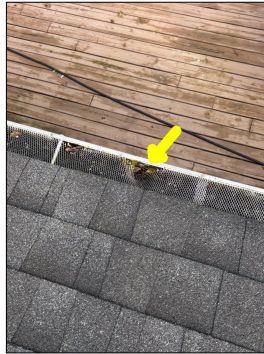
- Need to be cleaned
- A defective gutter/drainage system can cause excessive water to accumulate around the house, thus potentially causing water intrusion into the house or potential foundation problems due to excessive hydrostatic pressure. Also, a defective gutter/drainage system can cause excessive water to flow along the exterior walls, which could allow water to get behind the siding, soffit and fascia. An active or intermittent water intrusion source can cause mold growth and property damage.

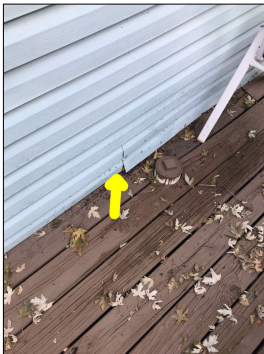
- Cracks and holes in siding, loose/detached siding, gaps in siding and missing siding have the potential to allow water/moisture, insects, bats, mice, wood destroying insects, pests, and rodents into the framing of a house. The intrusion of water/moisture, insects, bats, mice, wood destroying insects, pests, and rodents has the potential to cause damage to a house, such as wood rot, mold, property damage and structural damage.
- Recommend general contractor further evaluate and make necessary repairs

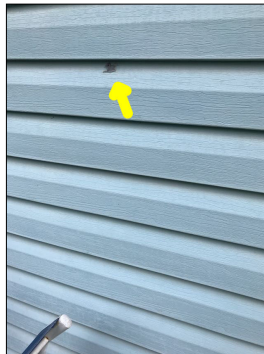
Unconventional application of caulk along the siding and unconventional repairs along the siding. This is considered abnormal and amateur craftsmanship. Amateur craftsmanship is prone to failure.

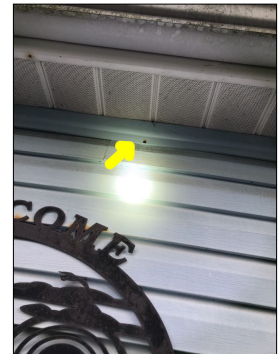
Exposed nails/fasteners along the siding. Exposed nails/fasteners are potential leak points. Exposed nails along the siding is considered amateur craftsmanship. Amateur craftsmanship is prone to failure and leakage.

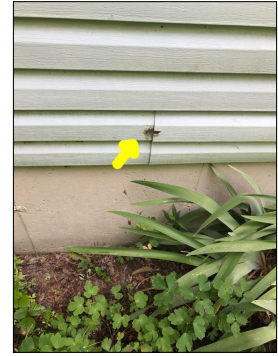
Damaged siding.

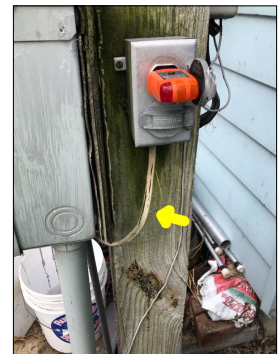
The wires are not wrapped in conduit. This is considered abnormal, amateur craftsmanship and a potential safety hazard. Wires should be wrapped in conduit to protect both humans and the electrical wiring. Wires that lack conduit can potentially get pulled, become loose, or damaged, thus creating shock hazards and/or fire hazards. Also, the sheathing around the wires is not rated for exterior use. The lack of proper sheathing can allow rain, snow, sunlight, wildlife, etc. to damage the wires, thus causing shock hazards, spark, arcing and/or fire.

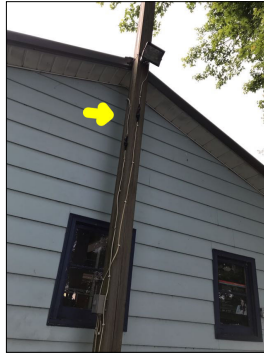
The wires are not wrapped in conduit. This is considered abnormal, amateur craftsmanship and a potential safety hazard. Wires should be wrapped in conduit to protect both humans and the electrical wiring. Wires that lack conduit can potentially get pulled, become loose, or damaged, thus creating shock hazards and/or fire hazards. Also, the sheathing around the wires is not rated for exterior use. The lack of proper sheathing can allow rain, snow, sunlight, wildlife, etc. to damage the wires, thus causing shock hazards, spark, arcing and/or fire.

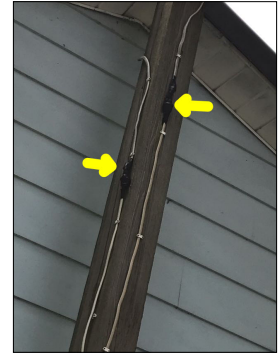
Unconventional spliced wires. This is considered amateur craftsmanship.

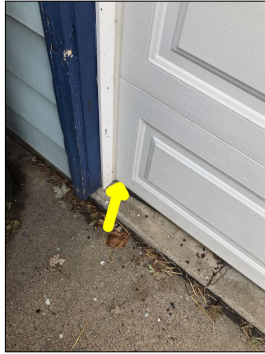
The weatherstrip is partially torn/missing along the overhead garage door. The lack of a proper weatherstrip can allow the intrusion of moisture, insects, wood destroying insects, mice and rodents into the property.

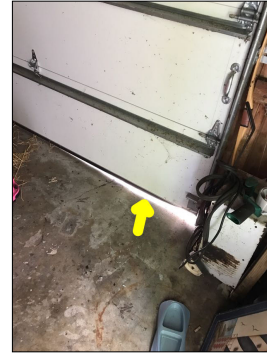
Daylight can be seen from the interior. This is an entry point for moisture, insects, mice, rodents, etc.

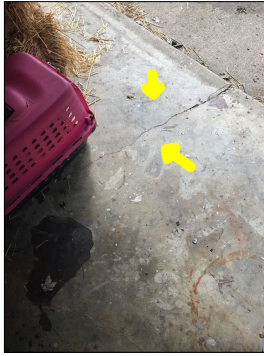
Cracks and deterioration along the floor.

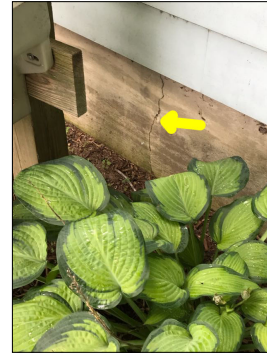
Crack along the foundation. Cracks are considered a defect.

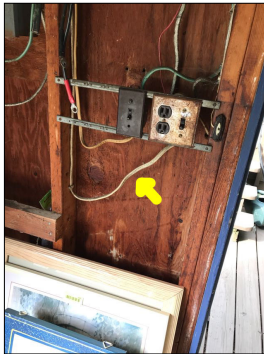
The wires are not wrapped in conduit. This is considered abnormal, amateur craftsmanship and a potential safety hazard. Wires should be wrapped in conduit to protect both humans and the electrical wiring. Wires that lack conduit can potentially get pulled, become loose, or damaged, thus creating shock hazards and/or fire hazards.

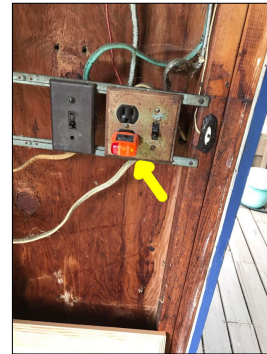
Non **GFCI** protected receptacles.

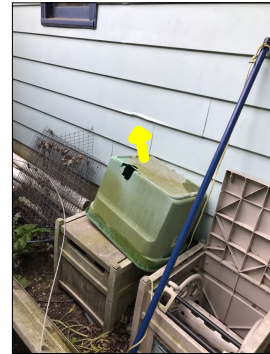
Damaged siding.

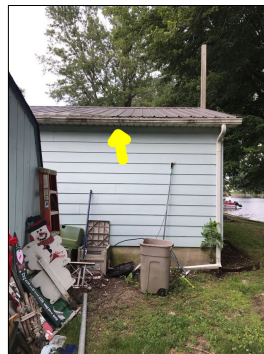
Unconventional sags along the gutter system. This is considered a defect as the sags will act as a catch for water.

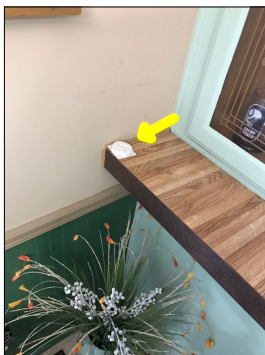
Pest control observed.

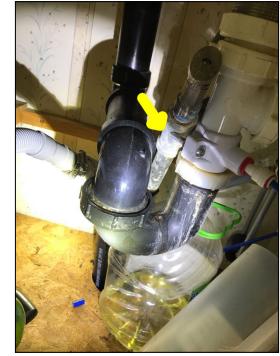
Aged galvanized water lines/pipes. Galvanized pipes no longer meet modern day plumbing standards. Galvanized pipes are prone to corroding from the inside out. Galvanized pipes are towards the end of their life expectancy. Repairs or replacement to galvanized pipes should be anticipated.

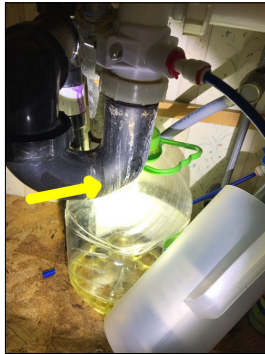
| <b>Roof</b> | | |
|---|---|---|
| Page 12 Item: 3 | Sink/Faucet/Plumbing | <ul style="list-style-type: none"> <li>• Active plumbing leak. An active or intermittent water source can cause mold growth and property damage.</li> </ul> |

Active plumbing leak. An active or intermittent water source can cause mold growth and property damage.

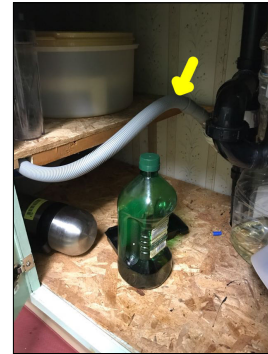
The dishwasher drain line does not have a high loop. A high loop prevents drain water from flowing into the dishwasher and contaminating the clean dishes.

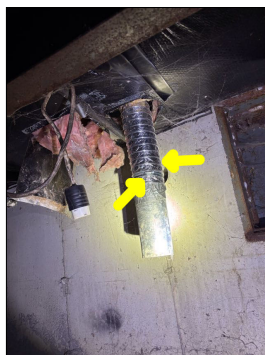
| <b>Roof</b> | | |
|---|---|---|
| Page 15 Item: 2 | Dryer Exhaust | <ul style="list-style-type: none"> <li>• The dryer ductwork does not vent to the exterior of the house. This is considered abnormal as it does not meet the industry standard. This is also a fire hazard.</li> </ul> |

The dryer ductwork does not vent to the exterior of the house. This is considered abnormal as it does not meet the industry standard. This is also a fire hazard.

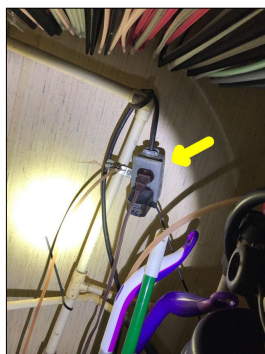
Unconventionally loose receptacle observed adjacent to the water softener. This is considered abnormal and amateur craftsmanship. The receptacle is hanging on a water supply line.

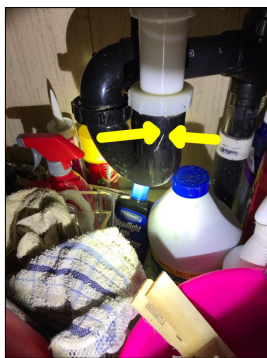
Active plumbing leak. An active or intermittent water source can cause mold growth and property damage.

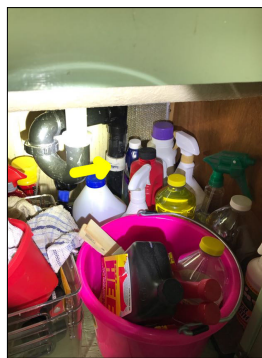
ABS and PVC material in contact with each other. This is considered abnormal and does not meet the industry standard. Different types of plumbing materials have the potential to create poor connections, thus creating leak points.

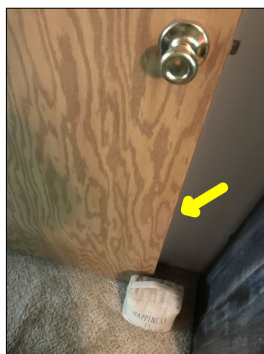
The door swings to a closed position. This is considered abnormal and a defect.

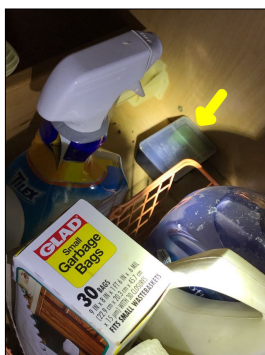
Pest control observed. Wildlife activity can cause property damage.

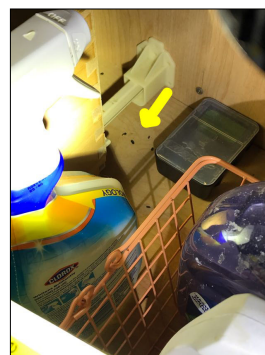
Mice droppings observed.

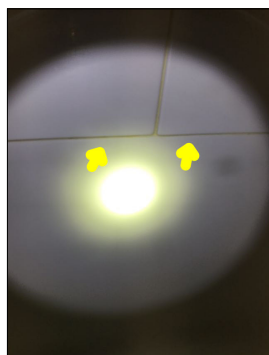
Unconventional beads of caulk along the shower/bath. This is considered amateur craftsmanship. The beads of caulk will discolor and deteriorate with time and potentially mold. The caulk will require regular maintenance to prevent water from getting underneath the caulk and behind the shower/bath wall. A properly installed shower/bath will have edges that overlap and the overlapped edges will properly shed water and create liquid tight seams. Beads of caulk can actually trap water and allow water to get behind the shower/bathtub wall and within the wall cavities, thus causing potential mold growth and property damage.

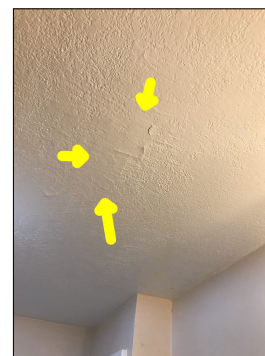
There is a contrast of texture along the ceiling. This is considered abnormal, amateur craftsmanship and an indication that previous repairs were made to the ceiling.

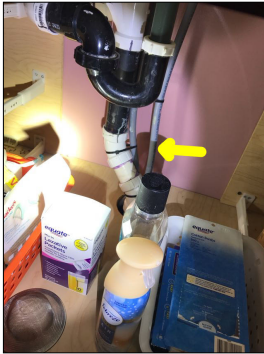
Polybutylene plumbing lines. Polybutylene pipes are prone to failure and no longer meet modern day plumbing standards. Recommend upgrading from polybutylene pipes to modern day plumbing materials, such as PEX or copper. Please note, polybutylene pipes can be concealed behind walls, ceilings, etc.

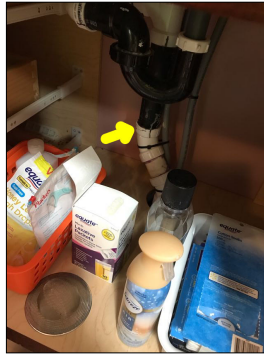
ABS and PVC material in contact with each other. This is considered abnormal and does not meet the industry standard. Different types of plumbing materials have the potential to create poor connections, thus creating leak points.

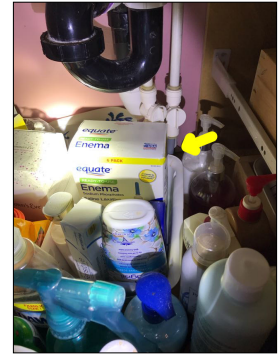
Polybutylene plumbing lines. Polybutylene pipes are prone to failure and no longer meet modern day plumbing standards. Recommend upgrading from polybutylene pipes to modern day plumbing materials, such as PEX or copper. Please note, polybutylene pipes can be concealed behind walls, ceilings, etc.

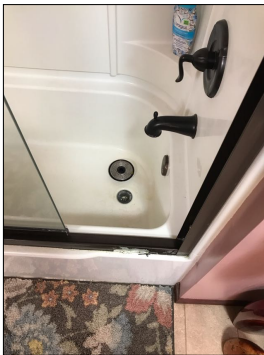
Missing drain stopper.

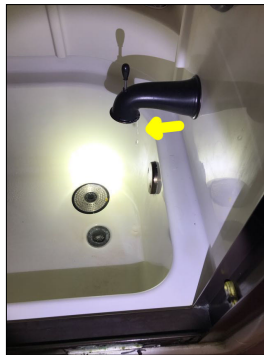
The bathtub faucet leaks while the showerhead is in operation. This is considered a defect. A properly functioning diverter will not allow any water through the bathtub faucet while the showerhead is in operation.

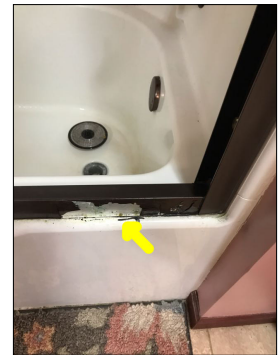
Flaking and peeling along the shower.

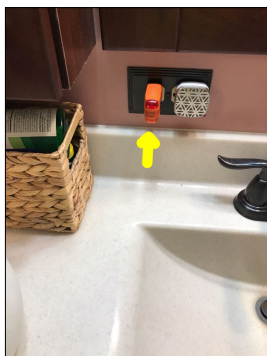
Inoperable receptacle. This receptacle might be linked to the inoperable GFCI circuit breaker wiring the circuit breaker panel. The receptacle is also damaged/chipped.

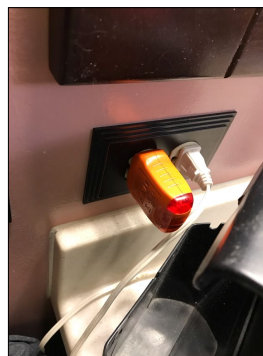
Inoperable receptacle. This receptacle might be linked to the inoperable GFCI circuit breaker wiring the circuit breaker panel. The receptacle is also damaged/chipped.

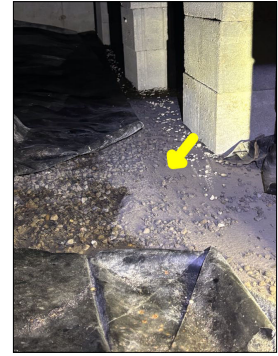
The crawl space has a gravel floor in some areas that exposes the earth. Gravel floors are not recommended. A gravel floor can allow the intrusion of moisture, insects, wood destroying insects, radon, mice, and rodents. An active or intermittent water source can cause mold growth and property damage, such as wood rot damage. It is recommended that the crawl space be properly encapsulated.

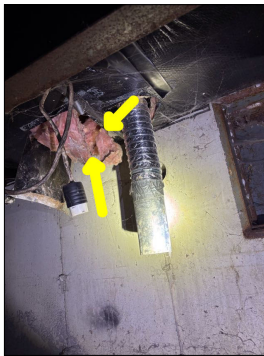
Torn and displaced insulation. This is considered abnormal and a defect.

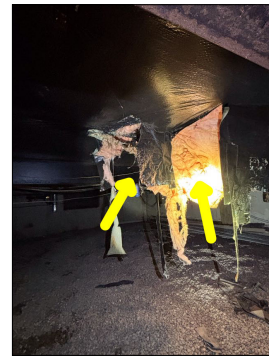
Torn and displaced insulation. This is considered abnormal and a defect.

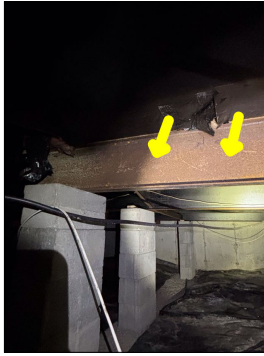
Rust/corrosion along the beam. This is an indication that the crawlspace has an active or intermittent water source. An active or intermittent water source can cause mold growth and property damage.

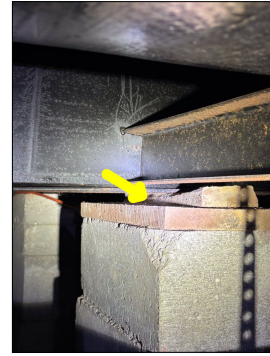
Wood shims wedged into the columns. This is considered abnormal and amateur craftsmanship. Wood shims will compress with time and age, thus potentially causing structural movement, cracks along the walls and ceilings, door and windows to not properly latch and floors to slope and squeak.

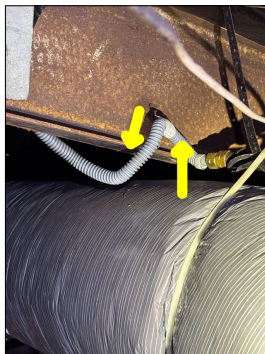
Coated brass fuel line. Coated brass no longer meets industry standards. Coated brass is also a safety as it is prone to failure.

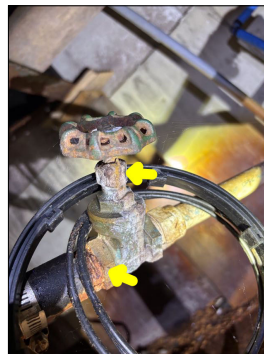
Rust and corrosion along the plumbing pipes.

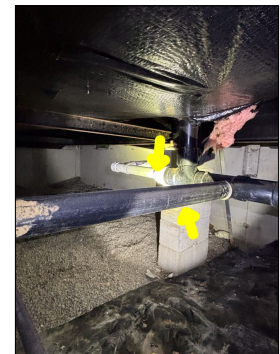
ABS and PVC material in contact with each other. This is considered abnormal and does not meet the industry standard. Different types of plumbing materials have the potential to create poor connections, thus creating leak points.

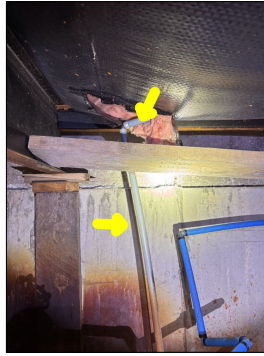
Polybutylene plumbing lines. Polybutylene pipes are prone to failure and no longer meet modern day plumbing standards. Recommended upgrading from polybutylene pipes to modern day plumbing materials, such as PEX or copper. Please note, polybutylene pipes can be concealed behind walls, ceiling, etc.

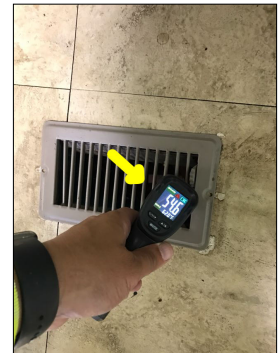
The photo identifies the temperature of the supply air while the air conditioner was in operation. The approximate temperature of the supply air was 54 degrees Fahrenheit.

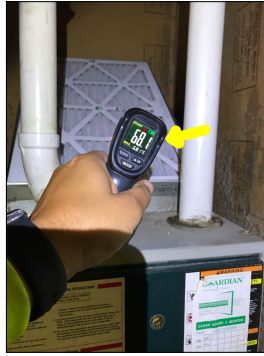
The photo identifies the temperature of the return air while the air conditioner was in operation. The approximate temperature of the return air was 68 degrees Fahrenheit.

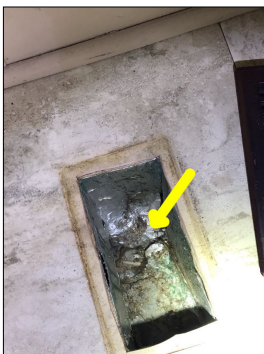
The HVAC ductwork is dirty. Recommended cleaning ductwork. Dirty ductwork can lead to poor air quality in every room of a home. Also, dirty ductwork can make heating and cooling less efficient and dirty ductwork can cause added wear and tear on HVAC heating and cooling systems thus shortening the lifespan of the systems.

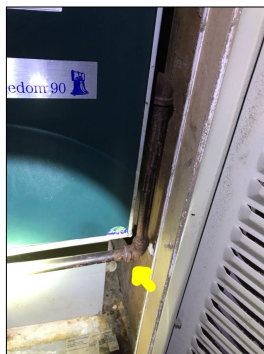
No drip leg/sediment trap. The lack of a drip leg/sediment trap can cause damage to the appliance. Sediment traps help prevent sediment, debris and moisture in the fuel line from getting into the gas valve or burner area.

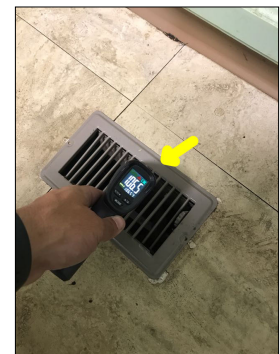
The photo identifies the temperature of the supply air while the furnace was in operation. The approximate temperature of the supply air was 106 degrees Fahrenheit.

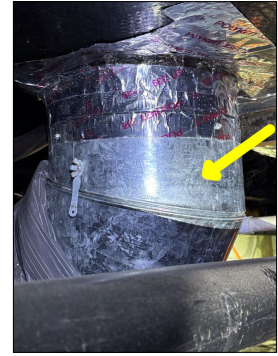
The HVAC ductwork lacks insulation in some areas. This is not a recommended practice. The lack of insulation along the ductwork can allow moisture and condensation to form along the ductwork. An active or intermittent water source can cause the ductwork to rust and corrode. A water source can also cause mold growth and property damage.

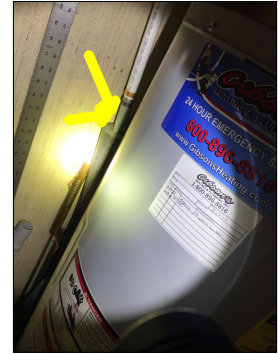
Polybutylene plumbing lines. Polybutylene pipes are prone to failure and no longer meet modern day plumbing standards. Recommend upgrading from polybutylene pipes to modern day plumbing materials, such as PEX or copper. Please note, polybutylene pipes can be concealed behind walls, ceilings, etc.

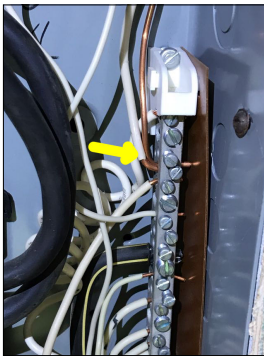
Double tapped neutral wires. Neutral wires should not share a terminal with any other wires, including ground wires. Double tapped neutrals are considered a safety hazard. Double tapped neutral wires do not allow the circuit to be isolated if the circuit needs to be worked on. Also, double tapped neutral wires under the same terminal can become loose, which could lead to arcing, overheating, spark and/or fire.

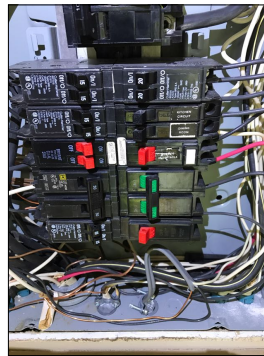
Electrical panel/circuit breaker manufacturer mismatch within the circuit breaker panel. The defect is because not all busbars are the same size and have the same dimensions. A circuit breaker from another manufacturer might not properly fit the busbar, thus creating a poor/loose connection.

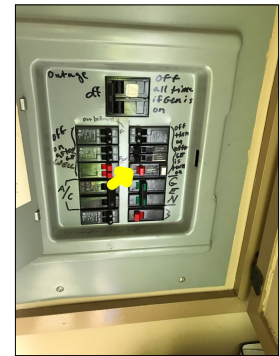
| <b>Roof</b> | | |
|---|---|---|
| Page 39 Item: 3 | Electrical | <ul style="list-style-type: none"> <li>• The GFCI circuit breaker is inoperable. The GFCI will not reset.</li> <li>• The electrical panel in the detached garage is an aged fuse panel. Fuse panels no longer meet modern day electrical standards and are considered a safety hazard due to their age. Recommend upgrading from the fuse panel to a modern day circuit breaker panel.</li> </ul> |

The GFCI circuit breaker is inoperable. The GFCI will not reset.
