# **FAMILYGUARD**

## **HOME INSPECTION REPORT**

**3643 Westport Dr. New Haven, IN 46774**  
**Inspection Prepared For: Seller**

**Date of Inspection: 8/8/2026**  
**Age of House: 22 Years**  
**Weather: Overcast**

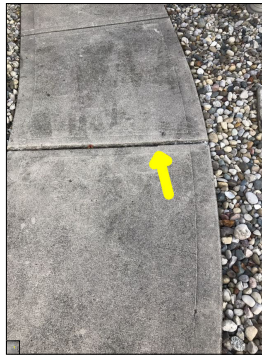
Uneven surfaces along the service walks.

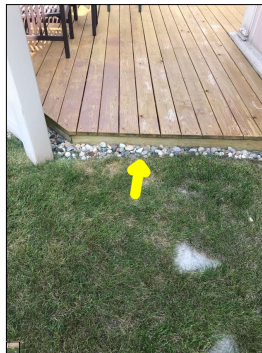
The deck has wood to soil contact. This is not a recommended practice. Water and moisture from the soil/earth can wick up along the deck and the water can be absorbed by the deck. An active or intermittent water source can cause property damage, such as wood rot damage. Also, the wood to soil contact can enable the infestation of wood destroying insects, such as termites or powderpost beetles.

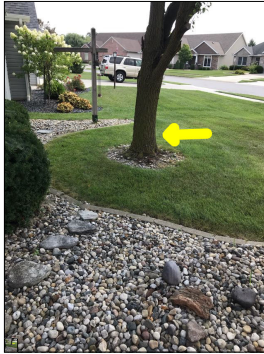
Trees in the front yard observed. Tree roots can cause property damage to plumbing lines that are routed underground. In most cases, homeowners are responsible for repairs along underground plumbing lines that are from the house to the main city sewer lines.

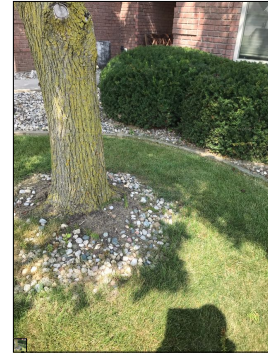
Tree adjacent to the house. Tree roots can cause foundation problems and can create structural damage to the foundation. Also, trees that are next to the house can potentially fall on the house, potentially causing bodily harm and damage to the house.

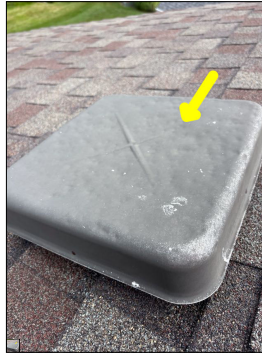
Dents along the roof vents. This is an indication of previous hail damage.

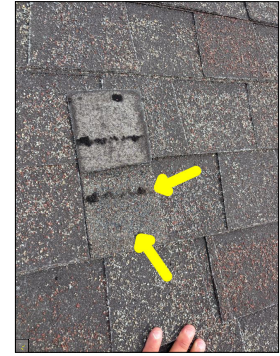
Loose/detached roof shingles. This is considered a defect and a potential leak point.

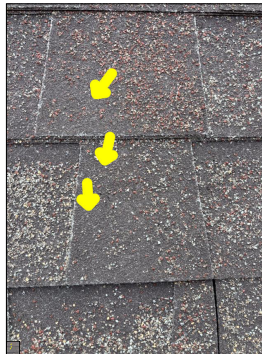
Granule loss along the roof shingles

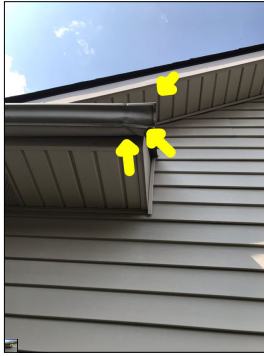
Dents/damage along the gutter system.

- Need to be cleaned
- Recommend general contractor further evaluate and make necessary repairs
- A defective gutter/drainage system can cause excessive water to accumulate around the house, thus potentially causing water intrusion into the house or potential foundation problems due to excessive hydrostatic pressure. Also, a defective gutter/drainage system can cause excessive water to flow along the exterior walls, which could allow water to get behind the siding, soffit and fascia. An active or intermittent water intrusion source can cause mold growth and property damage.

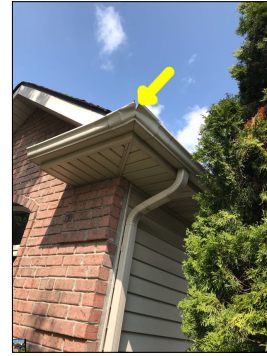
Dents/damage along the gutter system.

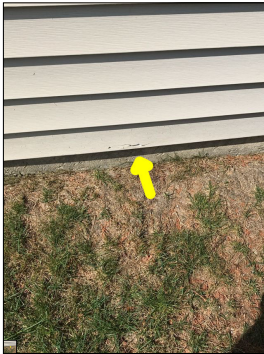
Damaged siding.

- Recommend general contractor further evaluate and make necessary repairs

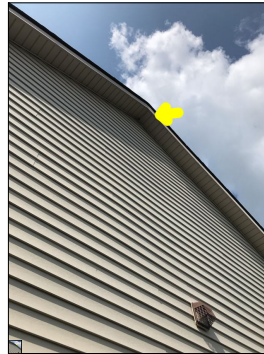
Wasp nest observed. Wasps can cause property damage and potentially sting those dwelling around the house.

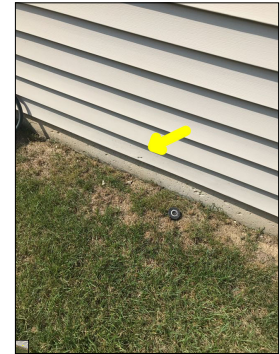
Damaged siding.

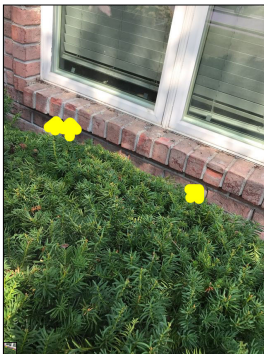
Deterioration along the brick siding.

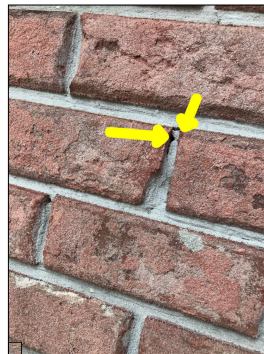
Deterioration along the mortar.

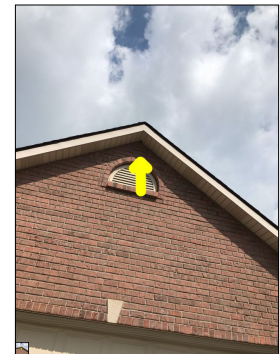
Wasp nest observed. Wasps can cause property damage and potentially sting those dwelling around the house.

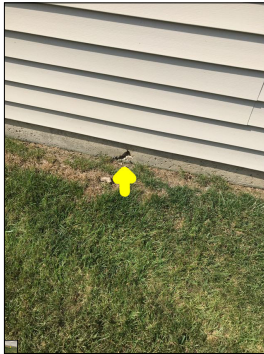
Pitting and deterioration along the slab foundation. These areas are considered a defect. These areas should be repaired/sealed to prevent the intrusion of moisture, insects, wood destroying insects, mice, and radon.

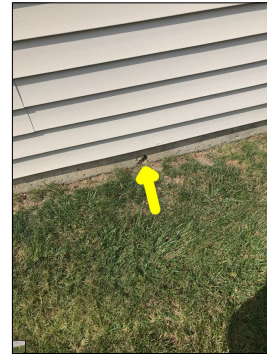
Pitting and deterioration along the slab foundation. These areas are considered a defect. These areas should be repaired/sealed to prevent the intrusion of moisture, insects, wood destroying insects, mice, and radon.

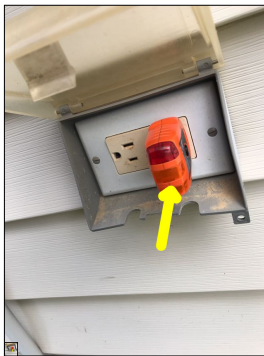
The receptacle is inoperable. This might be related to the tripped breaker within the circuit breaker panel. It is beyond the scope of a general home inspection to flip circuit breakers. Doing so could cause property damage.

- Recommend licensed electrician further evaluate and make necessary repairs.

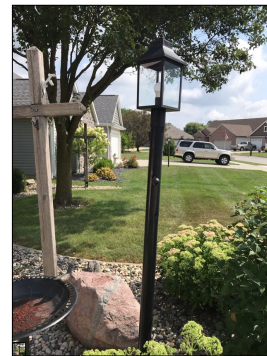
The front post light is not plumb and is loose. Also, covering the daylight sensor did not activate the light.

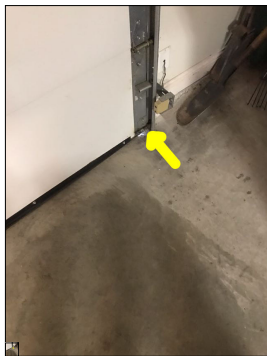
Daylight can be seen from the interior. This is an entry point for moisture, insects, mice, rodents, etc.

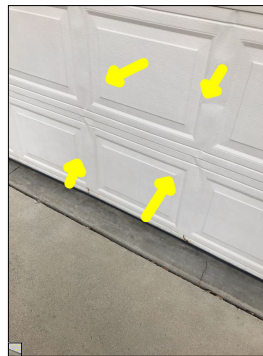
Dents/damage along the overhead garage door.

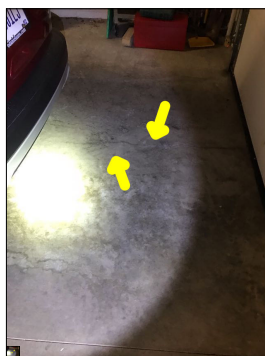
Cracks and deterioration along the floor.

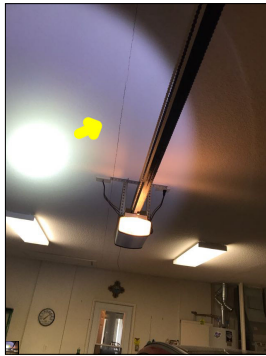
Cracks along the ceiling.

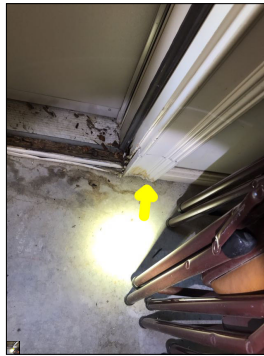
Discoloration along the wall and signs of water damage. Discoloration along the wall is considered abnormal and a defect. An active or intermittent water source can cause discoloration, mold growth and property damage.

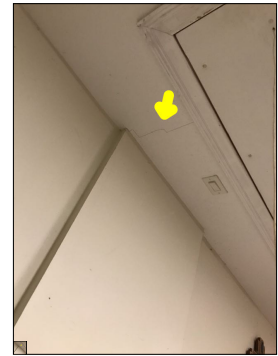
Cracks along the ceiling.

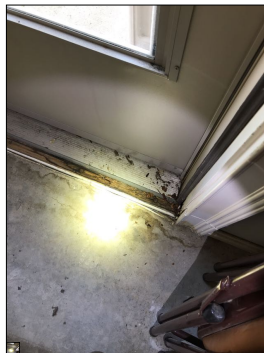
Wood rot damage along the service door.

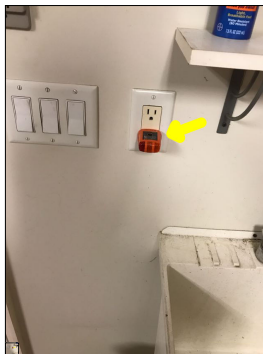
| Roof | | |
|---|---|---|
| Page 10 Item: 7 | Electrical | • Inoperable receptacles. |

The receptacle is inoperable. This might be related to the tripped breaker within the circuit breaker panel. It is beyond the scope of a general home inspection to flip circuit breakers. Doing so could cause property damage.

- Recommend licensed electrician further evaluate and make necessary repairs.

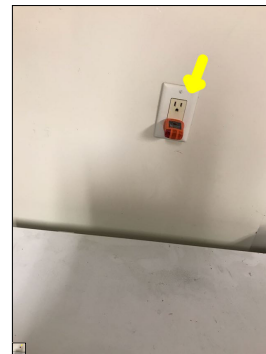
The receptacle is inoperable. This might be related to the tripped breaker within the circuit breaker panel. It is beyond the scope of a general home inspection to flip circuit breakers. Doing so could cause property damage.

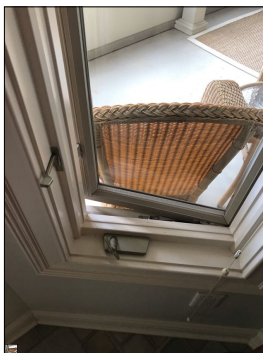
Missing window screens.

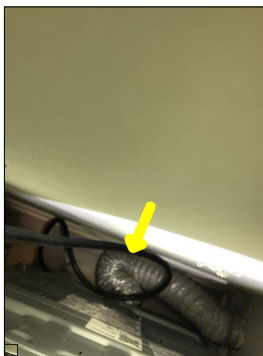
Unconventional/excessive bends along the dryer ductwork. Unconventional/excessive bends along the dryer ductwork can restrict airflow. Restricted airflow can cause overheating, spark and/or fire.

- Recommend cleaning ductwork

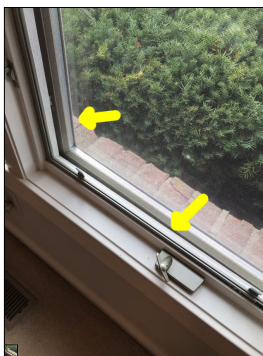
The window crank is defective. The crank is unable to close the window.

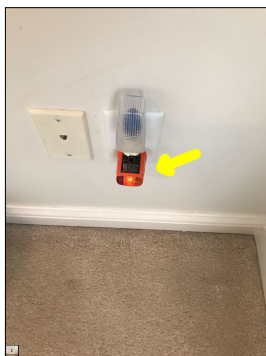
Open ground receptacles.

- Recommend licensed electrician further evaluate and make necessary repairs.

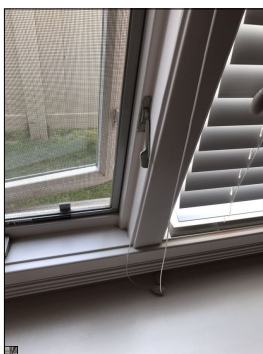
The lock/lever does not fully extend upward. This is considered abnormal and a defect. However, the window is still operable.

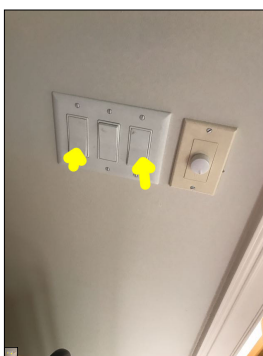
I was unable to find a function for the switches. There are no apparent lights or receptacles that are linked to the switches identified by the arrows. The middle switch goes to a receptacle within the bedroom.

- Recommend licensed electrician further evaluate and make necessary repairs.

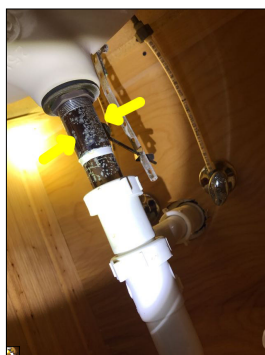
Rust/corrosion along the plumbing pipes.

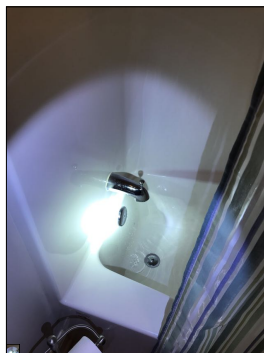
The bathtub faucet leaks while the showerhead is in operation. This is considered a defect. A properly functioning diverter will not allow any water through the bathtub faucet while the showerhead is in operation.

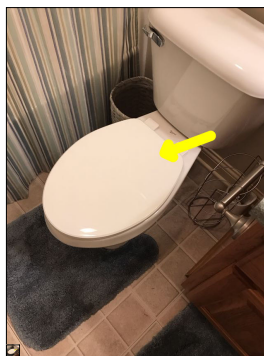
The toilet is loose. The toilet rocks back and forth. A toilet should not have any movement and be fully anchored and secured to the floor.

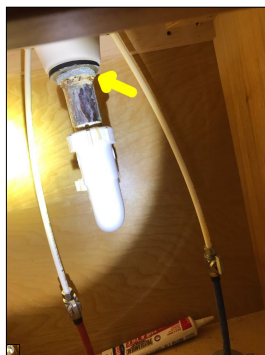
Rust/corrosion along the plumbing pipes.

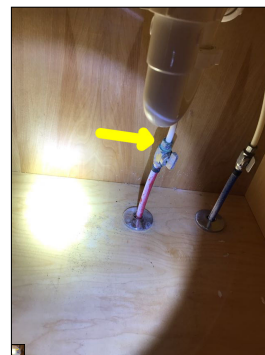
Rust/corrosion along the plumbing pipes.

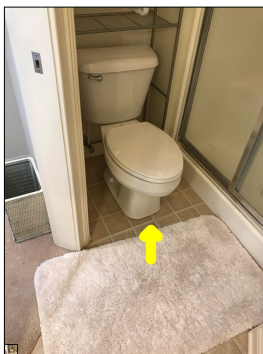
The toilet is loose. The toilet rocks back and forth. A toilet should not have any movement and be fully anchored and secured to the floor.

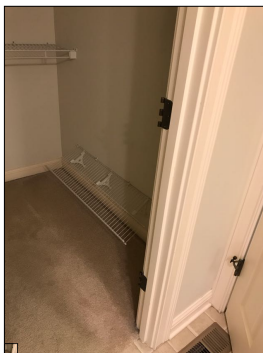
Missing door.

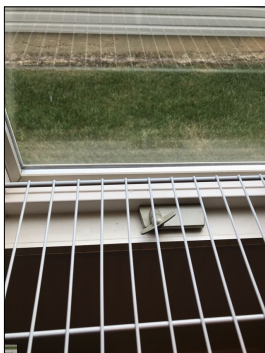
Missing window screens.

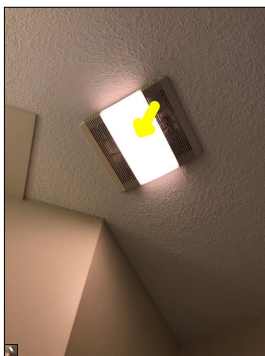
The casing to the light is cracked.

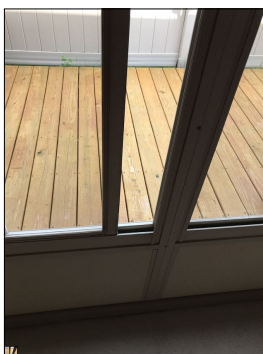
Missing window screens.

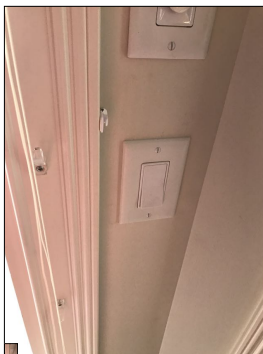
The switch is upside down.

- Recommend licensed electrician further evaluate and make necessary repairs.

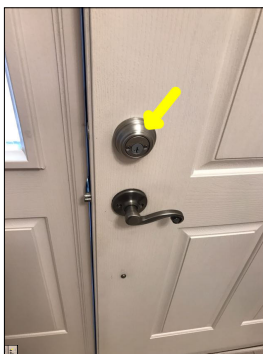
Double-keyed deadbolt lock. Double-keyed deadbolts are considered a safety hazard as they could create restricted egress.

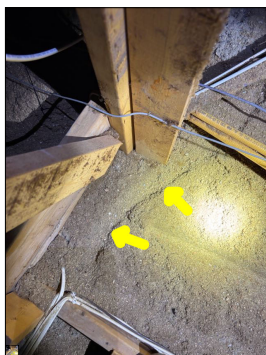
Mice/rodent tracks along the insulation. Wildlife activity can cause property damage.

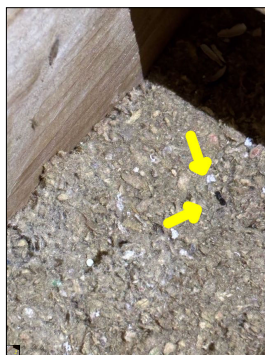
Mice/rodent droppings. Wildlife activity can cause property damage.

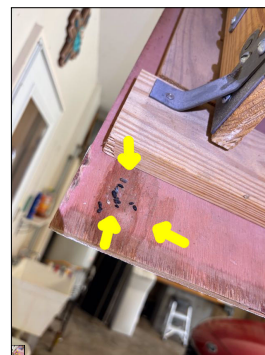
Mice/rodent droppings. Wildlife activity can cause property damage.

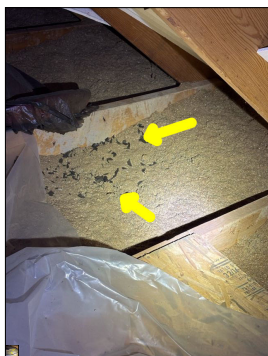
Debris and clutter within the attic. This type of debris and clutter is commonly caused by wildlife activity.

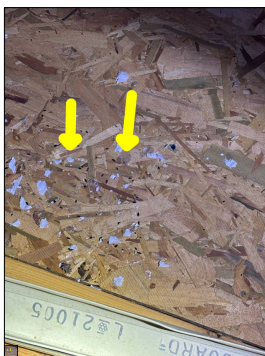
Debris and clutter within the attic. This type of debris and clutter is commonly caused by wildlife activity.

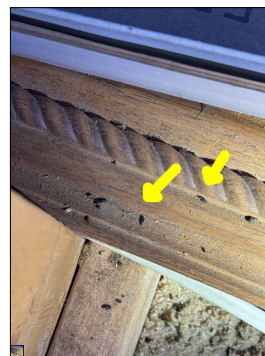
Mice/rodent droppings. Wildlife activity can cause property damage.

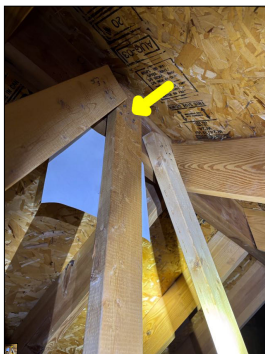
The board is loose. This is considered a defect.

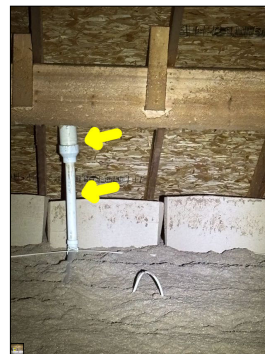
Th plumbing vent is not plumb and is crooked. This is considered abnormal and amateur craftsmanship.

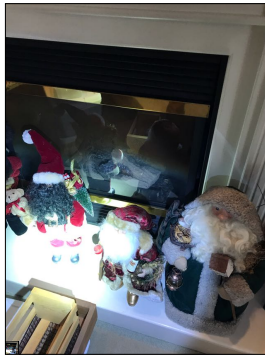
The fireplace is a gas fireplace. There is no apparent electronic ignition. It is beyond the scope of a general home inspection to light fuel burning appliances. Doing so could cause property damage. Recommend a licensed chimney/fireplace professional further evaluate to make sure the fireplace is in good working condition and is safe to use.

- Before using the fireplace, it is recommended that a licensed chimney/fireplace professional further evaluate to ensure the fireplace is in good working condition and is safe for usage.

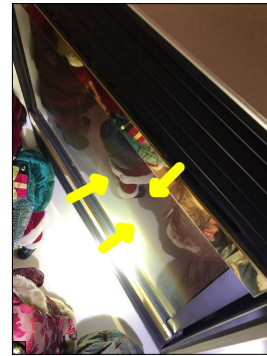
Discoloration along the glass panel. This is considered abnormal and a defect.

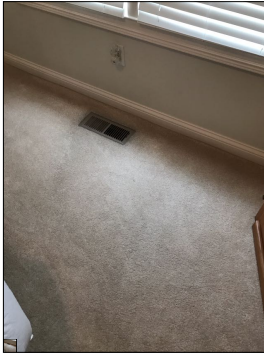
Please note, the house has sub slab HVAC ductwork. Sub slab ductwork can potentially allow water intrusion from the ground. Ground water entering into the ductwork can cause air quality problems and can hinder the performance of the heating and cooling systems. Also, sub slab ductwork can potentially increase indoor radon levels, allow the intrusion of insects, allow the intrusion of wood destroying insects and the intrusion of mice and other rodents.

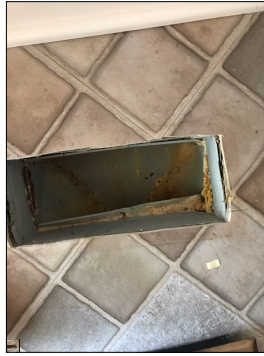
The HVAC ductwork is dirty. Recommended cleaning ductwork. Dirty ductwork can lead to poor air quality in every room of a home. Also, dirty ductwork can make heating and cooling less efficient and dirty ductwork can cause added wear and tear on HVAC heating and cooling systems thus shortening the lifespan of the systems.

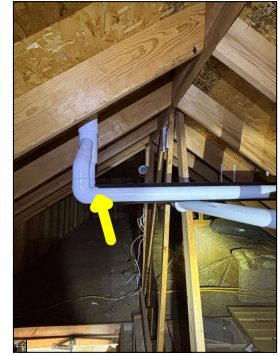
The exhaust for the furnace is sloped the wrong way. High efficiency furnaces create condensation during operation. The pipe should slope back towards the collector box within the furnace so the water can properly be discharged. When the pipe is sloped the wrong way, water can get trapped in the pipes, thus hindering the performance level of the furnace and in some cases it can cause the furnace to shut down due to poor drafting. This is located in the attic.

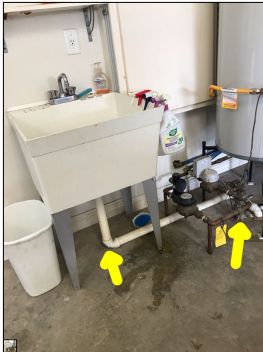
The sink unconventionally discharges into the floor drain/pit. This is not a recommended practice and does not meet the industry standard. The sink should discharge into the main drain pipes. Recommend licensed plumber further evaluate and make necessary repairs.

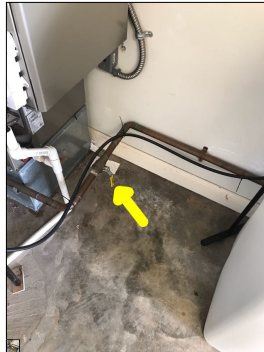
The water valve is closed. This is considered unusual.

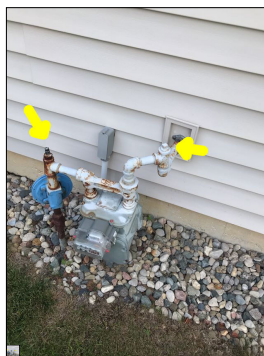
Rust and corrosion along the fuel lines. Rust and corrosion can create holes along the fuel lines, thus creating a fuel leak.

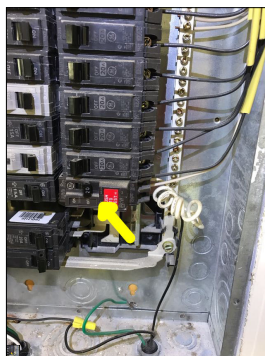
The circuit breaker is turned off. Circuit breakers turned off is considered abnormal. Recommend asking the seller why the circuit breaker is turned off to get additional information about the electrical system. It is recommended to have the circuit breaker turned on to ensure the circuit is in good working condition. A licensed electrician is recommended to check the circuit. Please note, it is beyond the scope of a general home inspection to turn breakers, doing so could potentially cause property damage.

- Recommend licensed electrician further evaluate and make necessary repairs

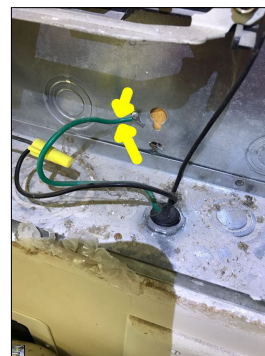
Loose/unused wires. Loose/unused wires are considered a safety hazard.
