# **FAMILYGUARD**

## **HOME INSPECTION REPORT**

**4110 Stillwood Dr. Fort Wayne, IN 46815**  
**Inspection Prepared For: Seller**

**Date of Inspection: 8/11/2026**  
**Age of House: 33**  
**Weather: Raining**

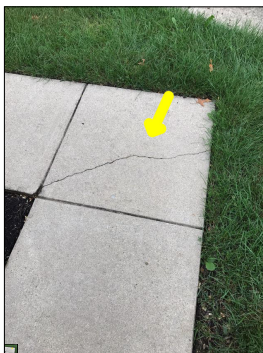
Cracks and deterioration along the service walks.

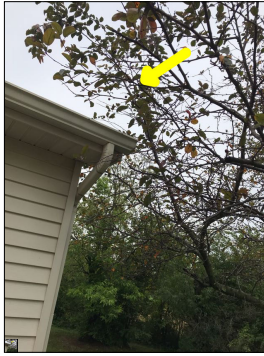
Vegetation against the siding/in proximity of the siding. This is not a recommended practice. Vegetation has the potential to harbor insects, wood destroying insects, rodents and hold moisture. Insects, wood destroying insects, rodents and moisture have the potential to create future problems for a house, such as structural damage, pest infestation and wood rot damage.

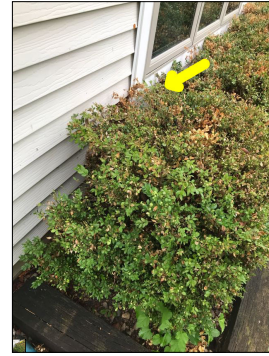
Vegetation against the siding/in proximity of the siding. This is not a recommended practice. Vegetation has the potential to harbor insects, wood destroying insects, rodents and hold moisture. Insects, wood destroying insects, rodents and moisture have the potential to create future problems for a house, such as structural damage, pest infestation and wood rot damage.

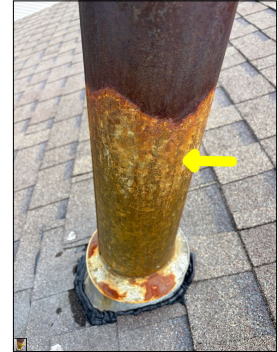
Rust and corrosion along the flue. Rust and corrosion can create holes along the flue, thus creating potential leak points.

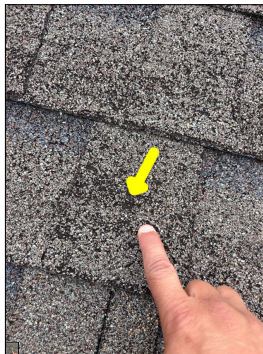
Granule loss along the roof shingles

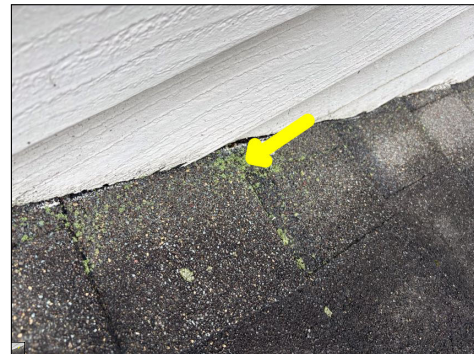
Biological growth along the roof. This is considered a defect. Biological growth has the potential to hold water. Shingles are not designed to hold water, shingles are designed to shed water.

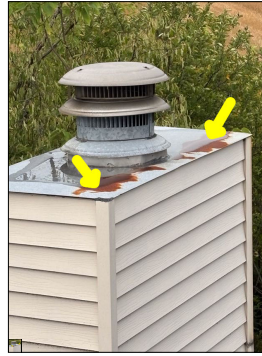
Rust and corrosion along the chimney. Rust and corrosion can create holes, thus creating leak points.

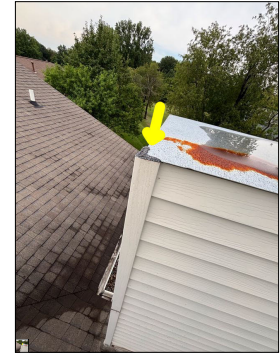
Unconventional application of roof sealant along the chimney. This is considered abnormal and amateur craftsmanship. Amateur craftsmanship is prone to failure and leakage.

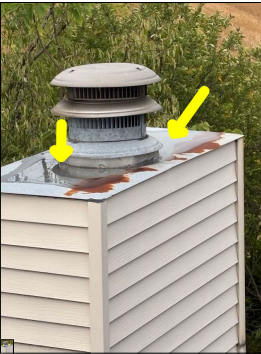
The top plate is holding water. Chimney top plates should be properly sloped, so they shed water. Failure to properly shed water can cause the top plate to prematurely deteriorate due to rust and corrosion. Also, leak points can arise due to a top plate not being sloped properly.

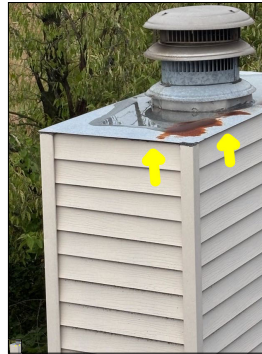
The chimney top plate does not have a proper drip edge to prevent water intrusion. The lack of a proper drip edge can allow water intrusion behind the chimney. An active or intermittent water source can cause mold growth and property damage.

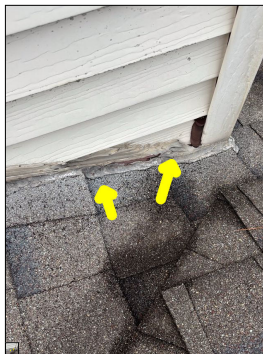
Unconventional application of sealant along the base of the chimney. This is considered abnormal and amateur craftsmanship. Amateur craftsmanship is prone to failure and leakage.

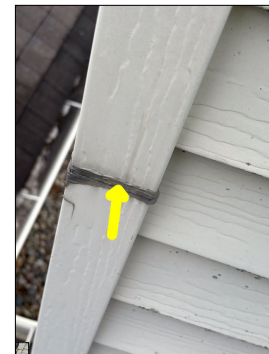
Unconventional application of sealant along the chimney. This is considered abnormal and amateur craftsmanship. Amateur craftsmanship is prone to failure and leakage.

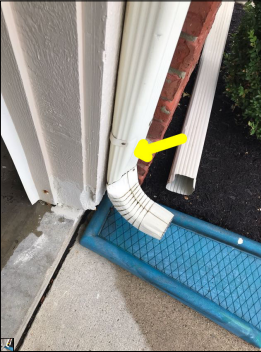
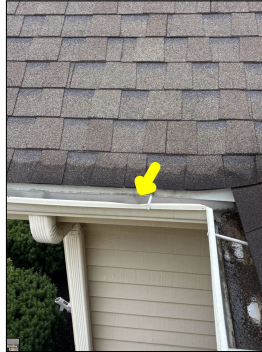
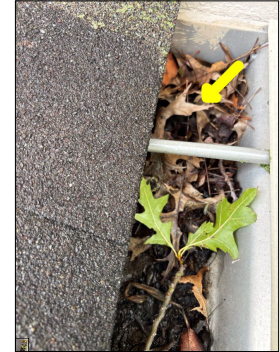
Dents/damage along the gutter system. Dents/damage along the gutter system. The gutter system is dirty and needs to be cleaned. A dirty gutter system can cause excessive water to accumulate around the house, thus potentially causing water intrusion into the house or potential foundation problems due to excessive hydrostatic pressure. Also, a dirty gutter system can cause excessive water to flow along the siding which could allow water to get behind the siding. An active or intermittent water intrusion source can cause mold growth and property damage.

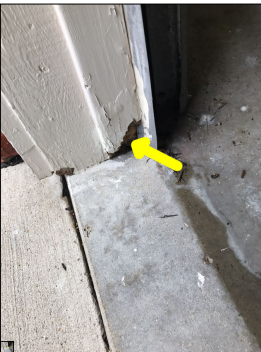
Wood rot damage.

- Cracks and holes in siding, loose/detached siding, gaps in siding and missing siding have the potential to allow water/moisture, insects, bats, mice, wood destroying insects, pests, and rodents into the framing of a house. The intrusion of water/moisture, insects, bats, mice, wood destroying insects, pests, and rodents has the potential to cause damage to a house, such as wood rot, mold, property damage and structural damage.
- Recommend general contractor further evaluate and make necessary repairs

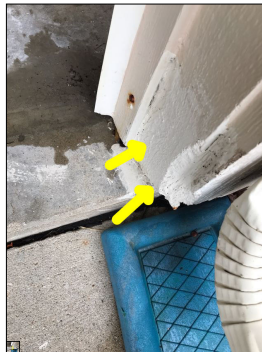
Deterioration along the siding.

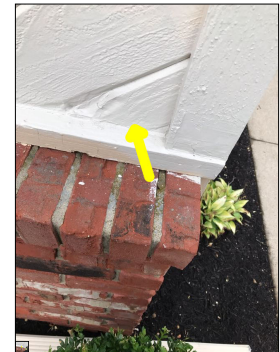
Wood rot damage.

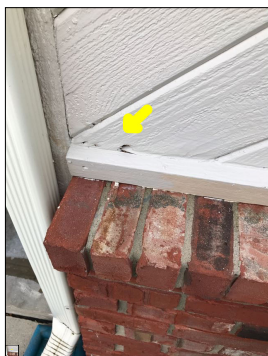
Wood rot damage.

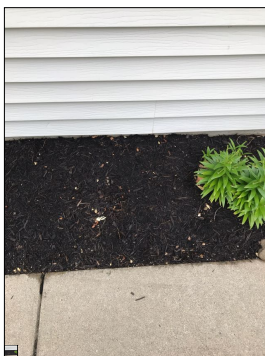
The siding is in proximity to the ground. Siding should have at least 6 to 8 inches of clearance above the ground. Maintaining proper clearances reduces access to wood structures behind the siding and helps preserve the house. The proper clearances help restrict access from wood destroying insects and/or moisture/water that might find its way behind the siding.

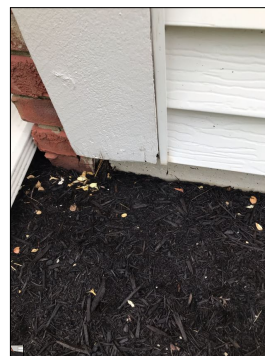
Wood rot damage.

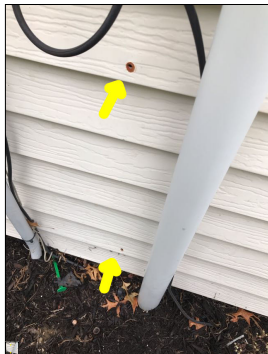
Holes along the siding.

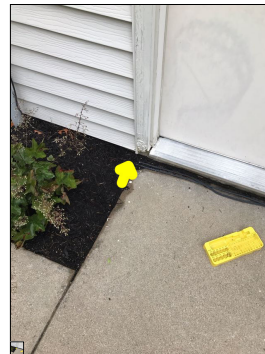
Wood rot damage.

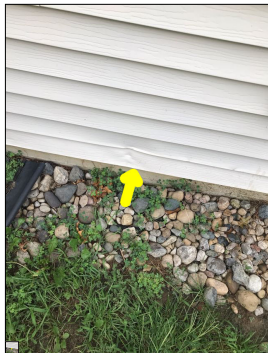
Dents along the siding.

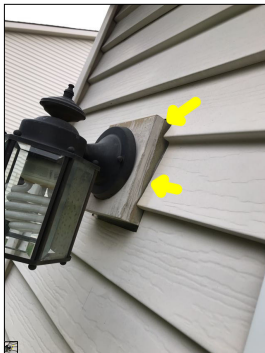
Missing J-channel.

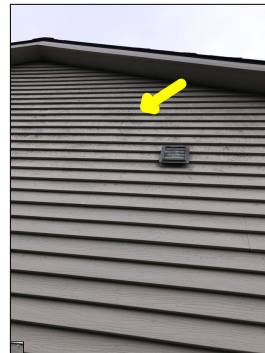
Discoloration along the siding.

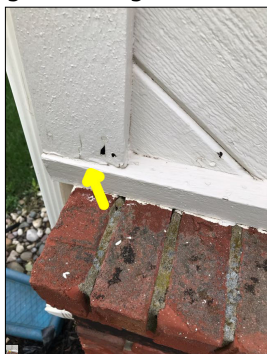
Wood rot damage.

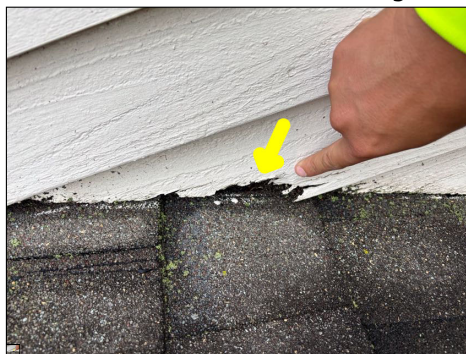
Wood rot damage.

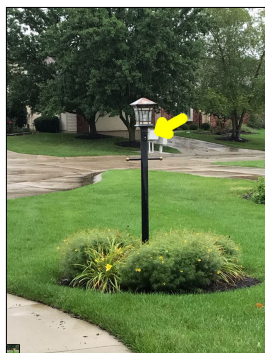
The light is inoperable. Upon covering the daylight sensor, the light still did not activate and turn on.

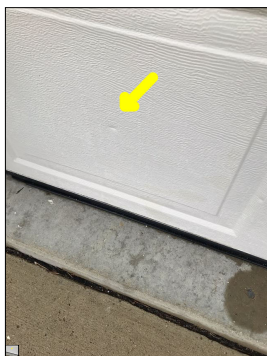
Dents/damage along the overhead garage door.

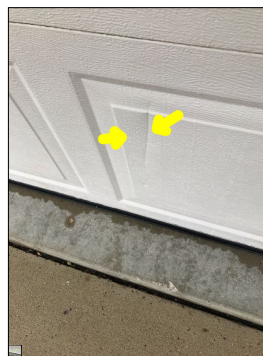
Dents/damage along the overhead garage door.

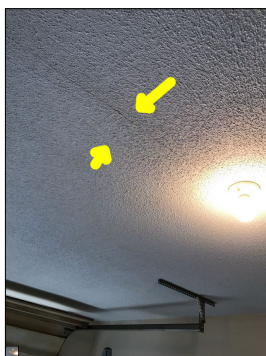
Cracks along the ceiling.

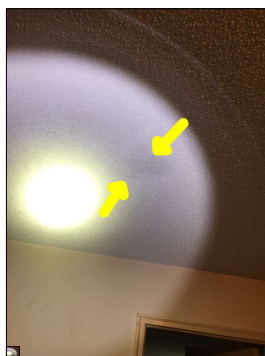
Areas along the popcorn ceiling are falling off.

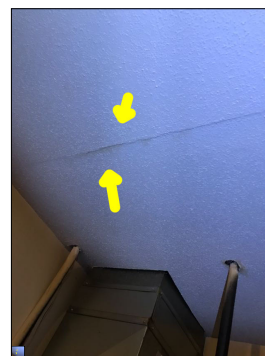
Discoloration and cracks along the ceiling.

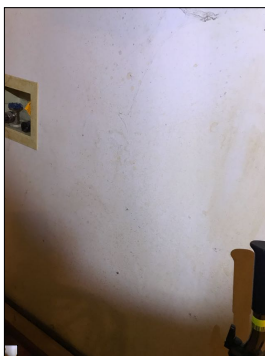
Discoloration along the wall. Discoloration along the ceiling is considered abnormal and a defect. An active or intermittent water source can cause discoloration, mold growth and property damage.

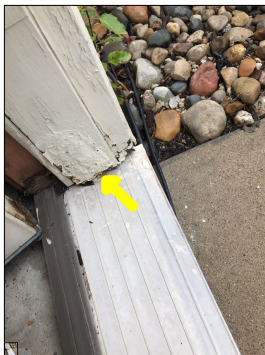
Wood rot damage along the service door.

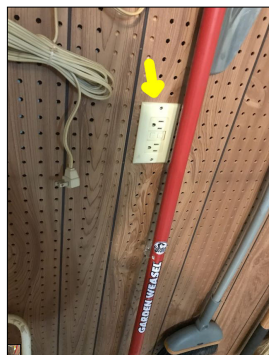
Loose receptacle.

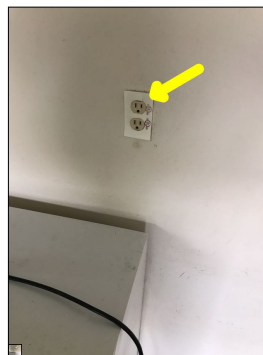
Missing receptacle cover.

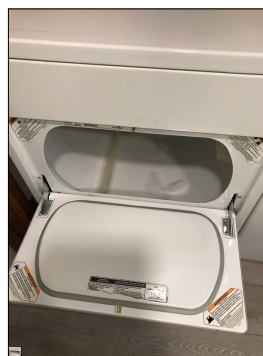
The dryer still spins when the door is open. This is considered a defect.

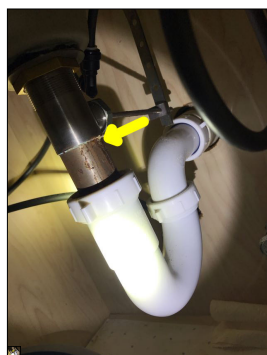
Rust/corrosion along the plumbing pipes.

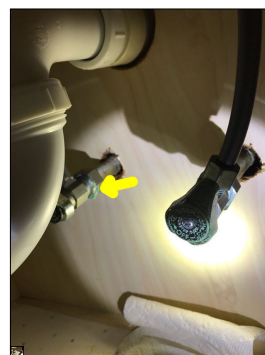
Rust/corrosion along the plumbing pipes.

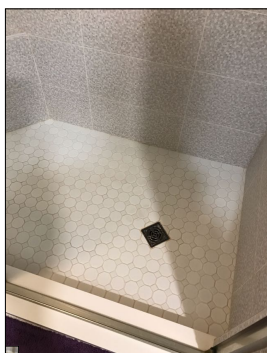
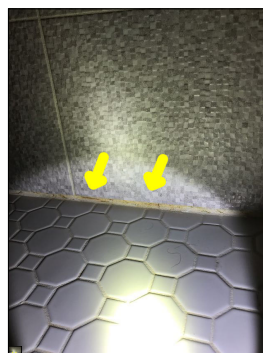
Cracks and deterioration along the mortar. Cracks are potential leak points. An active or intermittent water source can cause mold growth and property damage.

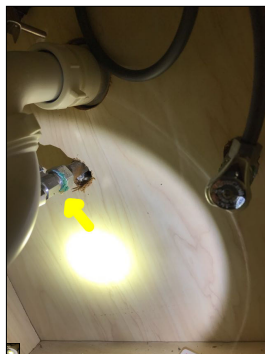
Rust/corrosion along the plumbing pipes.

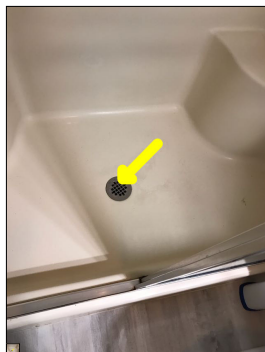
The grate is loose. This is considered a defect.

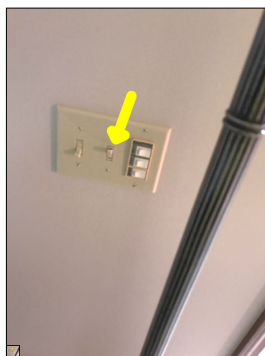
I was unable to find a function for the switch. There are no apparent lights or receptacles that are linked to the switch.

- Recommend licensed electrician further evaluate and make necessary repairs.

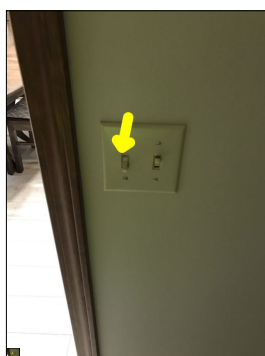
I was unable to find a function for the switch. There are no apparent lights or receptacles that are linked to the switch.

- Recommend licensed electrician further evaluate and make necessary repairs.

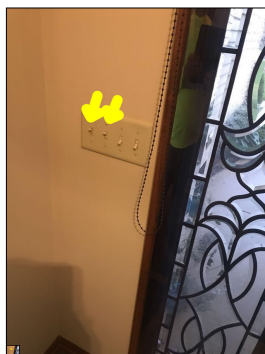
I was unable to find a function for the switch. There are no apparent lights or receptacles that are linked to the switch.

- Recommend licensed electrician further evaluate and make necessary repairs.

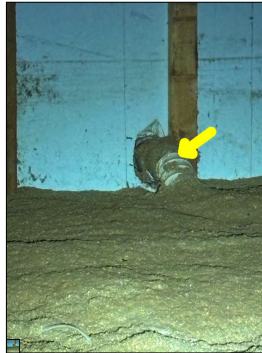
The exhaust ductwork lacks insulation. It is recommended for exhaust ductwork to be insulated in non climate controlled areas, such as an attic. The lack of insulation can cause condensation to form along the ductwork. An active or intermittent water source can cause mold growth and property damage.

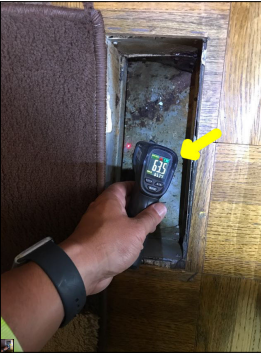
| Exterior | | |
|---|---|---|
| Page 26 Item: 3 | Cooling System | • The photo identifies the temperature of the supply air while the air conditioner was in operation. The approximate temperature of the supply air was 63 degrees Fahrenheit. The supply temperature for the cooling system is unconventionally high. This is considered a defect. A high supply temperature is unable to keep interior temperatures to desired levels. Recommend a licensed HVAC technician further evaluate and make necessary repairs. |

The photo identifies the temperature of the supply air while the air conditioner was in operation. The approximate temperature of the supply air was 63 degrees Fahrenheit. The supply temperature for the cooling system is unconventionally high. This is considered a defect. A high supply temperature is unable to keep interior temperatures to desired levels. Recommend a licensed HVAC technician further evaluate and make necessary repairs.

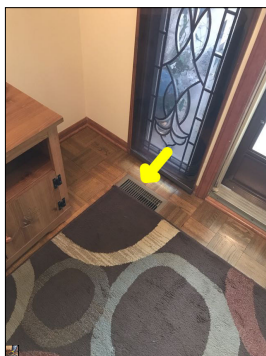
Please note, the house has sub slab HVAC ductwork. Sub slab ductwork can potentially allow water intrusion from the ground. Ground water entering into the ductwork can cause air quality problems and can hinder the performance of the heating and cooling systems. Also, sub slab ductwork can potentially increase indoor radon levels, allow the intrusion of insects, allow the intrusion of wood destroying insects and the intrusion of mice and other rodents.

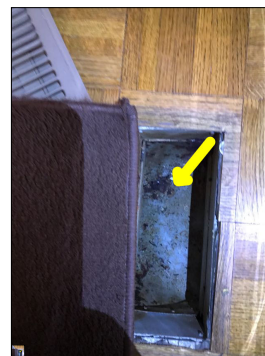
The HVAC ductwork is dirty. Recommended cleaning ductwork. Dirty ductwork can lead to poor air quality in every room of a home. Also, dirty ductwork can make heating and cooling less efficient and dirty ductwork can cause added wear and tear on HVAC heating and cooling systems thus shortening the lifespan of the systems.

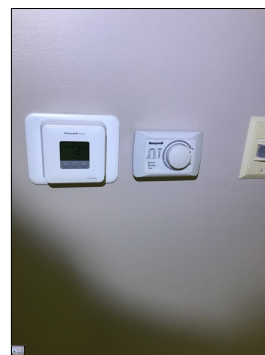
There is a humidistat, however, there is no apparent humidifier present.

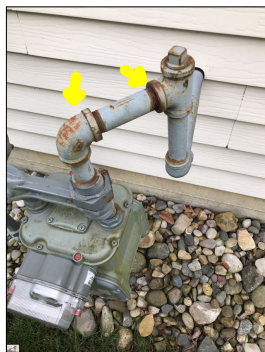
Rust and corrosion along the fuel lines. Rust and corrosion can create holes along the fuel lines, thus creating a fuel leak.

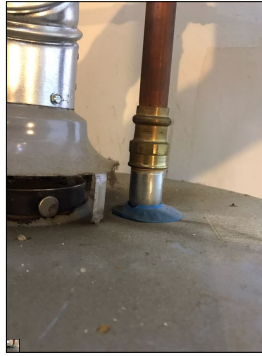
| Exterior | | |
|---|---|---|
| Page 30 Item: 2 | Water Heater | • The plastic rings adjacent to the water heater flue are melted. This is an indication that the water heater is backdrafting. This is a potential safety hazard as it can release carbon monoxide into the house. |

The plastic rings adjacent to the water heater flue are melted. This is an indication that the water heater is backdrafting. This is a potential safety hazard as it can release carbon monoxide into the house.

- Recommend licensed plumber further evaluate and make necessary repairs

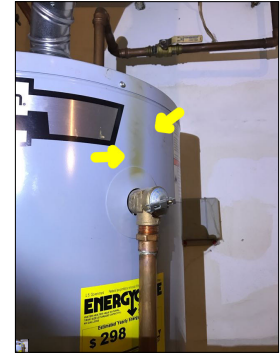
Unconventional discoloration along the water heater. This is considered abnormal.

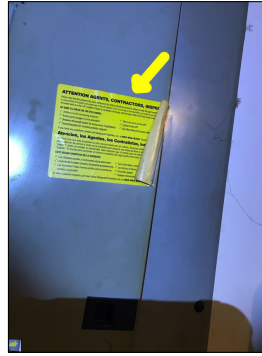
Winterized sticker along the electrical panel. This is an indication that the property was winterized in the past. Properties that are winterized normally indicate that they were vacant for an extended period of time. Homes that are vacant for an extended period of time can be problematic if they are not properly taken care of when vacant/winterized. Recommend finding out the history of the home and why it was winterized.

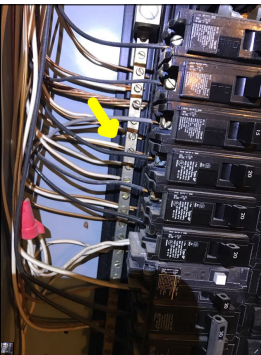
Double tapped neutral wires. Neutral wires should not share a terminal with any other wires, including ground wires. Double tapped neutrals are considered a safety hazard. Double tapped neutral wires do not allow the circuit to be isolated if the circuit needs to be worked on. Also, double tapped neutral wires under the same terminal can become loose, which could lead to arcing, overheating, spark and/or fire.

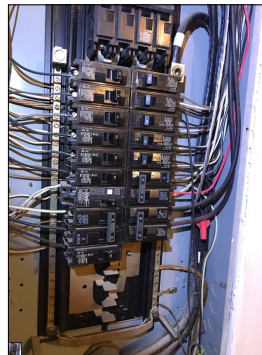
The circuit breaker panel is noisy. This is considered a defect and could be an indication of an overload or a defective circuit breaker. Noisy circuit breaker panels should be further evaluated by a licensed electrician.

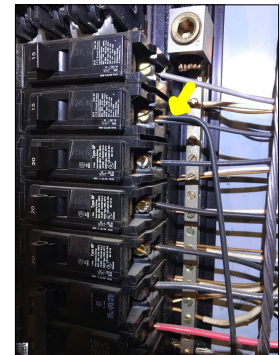
| Exterior | | |
|---|---|---|
| Page 31 Item: 3 | Electrical | • Double tapped circuit breaker. Two conductors inserted into a single circuit breaker that is rated for one conductor could become loose over time which could lead to overheating, arcing, spark and possible fire.<br>• The circuit breaker panel is noisy. This is considered a defect and could be an indication of an overload or a defective circuit breaker. Noisy circuit breaker panels should be further evaluated by a licensed electrician. |

Double tapped circuit breaker. Two conductors inserted into a single circuit breaker that is rated for one conductor could become loose over time which could lead to overheating, arcing, spark and possible fire.

- Recommend licensed electrician further evaluate and make necessary repairs
