# **FAMILYGUARD**

## **HOME INSPECTION REPORT**

**6340 Langwood Blvd. Fort Wayne, IN 46835**  
**Inspection Prepared For: Seller**

**Date of Inspection: 8/5/2026**  
**Age of House: 40 Years**  
**Weather: Clear**

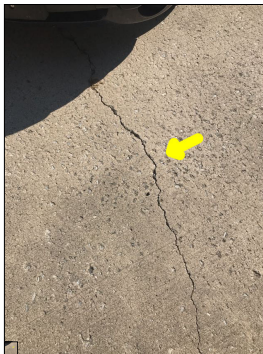
Cracks and deterioration along the driveway.

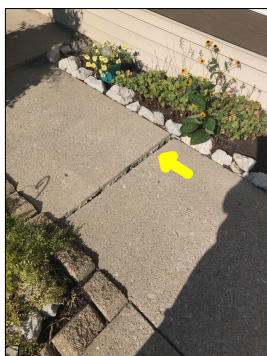
Uneven surfaces along the service walks.

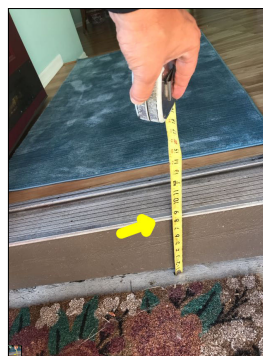
The riser/step is unconventionally high. This is a potential trip hazard. The recommended maximum height for a riser/step is 7 inches.

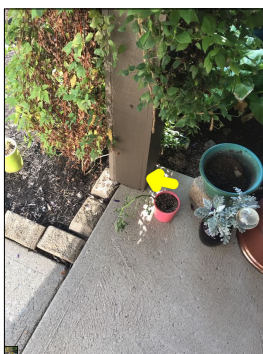
The column is loose.

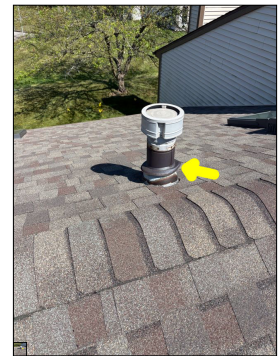
Rust and corrosion along the flue. Rust and corrosion can create holes along the flue, thus creating potential leak points.

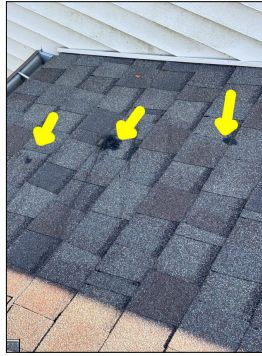
Unconventional application of sealant along the roof. This is considered abnormal and amateur craftsmanship. Amateur craftsmanship is prone to failure and leakage.

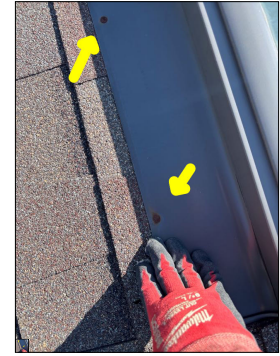
Exposed nailheads/staples. Exposed nailheads/staples are potential leak points.

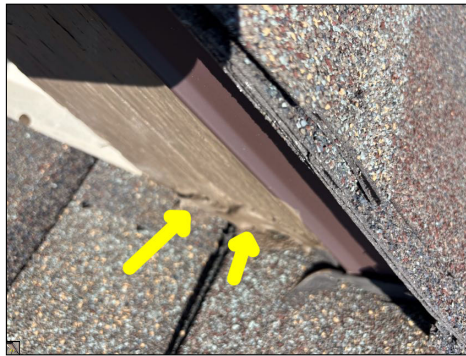
Unconventional application of sealant along the roof. This is considered abnormal and amateur craftsmanship. Amateur craftsmanship is prone to failure and leakage.

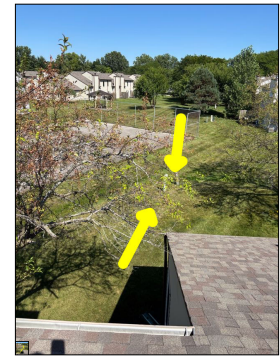
Vegetation in proximity of the roof. Falling branches can damage the roof system. Also, vegetation in proximity of the roof can enable small animals and rodents access to the roof. Wildlife activity can cause property damage.

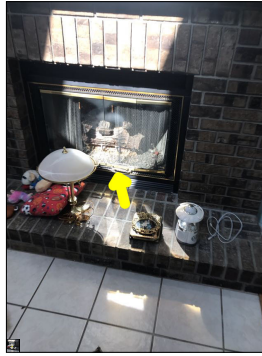
The blower is unconventionally noisy.

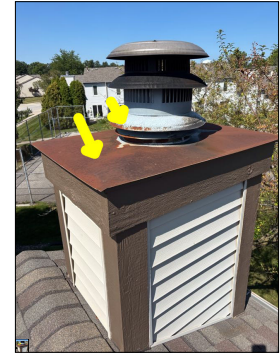
Rust and corrosion along the chimney. Rust and corrosion can create holes, thus creating leak points.

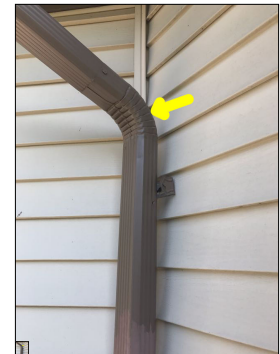
The downspout is loose.

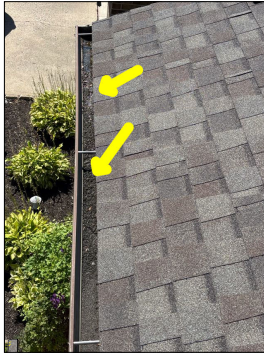
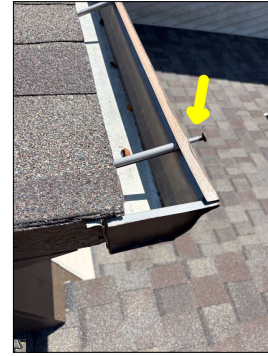
The gutter system is dirty and needs to be cleaned. A dirty gutter system can cause excessive water to accumulate around the house, thus potentially causing water intrusion into the house or potential foundation problems due to excessive hydrostatic pressure. Also, a dirty gutter system can cause excessive water to flow along the siding which could allow water to get behind the siding. An active or intermittent water intrusion source can cause mold growth and property damage.

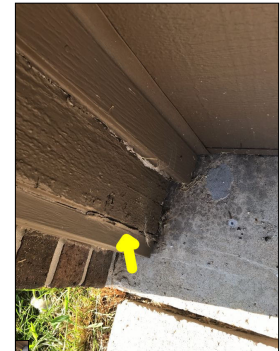
Gaps along the siding.

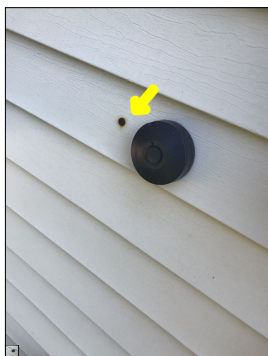
Exposed nails/fasteners along the siding. Exposed nails/fasteners are potential leak points. Exposed nails along the siding is considered amateur craftsmanship. Amateur craftsmanship is prone to failure and leakage.

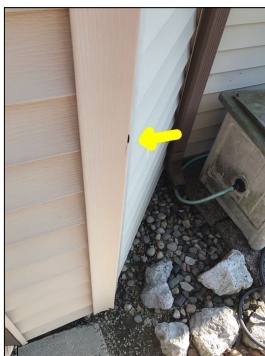
Damaged siding.

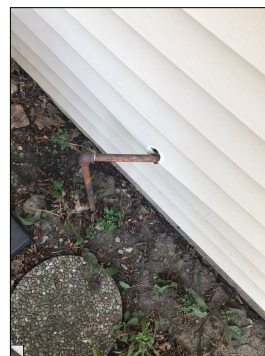
Holes along the siding.

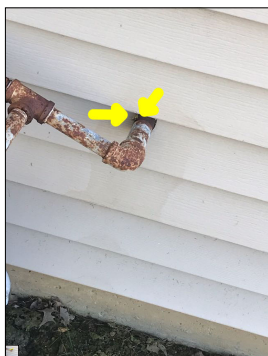
Wasp nest observed within the siding. Wasps can cause property damage and potentially sting those dwelling around the house.

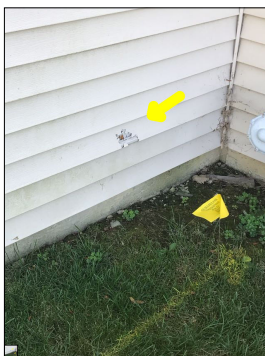
Damaged siding.

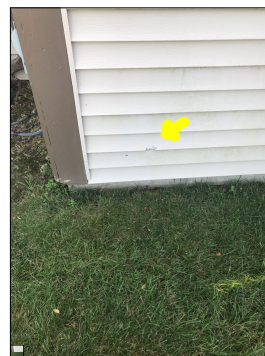
Damaged siding.

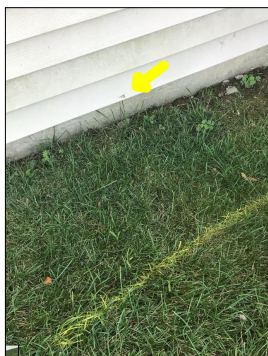
Damaged siding.

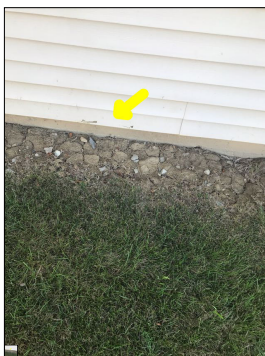
Damaged siding.

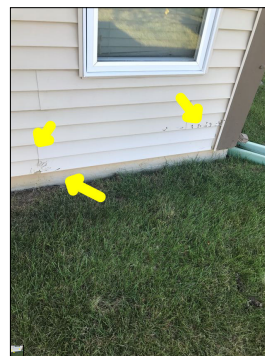
Damaged siding.

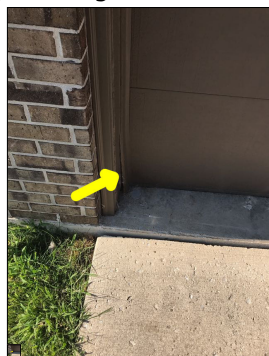
Loose/detached siding.

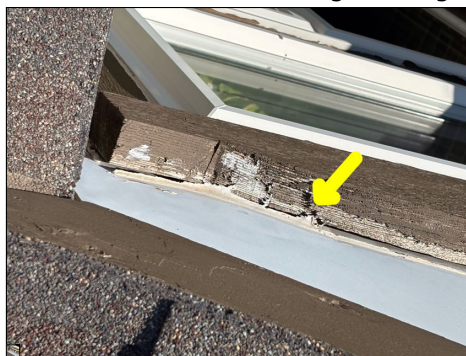
Gaps along the siding.

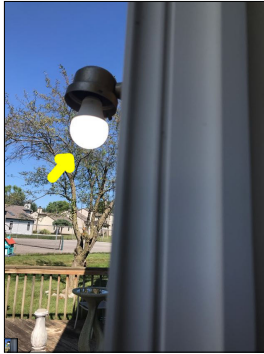
The weather protection cover is missing.

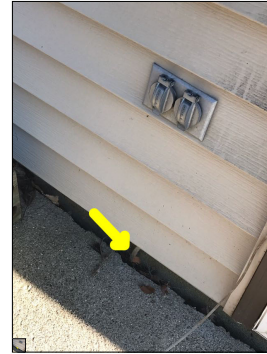
The wires are not wrapped in conduit. This is considered abnormal, amateur craftsmanship and a potential safety hazard. Wires should be wrapped in conduit to protect both humans and the electrical wiring. Wires that lack conduit can potentially get pulled, become loose, or damaged, thus creating shock hazards and/or fire hazards. Also, the sheathing around the wires is not rated for exterior use. The lack of proper sheathing can allow rain, snow, sunlight, wildlife, etc. to damage the wires, thus causing shock hazards, spark, arcing and/or fire.

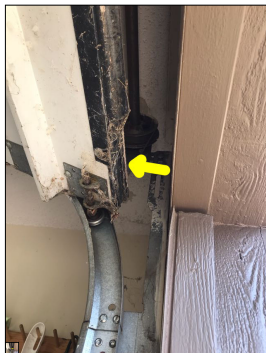
The weatherstrip is partially torn/missing along the overhead garage door. The lack of a proper weatherstrip can allow the intrusion of moisture, insects, wood destroying insects, mice and rodents into the property.

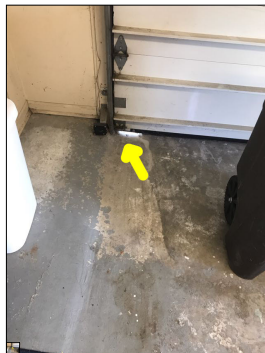
Daylight can be seen from the interior. This is an entry point for moisture, insects, mice, rodents, etc.

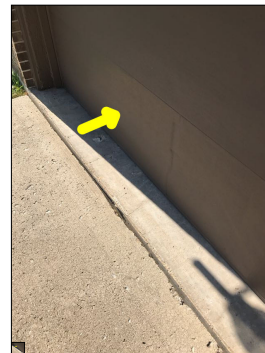
Dents/damage along the overhead garage door.

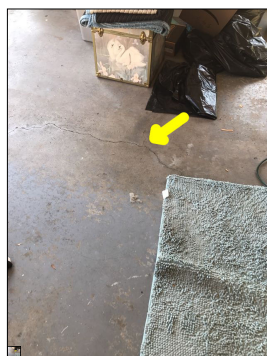
Cracks and deterioration along the floor.

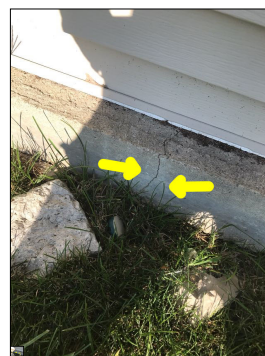
Crack along the slab. Cracks are considered a defect. Cracks should be repaired/sealed to prevent the intrusion of moisture, insects, radon, wood destroying insects, mice, etc.

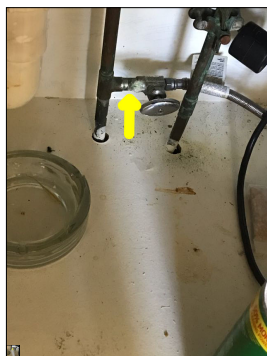
Rust/corrosion along the plumbing pipes.

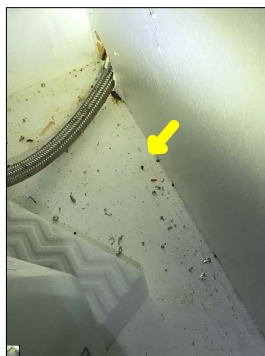
Mice/rodent droppings observed. Wildlife activity can cause property damage.

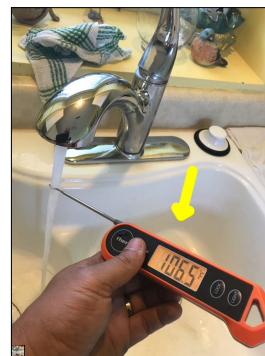
Temperature reading of the hot water during the time of the inspection. The approximate temperature of the hot water was 106 degrees Fahrenheit.

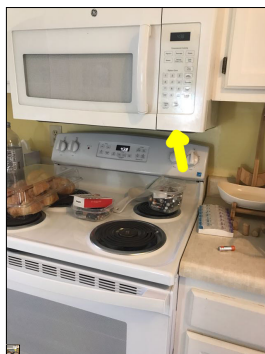
The microwave is unconventionally close to the burners. This is considered abnormal and amateur craftsmanship. This is also a potential fire hazard.

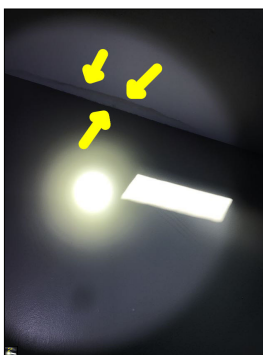
| Exterior | | |
|---|---|---|
| Page 18 Item: 2 | Walls/Ceiling | <ul style="list-style-type: none"><li>• Discoloration along the ceiling and signs of previous water damage. An active or intermittent water source can cause mold growth and property damage.</li></ul> |

Discoloration along the ceiling and signs of previous water damage. An active or intermittent water source can cause mold growth and property damage.

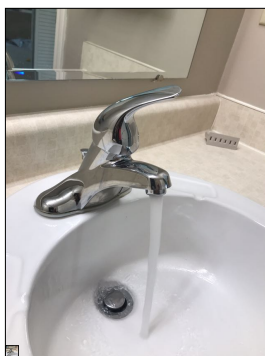
The faucet is loose.

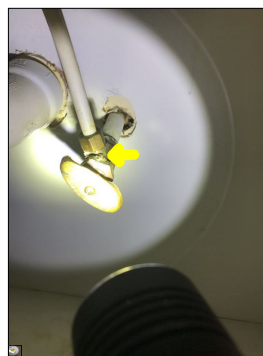
Rust/corrosion along the plumbing pipes.

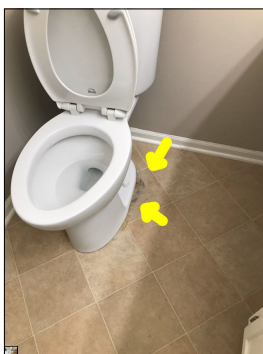
Discoloration along the floor. An active or intermittent water source can cause mold growth and property damage. No moisture detected in this area on the day of the inspection.

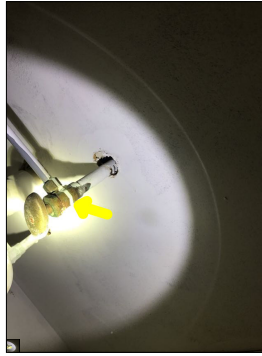
Rust/corrosion along the plumbing pipes.

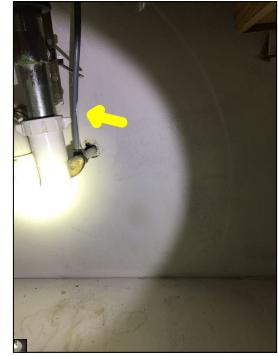
Polybutylene plumbing lines. Polybutylene pipes are prone to failure and no longer meet modern day plumbing standards. Recommend upgrading from polybutylene pipes to modern day plumbing materials, such as PEX or copper. Please note, polybutylene pipes can be concealed behind walls, ceilings, etc.

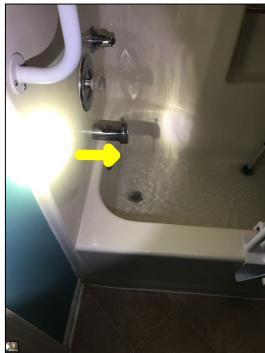
The bathtub faucet leaks while the showerhead is in operation. This is considered a defect. A properly functioning diverter will not allow any water through the bathtub faucet while the showerhead is in operation.

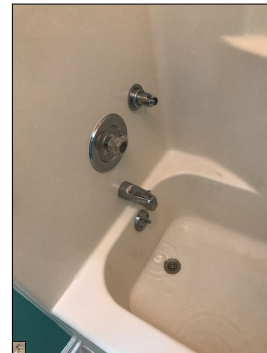
The diverter rod does not drop when the showerhead is turned off. This is considered abnormal and a defect. Unless the diverter rod is manually disengaged when turning the showerhead off, the next person to turn the bathtub faucet on will receive water from the showerhead.

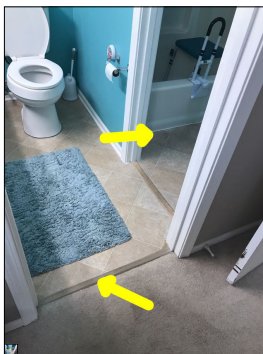
Missing doors.

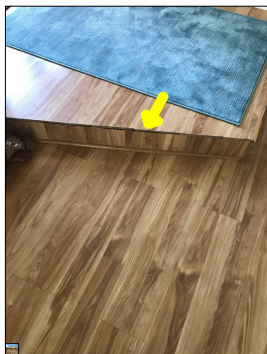
Missing trim pieces along the floor.

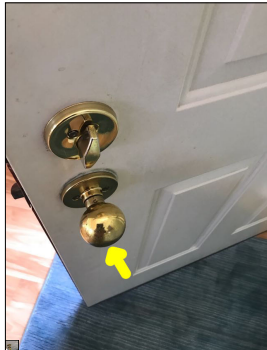
The door knob is loose.

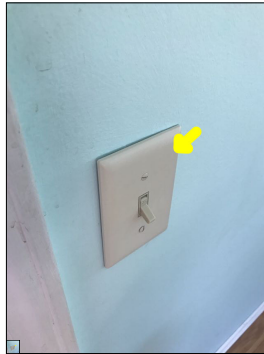
Loose switch/cover.

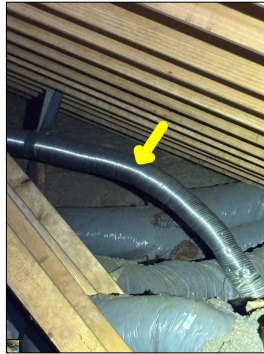
The exhaust ductwork lacks insulation. It is recommended for exhaust ductwork to be insulated in non climate controlled areas, such as an attic. The lack of insulation can cause condensation to form along the ductwork. An active or intermittent water source can cause mold growth and property damage. This appears to be the ductwork for the dryer.

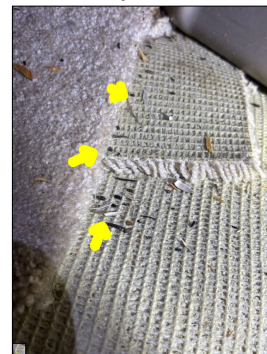
Mice/rodent droppings. Wildlife activity can cause property damage.

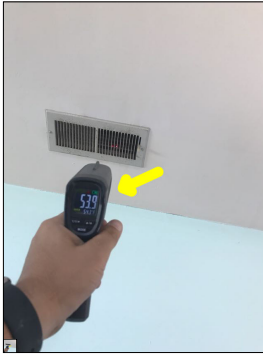
The photo identifies the temperature of the supply air while the air conditioner was in operation. The approximate temperature of the supply air was 53 degrees Fahrenheit.

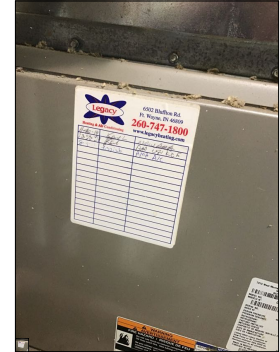
No current annual service maintenance record observed. It is recommended that appliances have annual maintenance to prolong the life of the appliance, ensure the appliance is operating at optimal performance, keep warranties valid and help avoid unexpected/costly repairs.

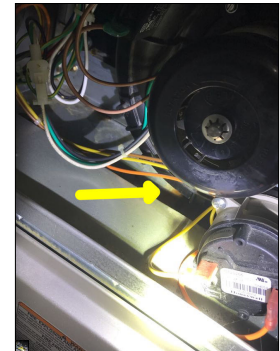
Rust and corrosion within the furnace cabinet. This is considered a defect. An active or intermittent water source can cause property damage.

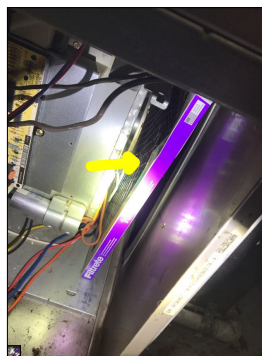
The furnace filter is dirty and displaced. Recommend cleaning/servicing the furnace.

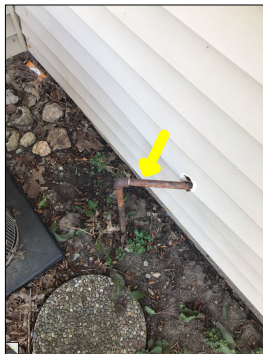
Rust and corrosion along the fuel lines. Rust and corrosion can create holes along the fuel lines, thus creating a fuel leak.

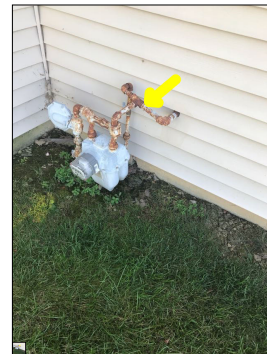
Rust and corrosion along the fuel lines. Rust and corrosion can create holes along the fuel lines, thus creating a fuel leak.

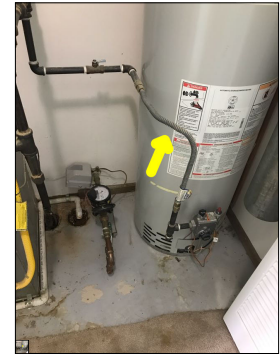
Coated brass fuel line. Coated brass no longer meets modern day plumbing standards and is considered a safety hazard. Recommend upgrading the fuel line to a modern day plumbing material, such as **CSSI** or black iron.

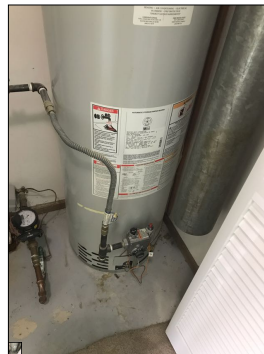
The water heater is noisy when the burners turn on. This is considered a defect. A noisy water heater is normally due to excessive sediments within the tank.

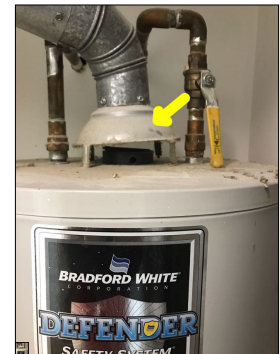
The draft hood is displaced and crooked. This is considered abnormal and a safety and the water heater might not draft properly, thus releasing carbon monoxide into the house.

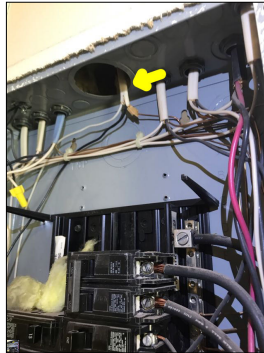
| Exterior | | |
|---|---|---|
| Page 35 Item: 3 | Electrical | <ul style="list-style-type: none"><li>• Wires routed through the knockout without a bushing or clamp. This is considered a safety hazard as the metal edge of the knockout could penetrate the wires, thus causing spark and a fire.</li></ul> |

Wires routed through the knockout without a bushing or clamp. This is considered a safety hazard as the metal edge of the knockout could penetrate the wires, thus causing spark and a fire.

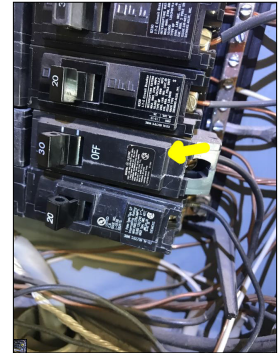
Electrical panel/circuit breaker manufacturer mismatch within the circuit breaker panel. The defect is because not all busbars are the same size and have the same dimensions. A circuit breaker from another manufacturer might not properly fit the busbar, thus creating a poor/loose connection.

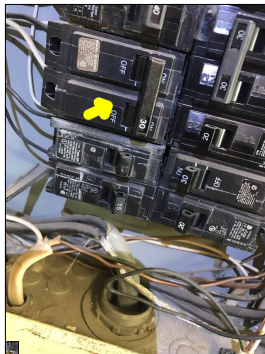
Electrical panel/circuit breaker manufacturer mismatch within the circuit breaker panel. The defect is because not all busbars are the same size and have the same dimensions. A circuit breaker from another manufacturer might not properly fit the busbar, thus creating a poor/loose connection.

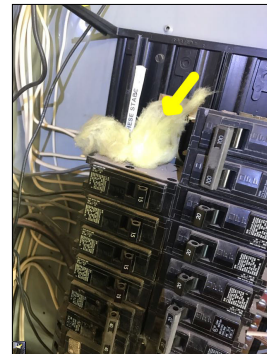
Insulation within the panel. This is a potential fire hazard as insulation is a combustible.
