# **FAMILYGUARD**

## **HOME INSPECTION REPORT**

**11378 S. State Rd. 13 La Fontaine, IN 46940**  
**Inspection Prepared For: Seller**

**Date of Inspection: 8/5/2026**  
**Age of House: 120+ Years**  
**Weather: Clear**

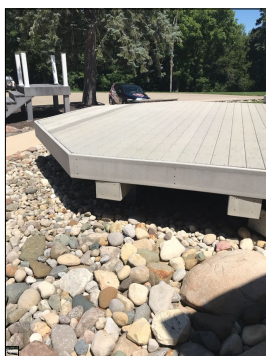
Missing railing along the deck.

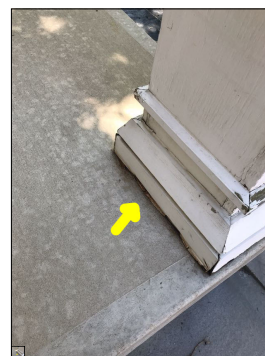
Wood rot damage along the columns.

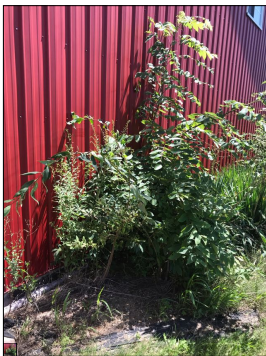
Vegetation against the siding/in proximity of the siding. This is not a recommended practice. Vegetation has the potential to harbor insects, wood destroying insects, rodents and hold moisture. Insects, wood destroying insects, rodents and moisture have the potential to create future problems for a house/structure such as structural damage, pest infestation and wood rot damage.

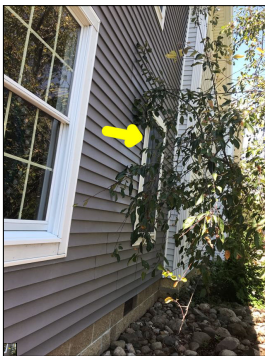
Vegetation against the siding/in proximity of the siding. This is not a recommended practice. Vegetation has the potential to harbor insects, wood destroying insects, rodents and hold moisture. Insects, wood destroying insects, rodents and moisture have the potential to create future problems for a house, such as structural damage, pest infestation and wood rot damage.

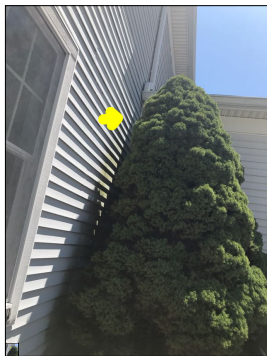
Vegetation against the siding/in proximity of the siding. This is not a recommended practice. Vegetation has the potential to harbor insects, wood destroying insects, rodents and hold moisture. Insects, wood destroying insects, rodents and moisture have the potential to create future problems for a house, such as structural damage, pest infestation and wood rot damage.

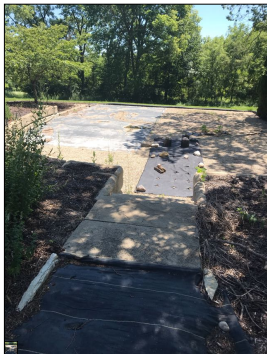
Unfinished landscaping.

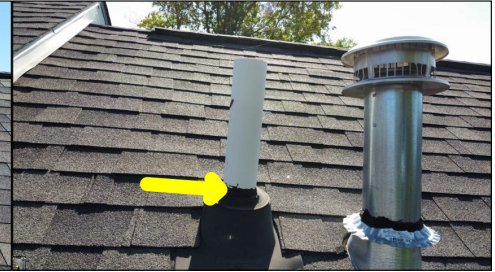
Unconventional application of roof sealant along the rubber flashing. Rubber flashing is designed to be caulkless. This is considered amateur craftsmanship. Most roof sealants are petroleum based. A petroleum based product can cause the rubber flashing to prematurely deteriorate, thus creating a leak point.

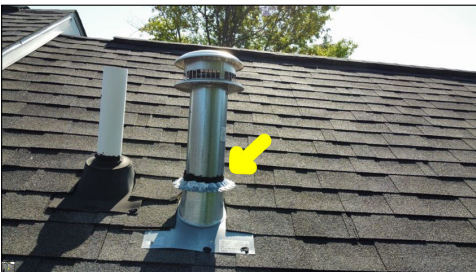
Unconventional application of sealant along the flue. This is considered abnormal and amateur craftsmanship. Amateur craftsmanship is prone to failure and leakage.

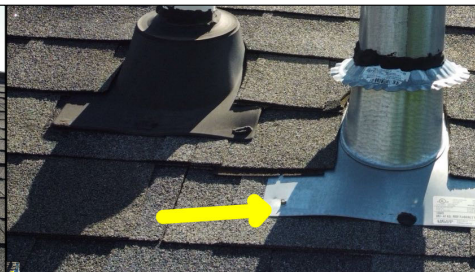
Exposed nailheads/staples. Exposed nailheads/staples are potential leak points.

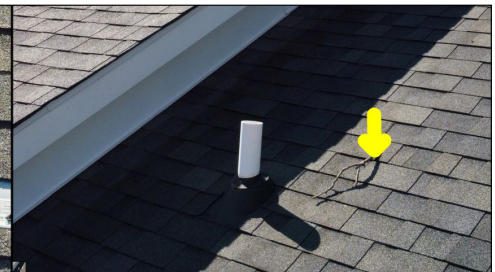
Tree branches observed along the roof. Falling tree branches can cause damage to the roof system, thus resulting in water intrusion into the attic/house.

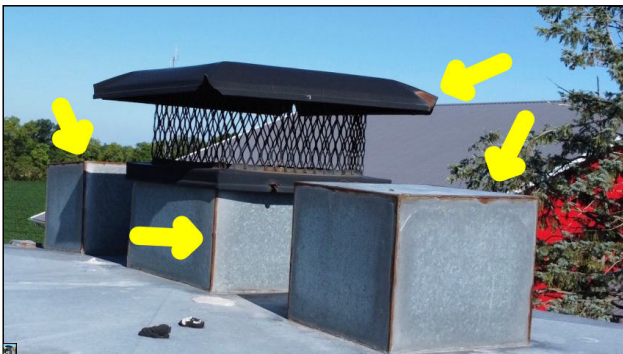
Rust and corrosion along the flashing. Rust and corrosion can create holes in the flashing, thus creating potential leak points. Also, it appears two of the flues have been abandoned, capped, and are no longer in use.

- Recommend chimney professional further evaluate and make necessary repairs
- Before using the fireplace, it is recommended that a licensed chimney/fireplace professional further evaluate to ensure the fireplace is in good working condition and is safe for usage.

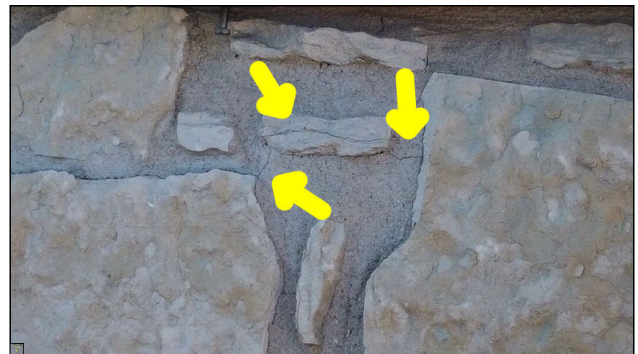
Cracks along the chimney. Cracks are considered defects and potential leak points.

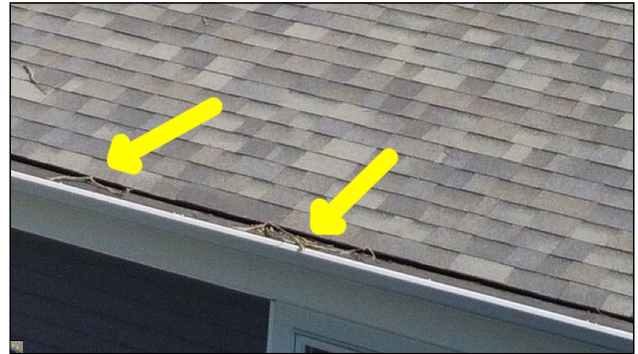
The gutter system is dirty and needs to be cleaned. A dirty gutter system can cause excessive water to accumulate around the house, thus potentially causing water intrusion into the house or potential foundation problems due to excessive hydrostatic pressure. Also, a dirty gutter system can cause excessive water to flow along the siding which could allow water to get behind the siding. An active or intermittent water intrusion source can cause mold growth and property damage.

- Recommend general contractor further evaluate and make necessary repairs
- A defective gutter/drainage system can cause excessive water to accumulate around the house, thus potentially causing water intrusion into the house or potential foundation problems due to excessive hydrostatic pressure. Also, a defective gutter/drainage system can cause excessive water to flow along the exterior walls, which could allow water to get behind the siding, soffit and fascia. An active or intermittent water intrusion source can cause mold growth and property damage.

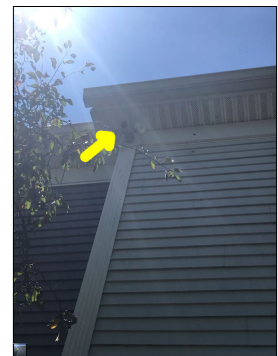
Hole along the siding.

- Cracks and holes in siding, loose/detached siding, gaps in siding and missing siding have the potential to allow water/moisture, insects, bats, mice, wood destroying insects, pests, and rodents into the framing of a house. The intrusion of water/moisture, insects, bats, mice, wood destroying insects, pests, and rodents has the potential to cause damage to a house, such as wood rot, mold, property damage and structural damage.
- Recommend general contractor further evaluate and make necessary repairs

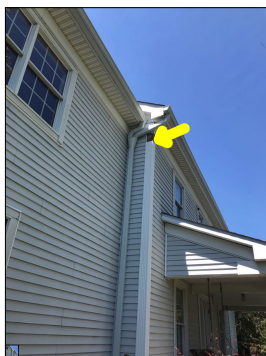
Missing siding.

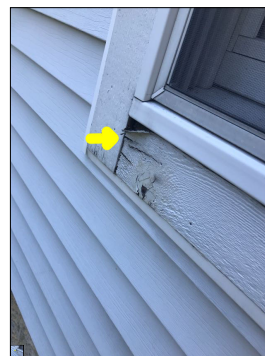
Wood rot damage.

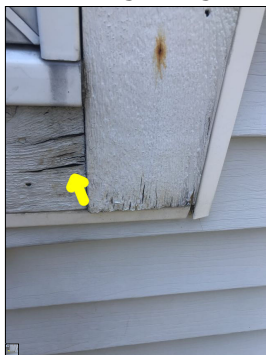
Wood rot damage.

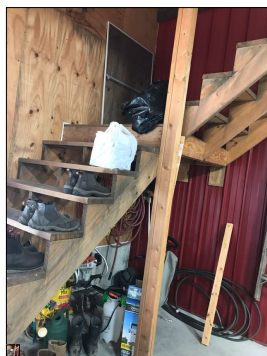
Missing handrail.

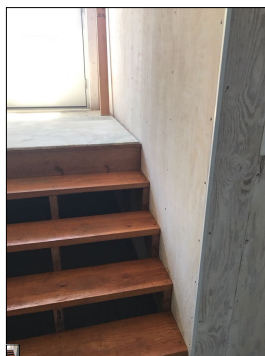
Missing handrail.

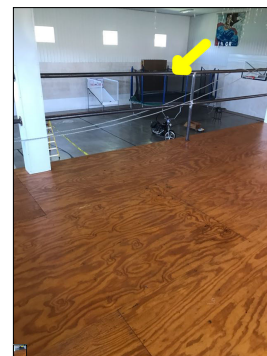
The spacing between the railing/cords exceeds four inches. Four inches is the recommended maximum distance between railing/cords. Spacing between the railing/cords that exceeds four inches is considered a safety hazard as a small child or pet could fall between the railing.

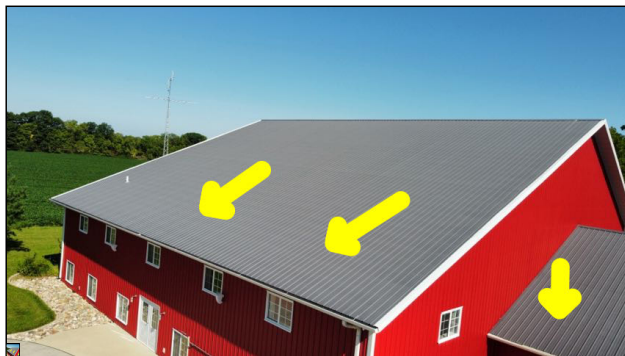
The metal roof is missing a snow/ice guard. The lack of a snow/ice guard can allow large sheets of ice and snow to slide off of the roof, thus potentially causing property damage and/or bodily harm.

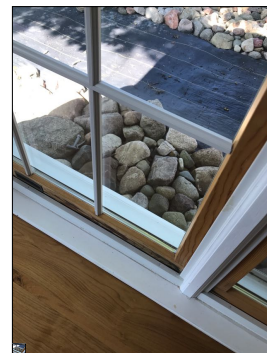
Missing window screens.

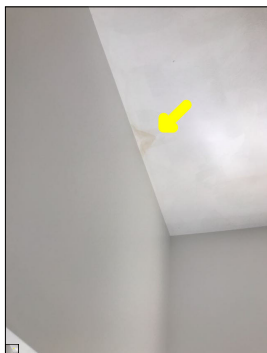
Discoloration along the ceiling and signs of previous water damage. An active or intermittent water source can cause mold growth and property damage.

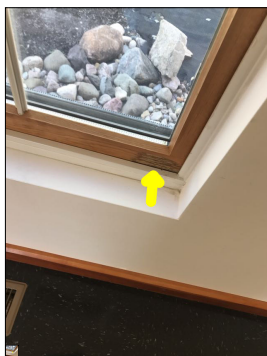
Discoloration along the window. An active or intermittent water source can cause discoloration, mold, and property damage.

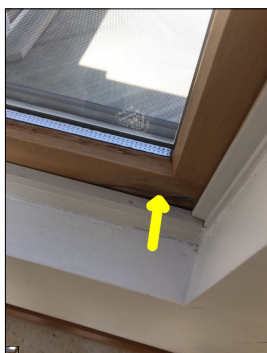
Discoloration along the window. An active or intermittent water source can cause discoloration, mold, and property damage.

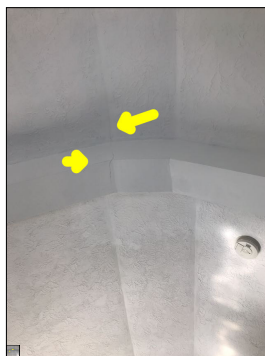
Cracks along the ceiling.

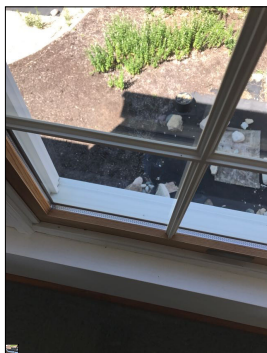
Missing window screens.

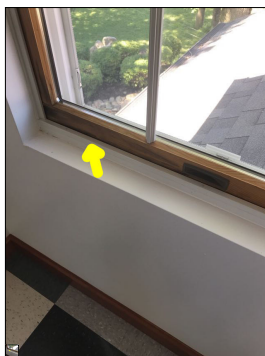
Discoloration along the window. An active or intermittent water source can cause discoloration, mold, and property damage.

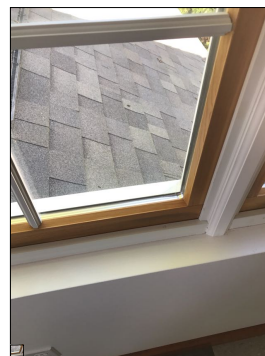
Missing window screens.

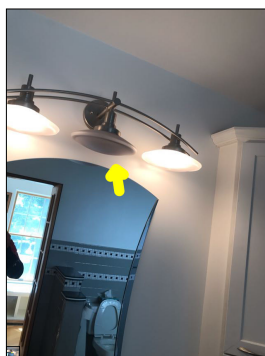
The light is inoperable. The bulb might be burned out.

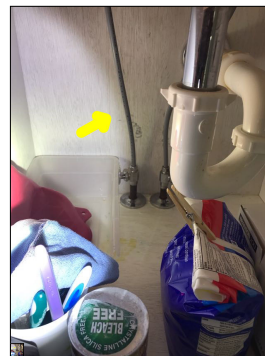
Polybutylene plumbing lines. Polybutylene pipes are prone to failure and no longer meet modern day plumbing standards. Recommend upgrading from polybutylene pipes to modern day plumbing materials, such as PEX or copper. Please note, polybutylene pipes can be concealed behind walls, ceilings, etc.

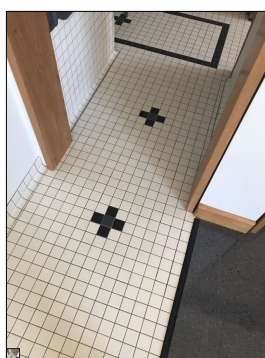
The floor slopes. This is considered abnormal and a defect.

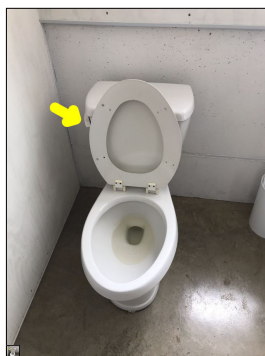
The lever has to be held down for a few seconds for the toilet to flush. This is considered abnormal and a defect. A toilet should properly flush by simply pressing down on the lever and then releasing from the lever.

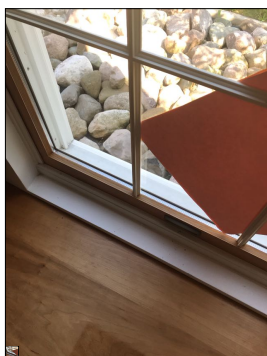
Missing window screens.

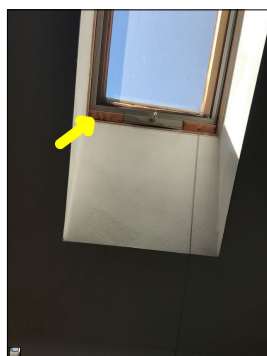
Discoloration along the ceiling and signs of previous water damage. An active or intermittent water source can cause mold growth and property damage.

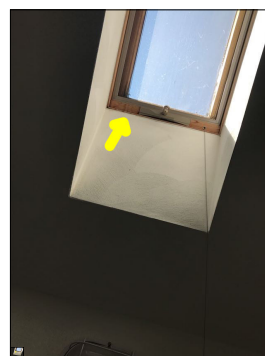
Discoloration along the ceiling and signs of previous water damage. An active or intermittent water source can cause mold growth and property damage.

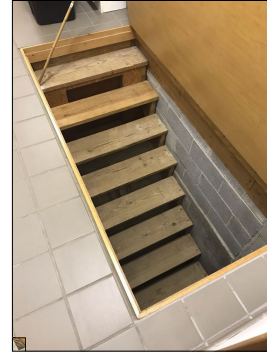
Missing handrail.

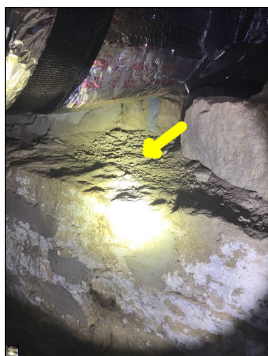
Dirt floor. Dirt floors are not recommended. A dirt floor can allow the intrusion of moisture, insects, wood destroying insects, radon, mice, and rodents. An active or intermittent water source can cause mold growth and property damage, such as wood rot damage. It is recommended that dirt floors be properly encapsulated.

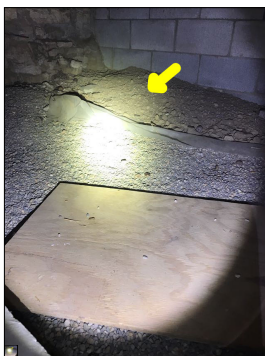
Dirt floor. Dirt floors are not recommended. A dirt floor can allow the intrusion of moisture, insects, wood destroying insects, radon, mice, and rodents. An active or intermittent water source can cause mold growth and property damage, such as wood rot damage. It is recommended that dirt floors be properly encapsulated.

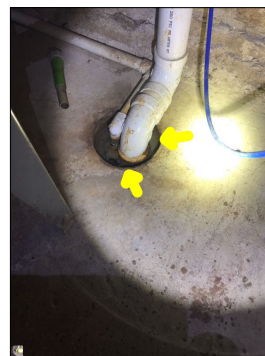
Standing water observed within the drain. This is an indication that the water table underneath the slab is high. High water tables can potentially cause water intrusion into house and create excessive hydrostatic pressure, thus creating water intrusion into the house and foundation defects.

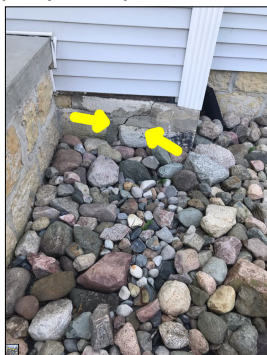
| Basement/Crawl Space | | |
|---|---|---|
| Page 36 Item: 3 | Foundation/Floor | <ul style="list-style-type: none"><li>• Crack along the foundation. Cracks are considered a defect. Cracks should be repaired/sealed to prevent the intrusion of moisture, insects, wood destroying insects, mice, and radon.</li></ul> |

Crack along the foundation. Cracks are considered a defect. Cracks should be repaired/sealed to prevent the intrusion of moisture, insects, wood destroying insects, mice, and radon.

- Limited visibility
- Cracks
- Recommend structural engineer further evaluate and make necessary repairs

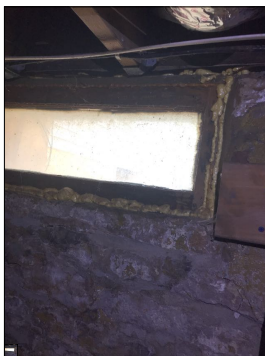
Aged windows.

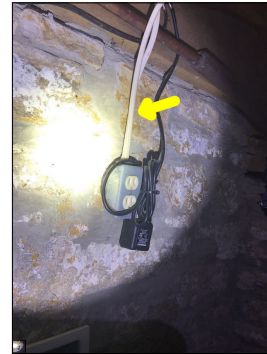
The wires along the concrete/stone are not wrapped in conduit. This is considered abnormal, amateur craftsmanship and a potential safety hazard. The wires can absorb moisture from the concrete/stone, thus causing arcing, spark and/or fire.

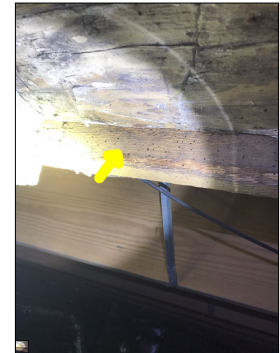
| Basement/Crawl Space | | |
|---|---|---|
| Page 38 Item: 6 | Beams/Subfloor/Joists/Columns | <ul style="list-style-type: none"><li>• Unconventional alterations and column supports. This is considered amateur craftsmanship. Amateur craftsmanship is prone to failure.</li><li>• Exit holes observed. Exit holes are an indication of an infestation of powderpost beetles. Powderpost beetles are a wood destroying insect and can cause structural damage and property damage.</li></ul> |

Exit holes observed. Exit holes are an indication of an infestation of powderpost beetles. Powderpost beetles are a wood destroying insect and can cause structural damage and property damage.

- Limited visibility
- Wood destroying insect damage
- Recommend structural engineer evaluate

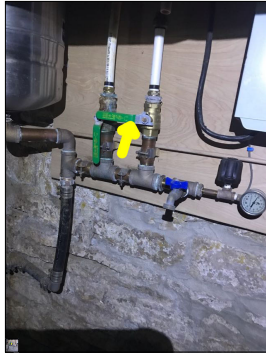
The water valve is closed. Recommend identifying why the valve is closed and where the water supply lines go behind the valve.

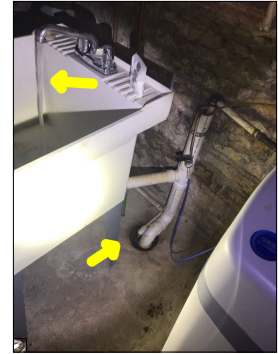
The sink unconventionally discharges into the floor drain/pit. This is not a recommended practice and does not meet the industry standard. The sink should discharge into the main drain pipes. Recommend licensed plumber further evaluate and make necessary repairs.

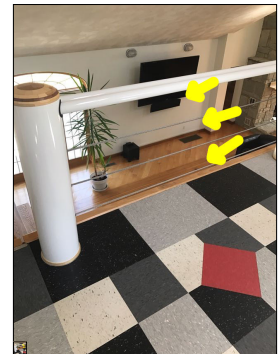
The spacing between the railing/cords exceeds four inches. Four inches is the recommended maximum distance between railing/cords. Spacing between the railing/cords that exceeds four inches is considered a safety hazard as a small child or pet could fall between the railing.

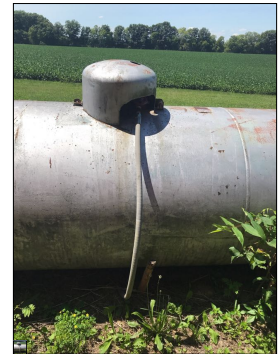
Gas smell noticed when inspecting the tank. This is a potential safety hazard.

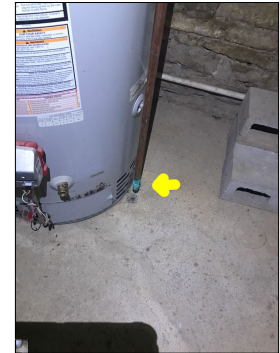
Corrosion along the end of the temperature and pressure relief valve extension. This is considered a defect and an indication that the water heater might have discharged in the past.

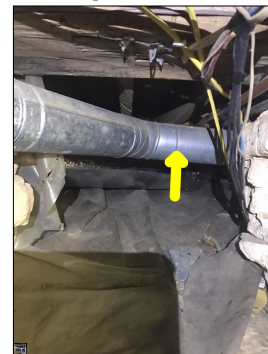
Negative sloped flue. This is not a recommended practice and is a potential safety hazard. A negative sloped flue can cause backdrafting which could cause carbon monoxide to leak into the house.

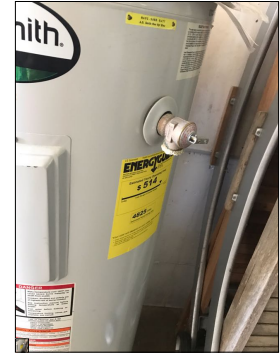
The temperature and pressure relief valve extension is missing. This is a potential safety hazard.

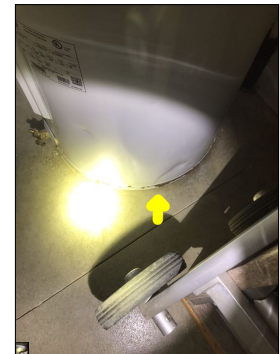
Rust and corrosion along the water heater. This is considered a defect. An active or intermittent water source can cause property damage and mold growth. Also, there is a dent along the water heater.

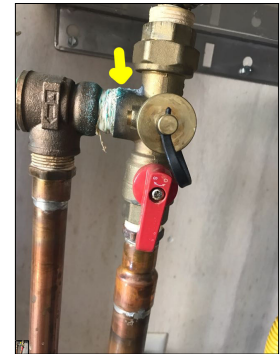
Corrosion along the water supply lines.

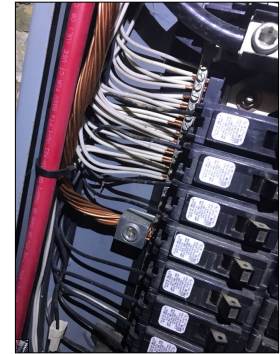
Double tapped neutral wires. Neutral wires should not share a terminal with any other wires, including ground wires. Double tapped neutrals are considered a safety hazard. Double tapped neutral wires do not allow the circuit to be isolated if the circuit needs to be worked on. Also, double tapped neutral wires under the same terminal can become loose, which could lead to arcing, overheating, spark and/or fire.

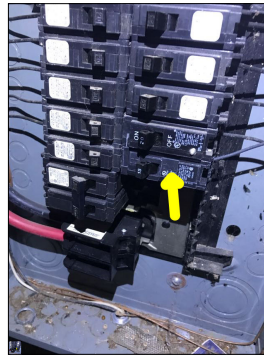
Electrical panel/circuit breaker manufacturer mismatch within the circuit breaker panel. The defect is because not all busbars are the same size and have the same dimensions. A circuit breaker from another manufacturer might not properly fit the busbar, thus creating a poor/loose connection.

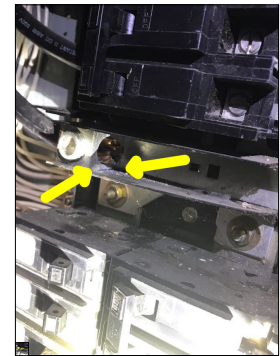
| Basement/Crawl Space | | |
|---|---|---|
| Page 48 Item: 3 | Electrical | <ul style="list-style-type: none"><li>• Rust and corrosion within the circuit breaker panel. This is considered abnormal and a potential safety hazard. An active or intermittent water source can cause rust and corrosion. Rusted/corroded terminals and connections increase resistance in the circuit that can cause overheating, thus causing arcing, spark and/or fire. Some areas of rust and corrosion may not be visible and could be concealed behind breakers, wires, etc.</li><li>• The bonding screw is not removed from the sub panel. This is a potential safety hazard.</li></ul> |

Rust and corrosion within the circuit breaker panel. This is considered abnormal and a potential safety hazard. An active or intermittent water source can cause rust and corrosion. Rust/corroded terminals and connections increase resistance in the circuit that can cause overheating, thus causing arcing, spark and/or fire. Some areas of rust and corrosion may not be visible and could be concealed behind breakers, wires, etc.
