Inspection report for the property at  
1406 E Gump Rd, Fort Wayne, IN 46845

This report is prepared exclusively for **Becky Skurner / Christy Hire**  
Inspected On: **08-28-2026**

Peak To Pillar Home Inspectors LLC  
2604359278

Peter Fennig , Indiana State License  
#HI02500018

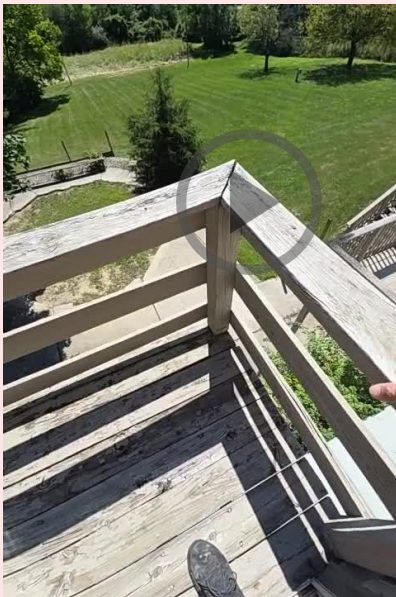
**ES-7 ■ Exterior Structures:** The second-story cantilevered balcony exhibited excessive movement during normal use. Guardrails and decking were loose, and the balcony did not feel structurally sound. The outside edges of the decking extend beyond the supporting floor joists and the presence of a proper rim/band joist securing the cantilevered framing could not be confirmed. Recommend avoiding use of the balcony until it has been evaluated and repaired by a qualified structural contractor or engineer.

*Second floor balcony railings are very loose, deck boards are not fully secured in multiple locations and Lacks a rim board on the south end or floor joists on the East and West Ends*

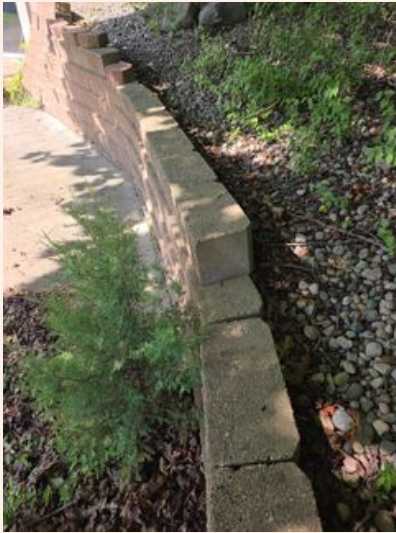
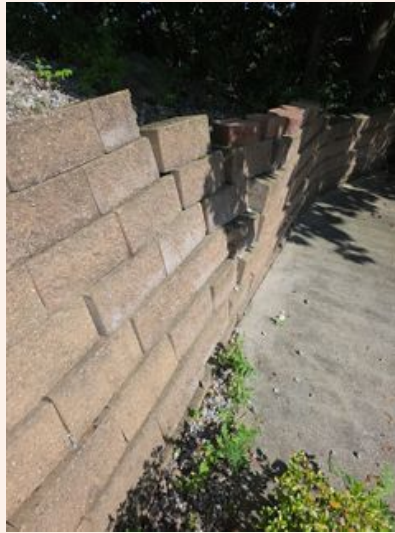
The rear southeast retaining wall has minor localized movement and displacement. Most of the wall appeared solid, with only a handful of blocks, primarily along the top course, found to be loose. Recommend monitoring and repairing the affected section as needed to prevent further movement.

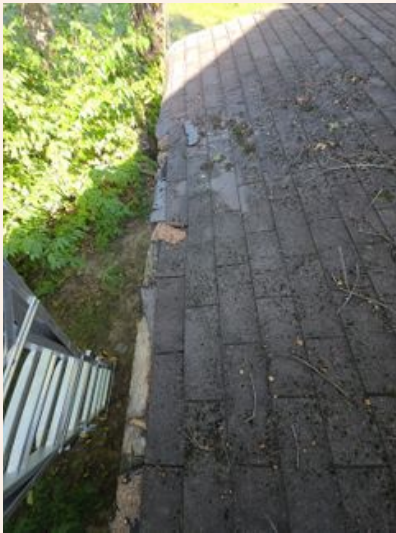
The roof over the attached shed on the east side of the house is in poor condition, particularly along the north side. Multiple damaged and missing shingles, soft spots, and deterioration of the roof decking and eaves were observed.

Replacement of this roof section is recommended due to the extent of deterioration.

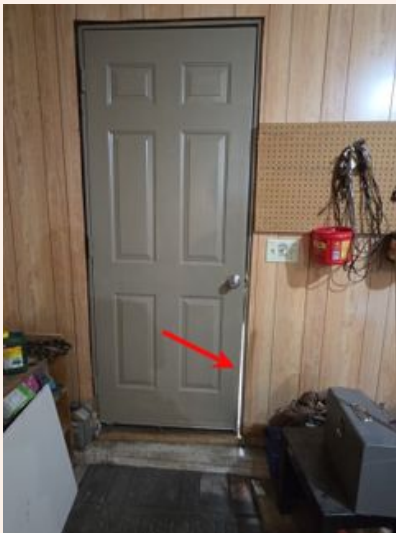
*Light can be seen through the bottom right of the garage door*

Recommendation: Have a licensed contractor adjust or repair the garage door and weatherstripping as needed.

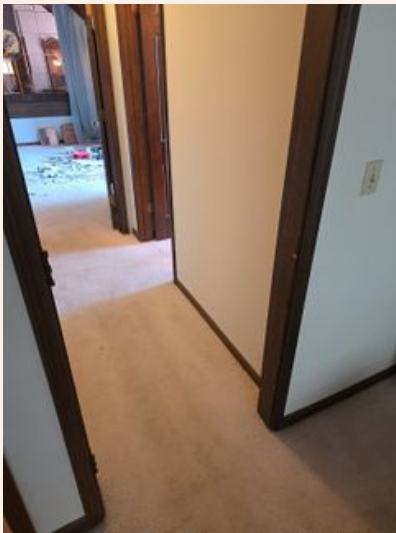
Problem: The second-floor west bedroom is missing its entry door.

*Second floor West bedroom is missing a door*

Recommendation: Have a licensed contractor install a replacement door as needed.

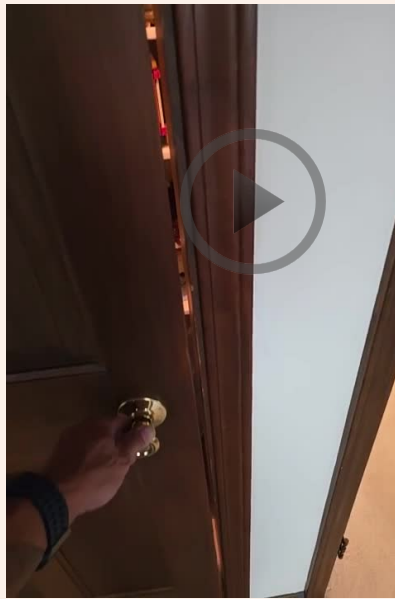
Problem: The second-floor west bedroom closet door jamb is missing the door stops.

*(This video is only viewable online.)  
Second floor West bedroom closet door jamb is missing stops*

Recommendation: Have a licensed contractor install new door stops as needed.

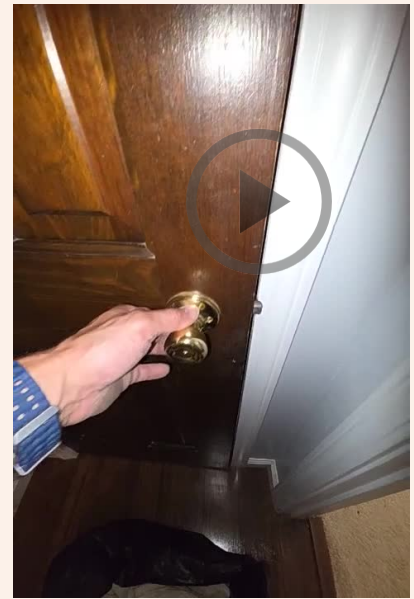
*(This video is only viewable online.)  
Main floor hallway closet does not latch*

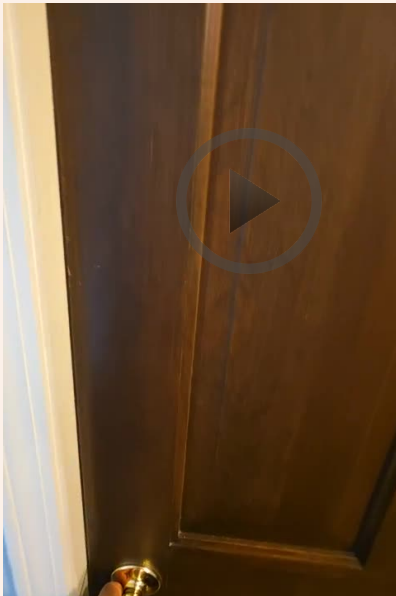
Problem: The main-floor hallway closet nearest the living room is missing the door jamb stops.

*(This video is only viewable online.)  
Main floor hallway closet closest to the living room is missing door jamb stops*

Recommendation: Have a licensed contractor install new door stops as needed.

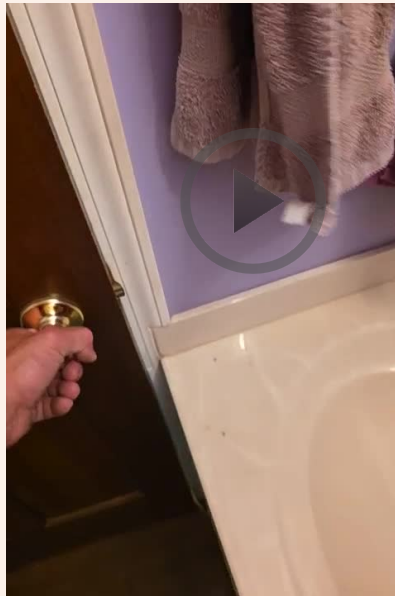
*(This video is only viewable online.)  
Main floor hallway bathroom door does not close*

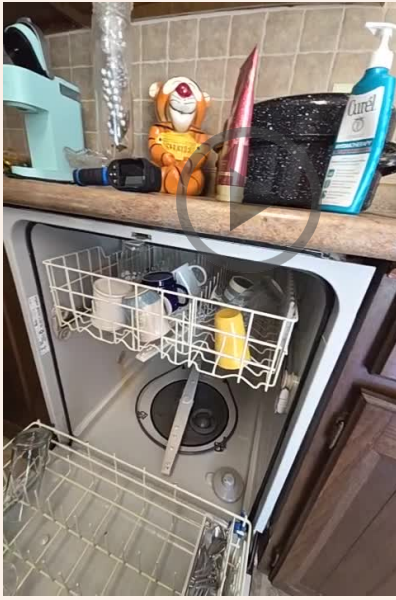
Effect: The appliance may shift or tip forward when the door or racks are extended, potentially causing damage or injury.

*Dishwasher is not secured to the countertops*

Recommendation: Have a licensed contractor properly secure the dishwasher as needed.

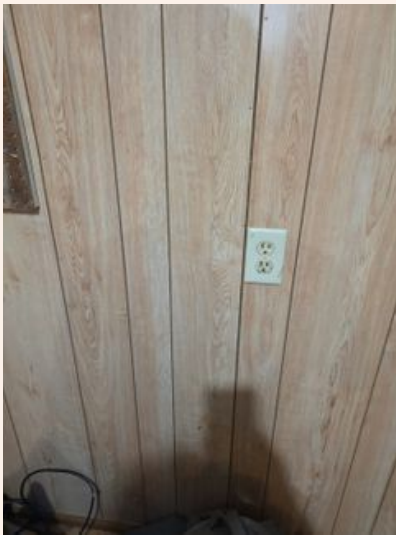
*Attached garage Outlets are not GFCI protected*

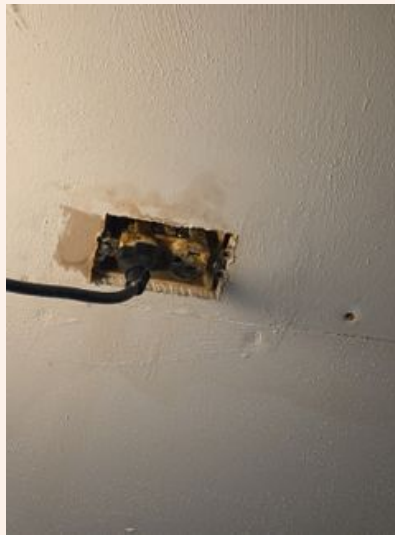
*Outlet for the garage door opener in the attached garage is missing a cover*

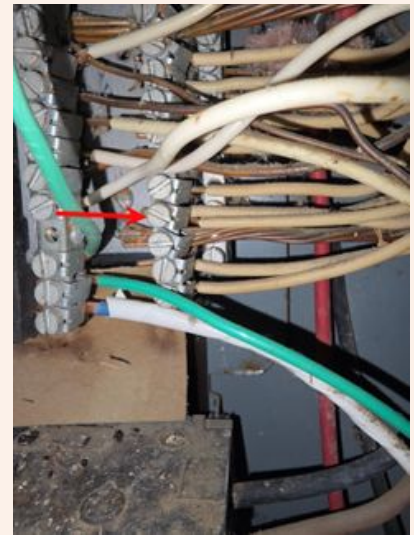
*Two neutrals are sharing the same terminal screw in the main electric panel*

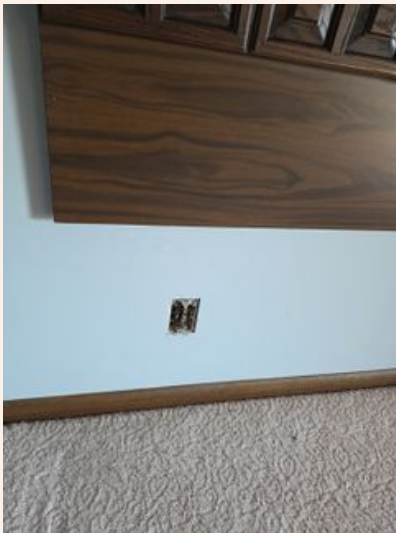
*Damaged Outlet and missing cover in the second floor east bedroom on the East wall*

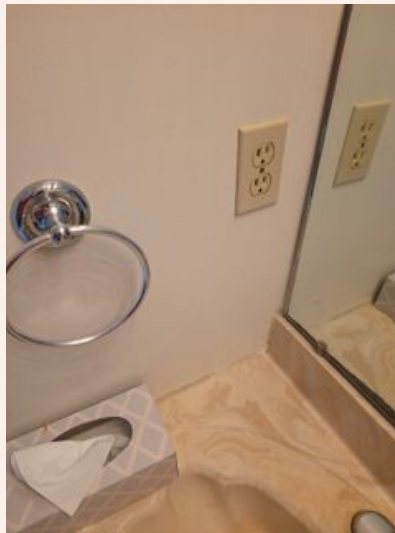
*Two outlets not GFCI protected in the second floor bathroom*

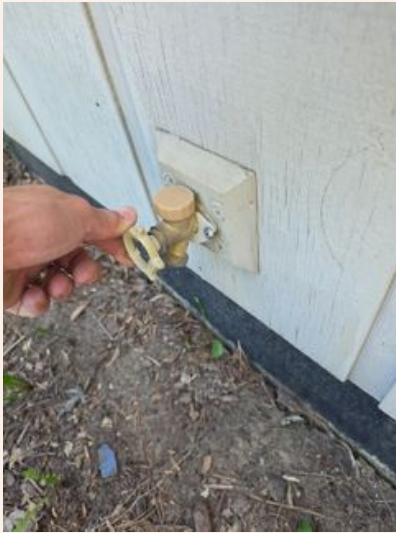
*Exterior water spigot on the front of the house was not working at the time of the inspection*

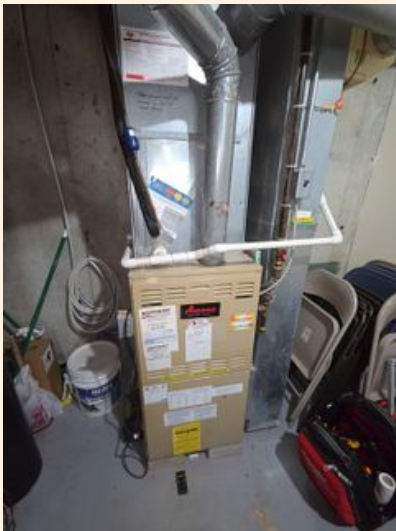
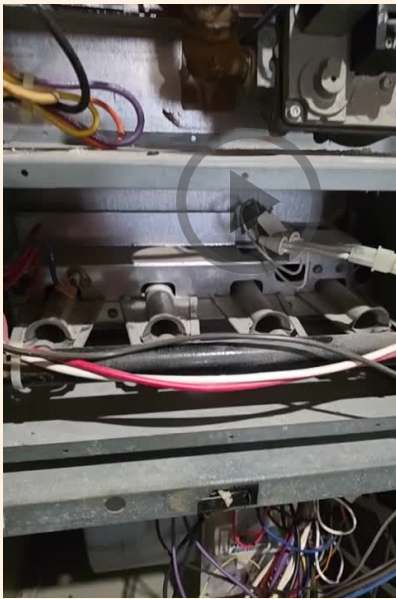
The forced-air gas furnace was manufactured in 1999 and is well beyond its typical service life expectancy. It was operating as intended and producing heat at the time of the inspection. Recommend budgeting for replacement while continuing routine maintenance.

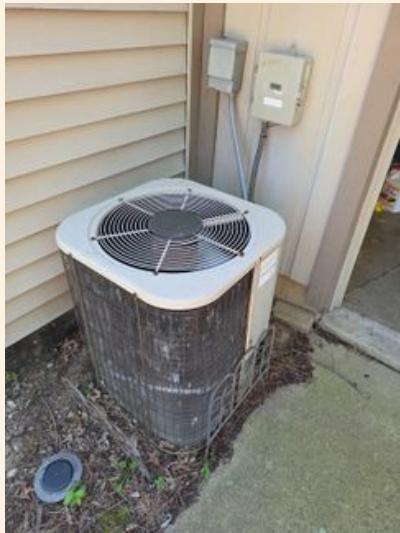
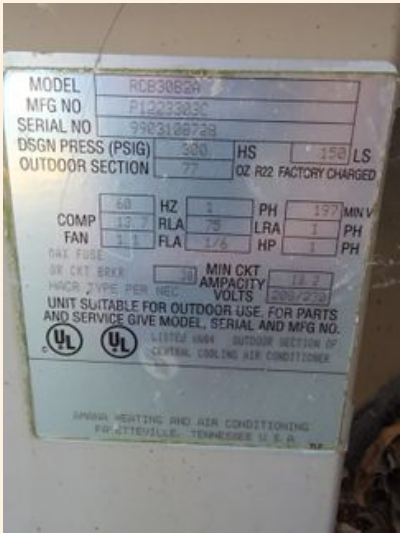
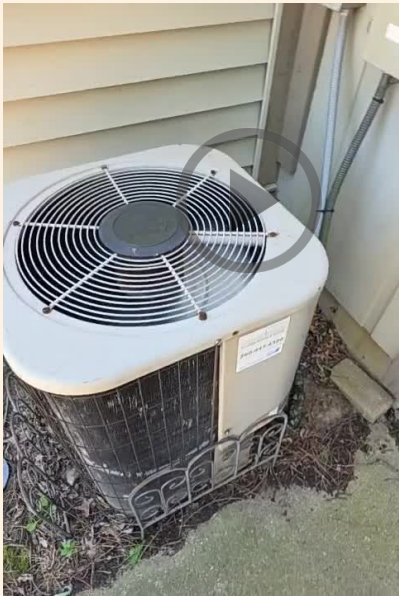
The central air conditioning system was manufactured in 1999 and is well beyond its typical service life expectancy. It was operating as intended at the time of the inspection, with a normal temperature drop confirmed using thermal imaging. Recommend budgeting for replacement while

continuing routine maintenance.

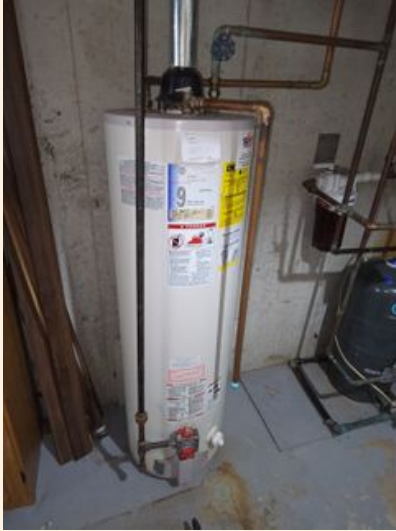
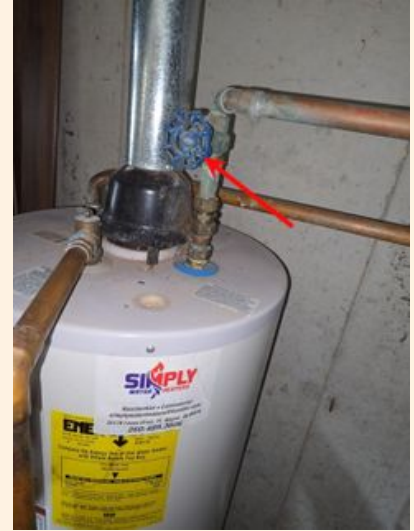
The gas water heater was manufactured in 2001 and is well beyond its typical service life expectancy. At the time of the inspection, it was operating as intended and supplying hot water. Although functional, its advanced age increases the likelihood of future repairs or replacement. Recommend budgeting for replacement while continuing to monitor the unit for signs of leakage or declining performance.

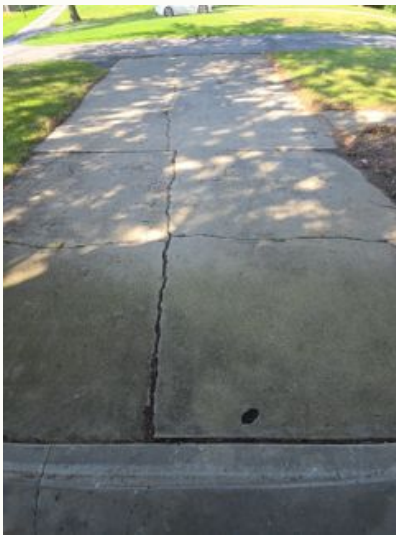
The backyard concrete walkways and patio exhibit minor deferred maintenance, including areas of surface / edge chipping and cracking. Recommend routine maintenance and repairs as needed to help prevent further deterioration and extend their service life.

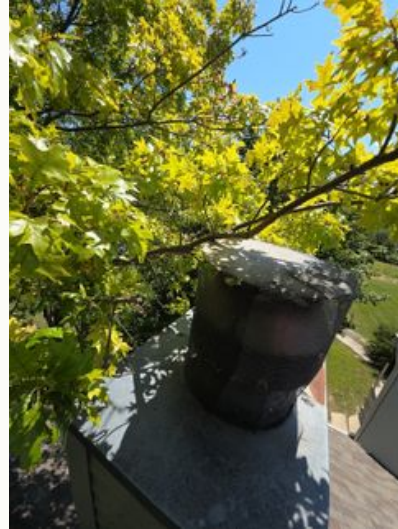
Effect: Vegetation can trap moisture, damage roofing materials, and accelerate deterioration.

Recommendation: Trim back trees and vegetation to provide adequate clearance from the roof, chimney chase, and roof penetrations.

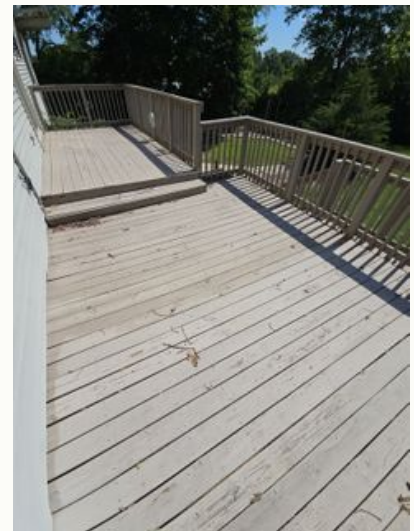
The backyard deck is in generally serviceable condition but is in need of routine maintenance. The guardrails are loose and should be stiffened, the stair railing is separating from the main deck railing and is very loose, and the deck and railings would benefit from cleaning, power washing, and resealing. Recommend completing these maintenance items to improve safety and help extend the life of the deck.

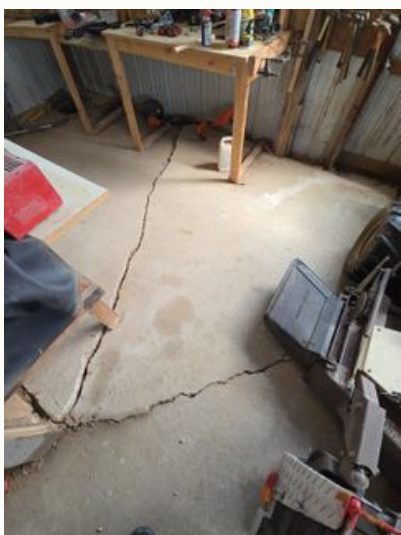
The detached garage/horse barn is a pole barn constructed with ribbed metal siding and metal roofing over pole barn framing with engineered roof trusses. Large sliding doors are located on both the north and south ends. The interior was in generally typical condition for a structure of this

type. A large concrete slab extends down the center of the barn, covering approximately one-third of the floor area, while the remaining stable areas consist primarily of dirt floors, with some sections covered with OSB panels for workbench areas. The concrete slab exhibits numerous cracks, including a significant crack near the north end where a large section has settled approximately 2 inches below the adjacent slab, along with additional moderate cracking concentrated near the southeast corner. Electrical service and lighting were installed throughout the barn, and all accessible receptacles tested were GFCI protected and functioning as intended at the time of the inspection. Recommend routine maintenance of the structure, sealing and monitoring concrete cracks as needed, and addressing the active groundhog burrows around and beneath the barn to help prevent additional soil erosion and settlement.

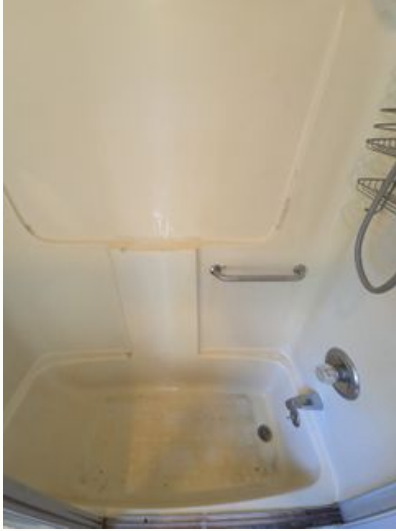
**Problem:** The second-floor bathtub and surround exhibit multiple chips and signs of cosmetic wear.

**Recommendation:** Repair or refinish the affected areas as needed for cosmetic improvement and

monitor for any future signs of leakage.

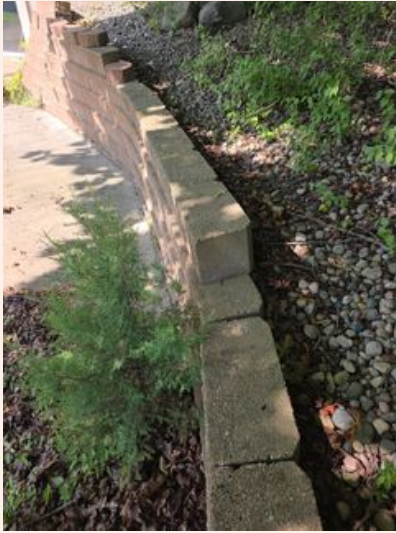
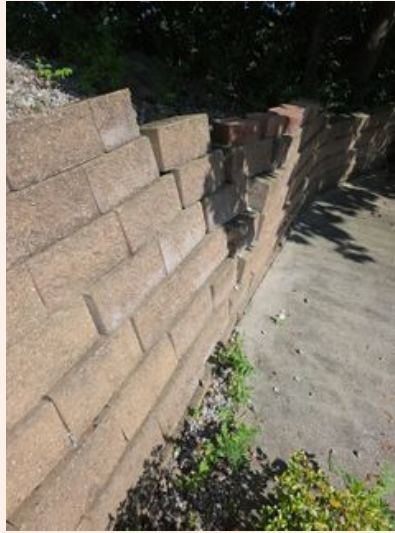
The rear southeast retaining wall has minor localized movement and displacement. Most of the wall appeared solid, with only a handful of blocks, primarily along the top course, found to be loose. Recommend monitoring and repairing the affected section as needed to prevent further movement.

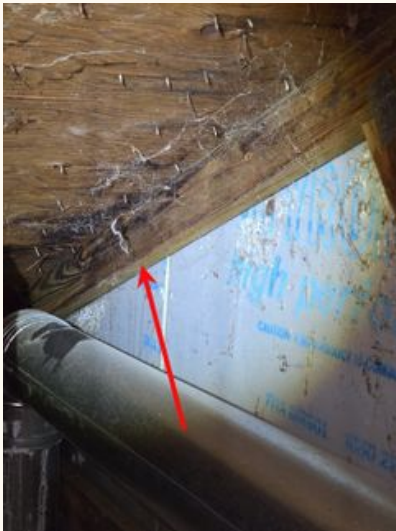
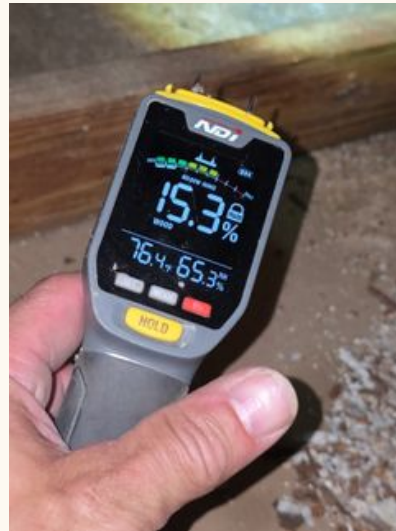
Elevated moisture levels were detected in the roof framing where the garage roof intersects the front of the house. This area showed higher moisture content than the surrounding framing, indicating possible water intrusion. The condition is consistent with the section below where the fascia flashing appears to be installed backwards.

Recommend monitoring this area after the fascia flashing has been repaired to confirm the moisture levels return to normal and no additional water intrusion is occurring.

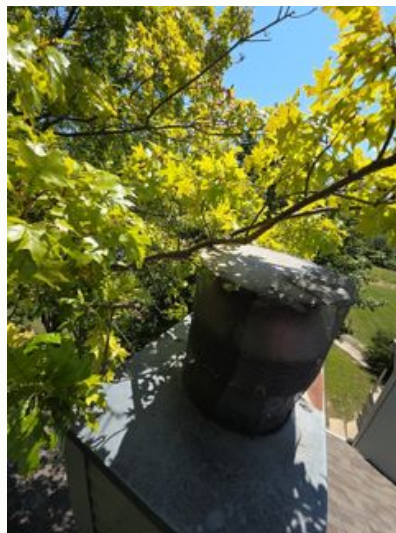
Problem: Trees and surrounding vegetation are in contact with the front northeast lower roof, as well as the second-story chimney chase and roof vent on the west end of the roof.

Recommendation: Trim back trees and vegetation to provide adequate clearance from the roof, chimney chase, and roof penetrations.

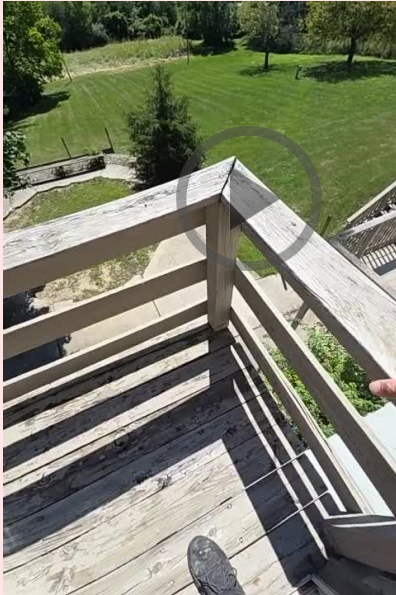
**⚠️ (ES-7) Significantly Deficient:** The second-story cantilevered balcony exhibited excessive movement during normal use. Guardrails and decking were loose, and the balcony did not feel structurally sound. The outside edges of the decking extend beyond the supporting floor joists and the presence of a proper rim/band joist securing the cantilevered framing could not be confirmed. Recommend avoiding use of the balcony until it has been evaluated and repaired by a qualified structural contractor or engineer.

*Second floor balcony railings are very loose, deck boards are not fully secured in multiple locations and Lacks a rim board on the south end or floor joists on the East and West Ends*

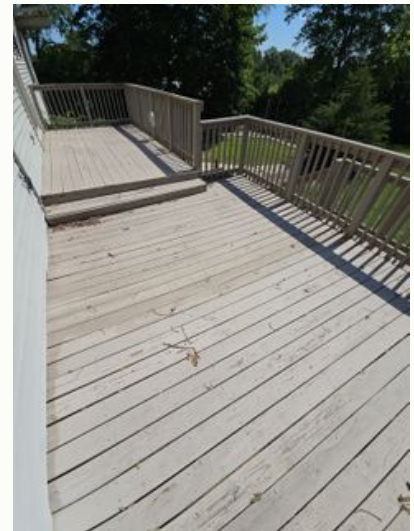
The backyard deck is in generally serviceable condition but is in need of routine maintenance. The guardrails are loose and should be stiffened, the stair railing is separating from the main deck railing and is very loose, and the deck and railings would benefit from cleaning, power washing, and resealing. Recommend completing these maintenance items to improve safety and help extend the life of the deck.

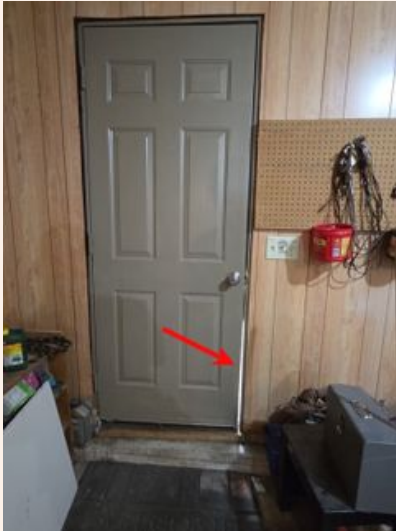
*Light can be seen through the bottom right of the garage door*

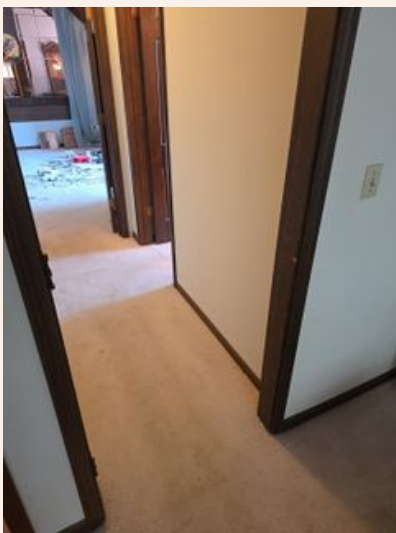
*Second floor West bedroom is missing a door*

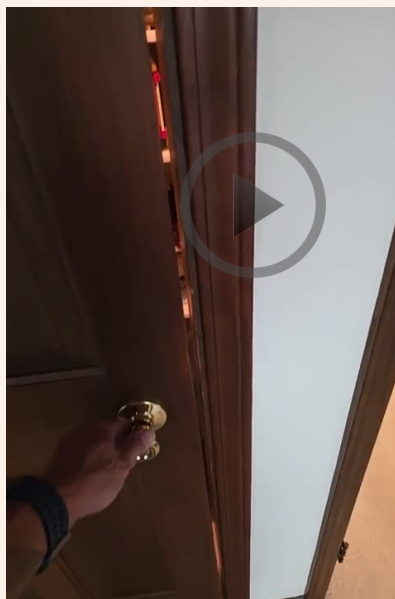
*(This video is only viewable online.)  
Second floor West bedroom closet door jamb is missing stops*

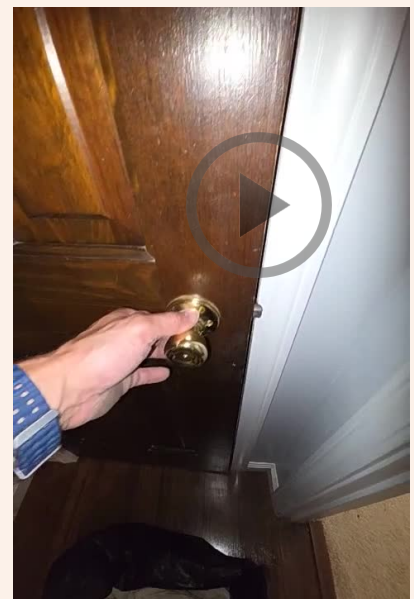
*(This video is only viewable online.)  
Main floor hallway closet does not latch*

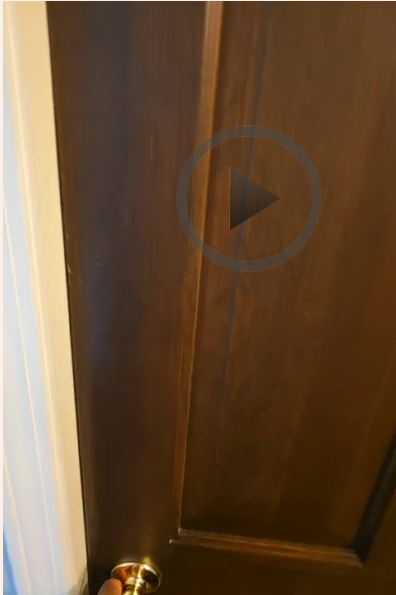
*Main floor hallway closet closest to the living room is missing door jamb stops*

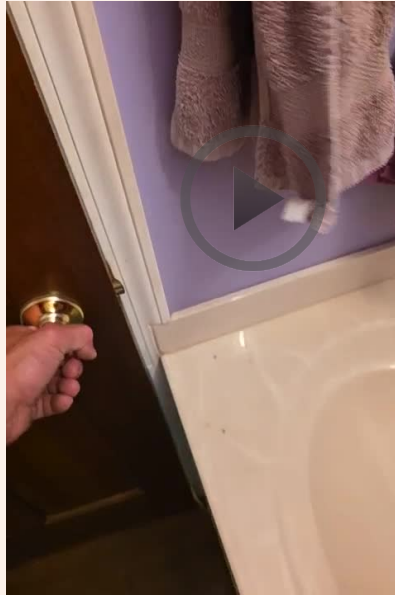
*Main floor hallway bathroom door does not close*

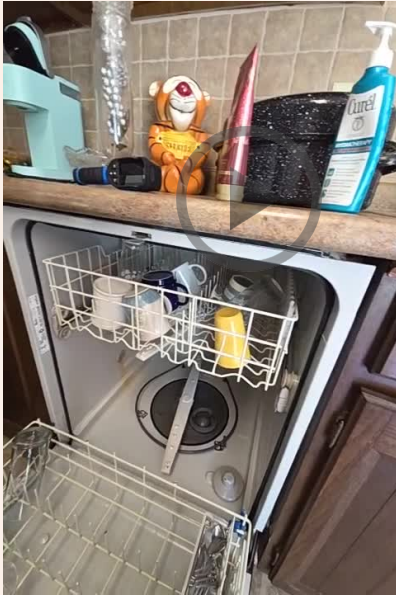
*Dishwasher is not secured to the countertops*

Recommendation: Have a qualified contractor or appliance technician evaluate and repair or replace the garbage disposal as needed.

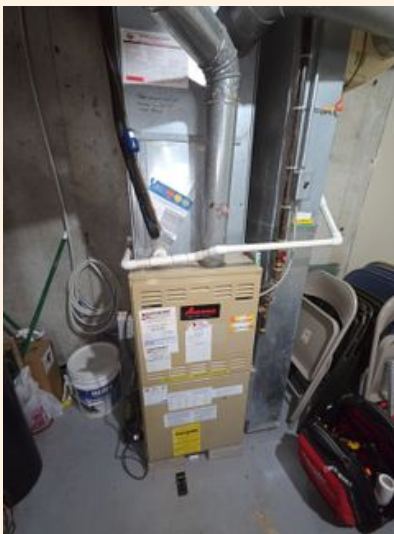
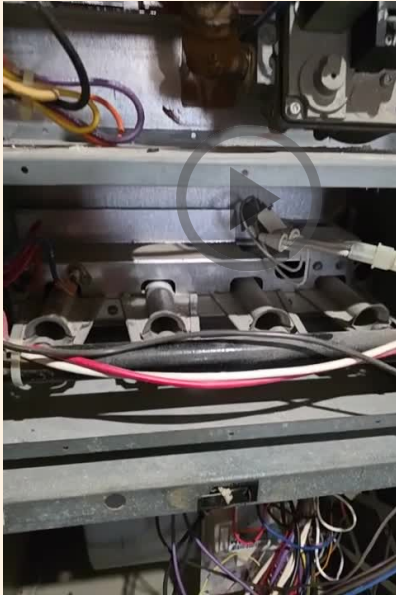
The forced-air gas furnace was manufactured in 1999 and is well beyond its typical service life expectancy. It was operating as intended and producing heat at the time of the inspection. Recommend budgeting for replacement while continuing routine maintenance.

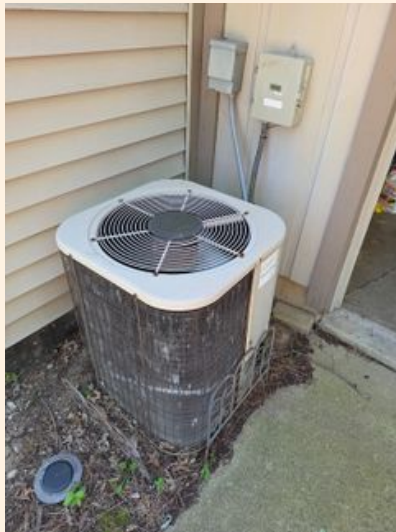
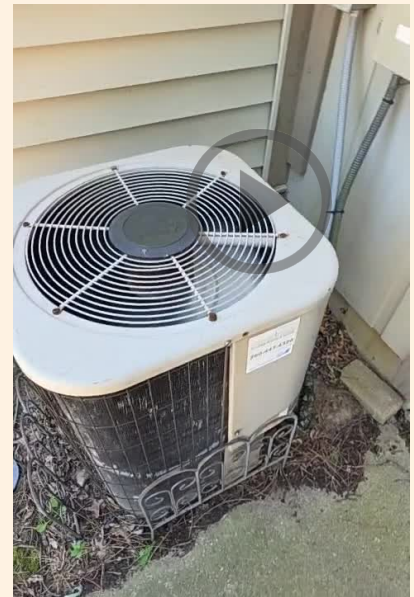
The central air conditioning system was manufactured in 1999 and is well beyond its typical service life expectancy. It was operating as intended at the time of the inspection, with a normal temperature drop confirmed using thermal imaging. Recommend budgeting for replacement while continuing routine maintenance.

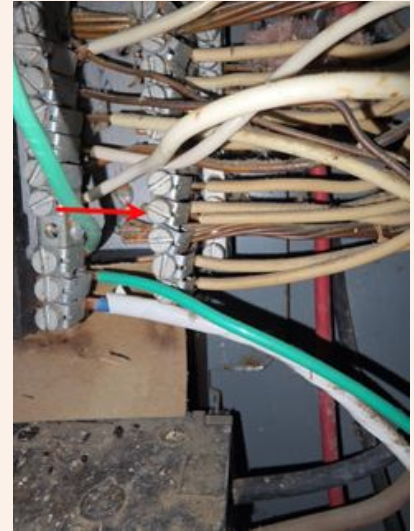
*Two neutrals are sharing the same terminal screw in the main electric panel*

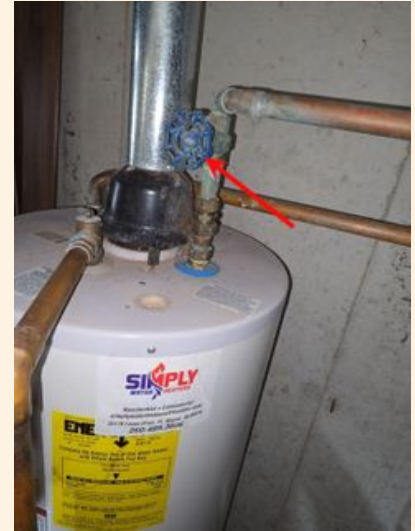
The gas water heater was manufactured in 2001 and is well beyond its typical service life expectancy. At the time of the inspection, it was operating as intended and supplying hot water. Although functional, its advanced age increases the likelihood of future repairs or replacement. Recommend budgeting for replacement while continuing to monitor the unit for signs of leakage or declining performance.
