FAMILYGUARD

HOME INSPECTION REPORT

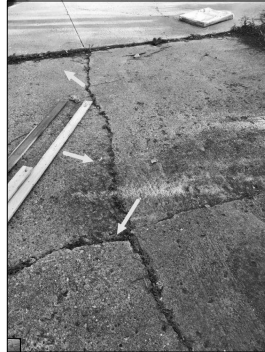
Cracks and deterioration along the driveway.

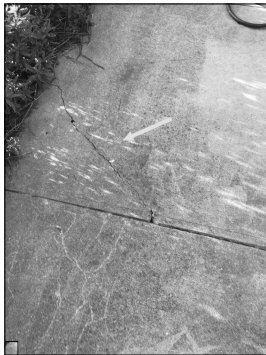
Cracks and deterioration along the service walks.

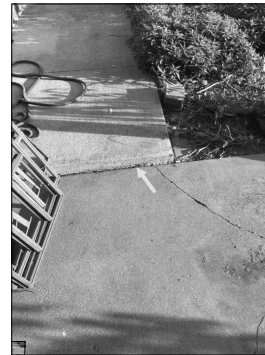
Uneven surfaces along the service walks.

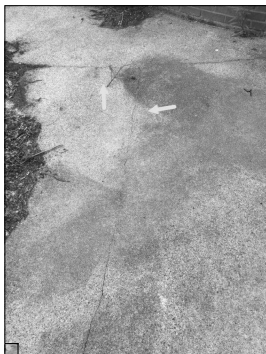
Cracks and deterioration along the porch.

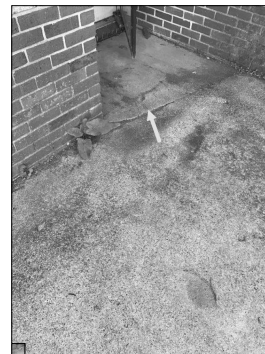
Cracks and deterioration along the porch.

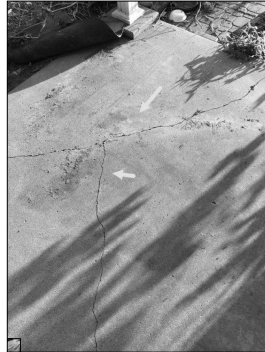
Cracks and deterioration along the patio.

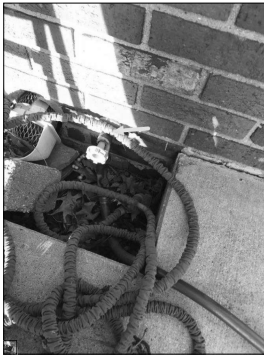
No anti-siphon/frost free valve. The lack of an anti-siphon valve can allow water back flow into the water supply lines, thus contaminating potable water. This is a potential safety hazard. The lack of a frost free valve can allow water to stay within the hose bib, which could potentially freeze during cold months and cause the pipe to rupture. This can cause property damage.

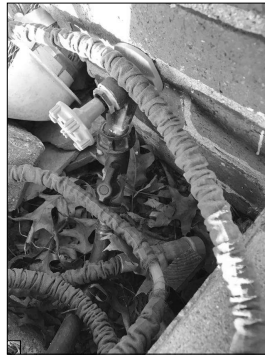
The hose bib leaks during operation. This is considered a defect.

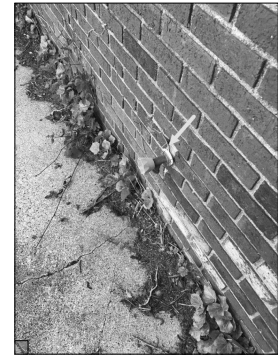
No anti-siphon/frost free valve. The lack of an anti-siphon valve can allow water back flow into the water supply lines, thus contaminating potable water. This is a potential safety hazard. The lack of a frost free valve can allow water to stay within the hose bib, which could potentially freeze during cold months and cause the pipe to rupture. This can cause property damage.

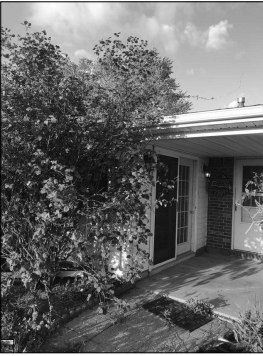
Vegetation against the siding/in proximity of the siding. This is not a recommended practice. Vegetation has the potential to harbor insects, wood destroying insects, rodents and hold moisture. Insects, wood destroying insects, rodents and moisture have the potential to create future problems for a house, such as structural damage, pest infestation and wood rot damage.

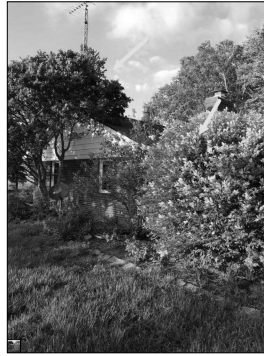
Vegetation against the siding/in proximity of the siding. This is not a recommended practice. Vegetation has the potential to harbor insects, wood destroying insects, rodents and hold moisture. Insects, wood destroying insects, rodents and moisture have the potential to create future problems for a house, such as structural damage, pest infestation and wood rot damage.

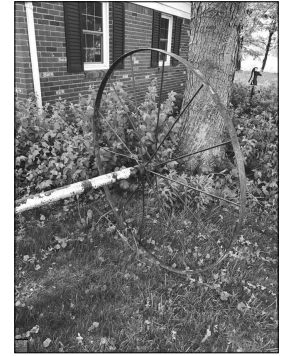
Tree adjacent to the house. Tree roots can cause foundation problems and can create structural damage to the foundation. Also, trees that are next to the house can potentially fall on the house, potentially causing bodily harm and damage to the house.

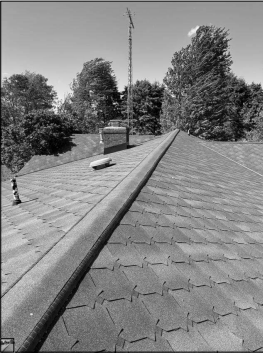
General photo of the roof.

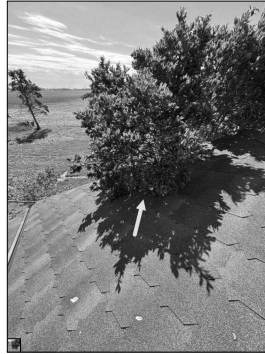
Vegetation in proximity of the roof. Falling branches can damage the roof system. Also, vegetation in proximity of the roof can enable small animals and rodents access to the roof. Wildlife activity can cause property damage.

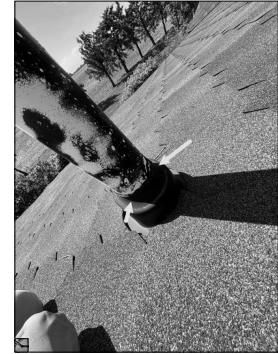
Unconventional application of roof sealant along the rubber flashing. Rubber flashing is designed to be caulkless. This is considered amateur craftsmanship. Most roof sealants are petroleum based. A petroleum based product can cause the rubber flashing to prematurely deteriorate, thus creating a leak point.

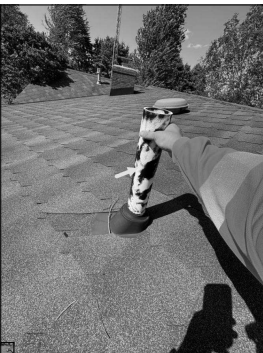
The plumbing vent is loose. It can move back and forth. Plumbing vents should not have any movement and be fully secured.

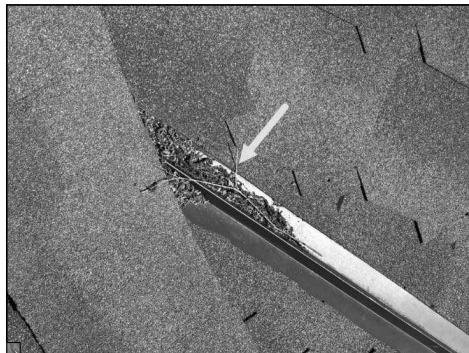
Debris along the roof. Excessive debris along the roof can restrict the ability of the roof to shed water, thus creating potential leak points.

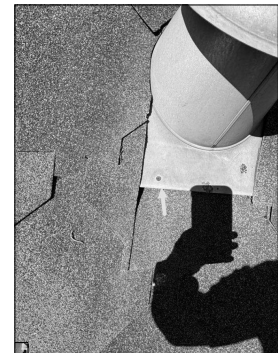
Exposed nailheads/staples. Exposed nailheads/staples are potential leak points.

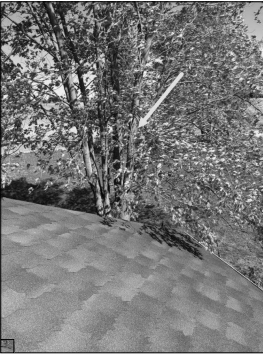
Vegetation in proximity of the roof. Falling branches can damage the roof system. Also, vegetation in proximity of the roof can enable small animals and rodents access to the roof. Wildlife activity can cause property damage.

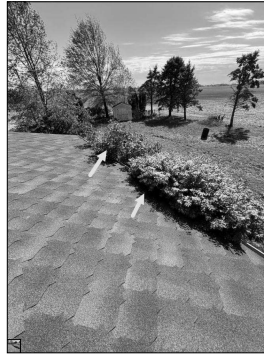
Vegetation in proximity of the roof. Falling branches can damage the roof system. Also, vegetation in proximity of the roof can enable small animals and rodents access to the roof. Wildlife activity can cause property damage.

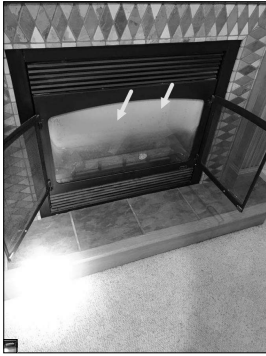
The glass pane is unconventionally fogged and discolored. This is considered abnormal and a defect.

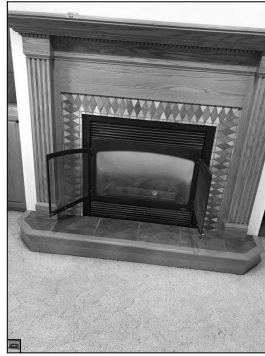
The fireplace is a gas fireplace. There is no apparent electronic ignition. It is beyond the scope of a general home inspection to light fuel burning appliances. Doing so could cause property damage. Recommend a licensed chimney/fireplace professional further evaluate to make sure the fireplace is in good working condition and safe to use. The adjacent wall switch did not activate the fireplace.

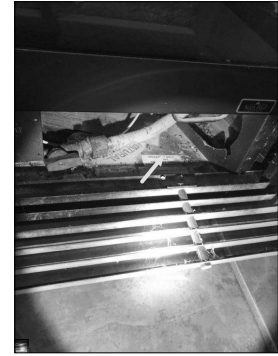
Mice droppings observed underneath the fireplace. Wildlife activity can cause property damage.

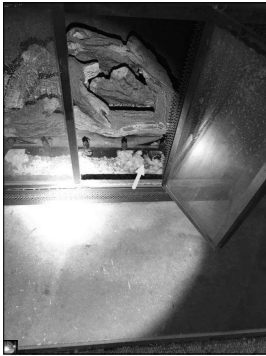
The fireplace is a gas fireplace. There is no apparent electronic ignition. It is beyond the scope of a general home inspection to light fuel burning appliances. Doing so could cause property damage. Recommend a licensed chimney/fireplace professional further evaluate to make sure the fireplace is in good working condition and safe to use.

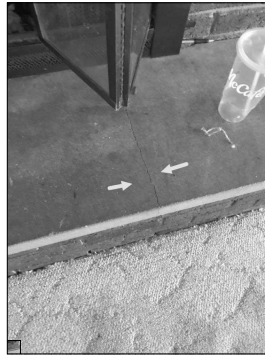
Crack along the hearth.

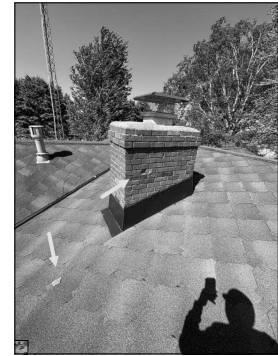
Deterioration and cracking along the chimney. Deterioration and cracks are potential leak points.

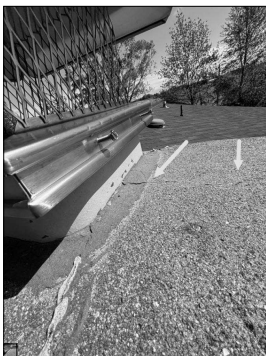
Cracks along the chimney. Cracks are considered defects and potential leak points.

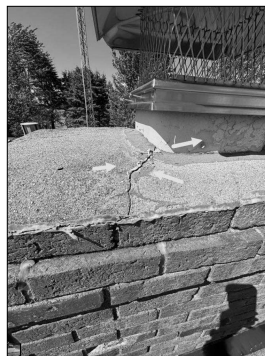
Deterioration and cracking along the brick. Also, deterioration and cracking along the clay tile. Cracks and deterioration along the clay tile can cause improper drafting, thus creating a safety hazard.

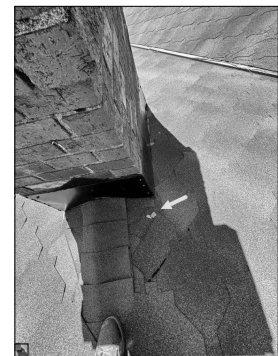
Deterioration and cracking along the chimney. Deterioration and cracks are potential leak points.

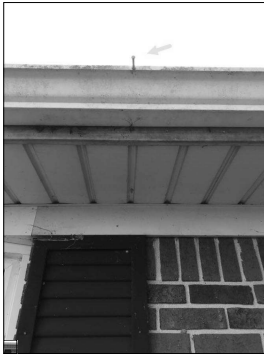
Loose gutter spikes.

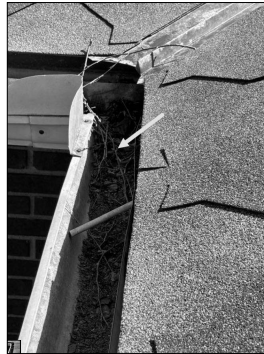
The gutter system is dirty and needs to be cleaned. A dirty gutter system can cause excessive water to accumulate around the house, thus potentially causing water intrusion into the house or potential foundation problems due to excessive hydrostatic pressure. Also, a dirty gutter system can cause excessive water to flow along the siding which could allow water to get behind the siding. An active or intermittent water intrusion source can cause mold growth and property damage.

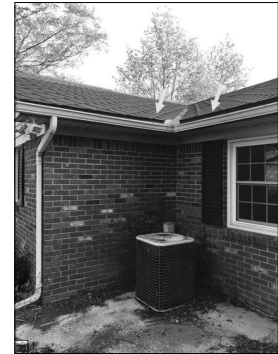
Unconventional sags along the gutter system. This is considered a defect as the sags will act as a catch for water.

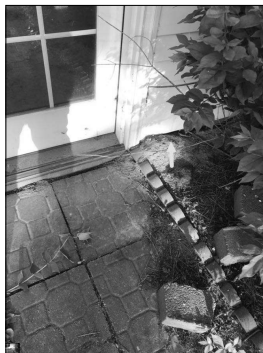
The siding is in proximity to the ground. Siding should have at least 6 to 8 inches of clearance above the ground. Maintaining proper clearances reduces access to wood structures behind the siding and helps preserve the house. The proper clearances help restrict access from wood destroying insects and/or moisture/water that might find its way behind the siding.

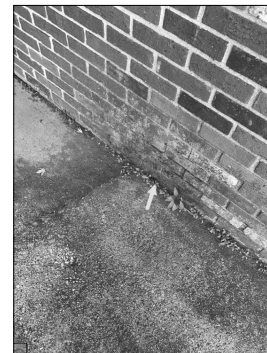
Biological growth along the siding.

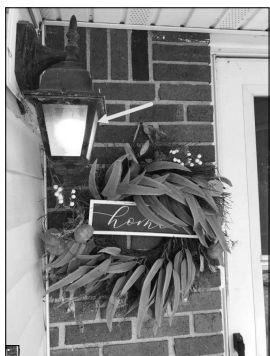
The light flickers. This is considered a defect.

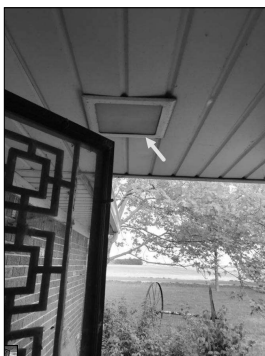
The light is inoperable.

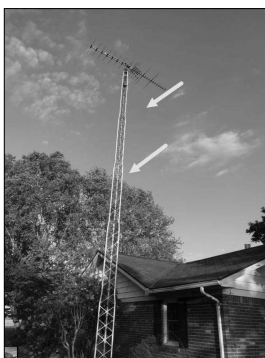
Large antenna observed adjacent to the house.

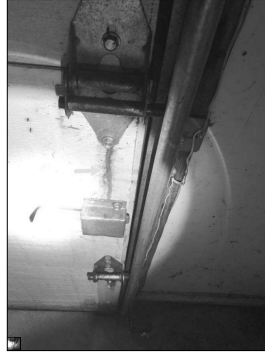
Rust and corrosion along the overhead door. Rust/corrosion along the door is considered a defect.

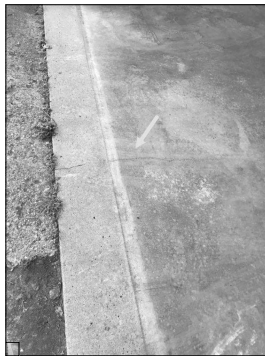
Cracks and deterioration along the floor.

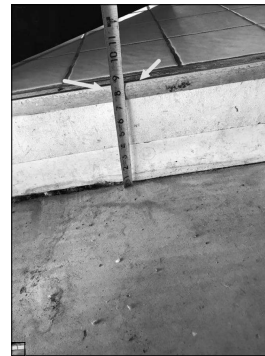
The riser/step is unconventionally high. This is a potential trip hazard. The recommended maximum height for a riser/step is 7 inches.

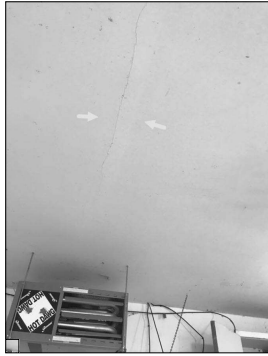
Cracks along the ceiling.

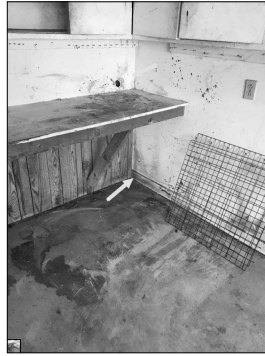
Discoloration along the walls. Also, hole along the wall.

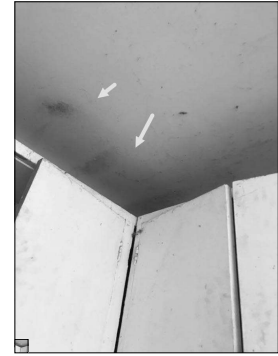
Discoloration along the ceiling. Discoloration along the ceiling is considered abnormal and a defect. An active or intermittent water source can cause discoloration, mold growth and property damage.

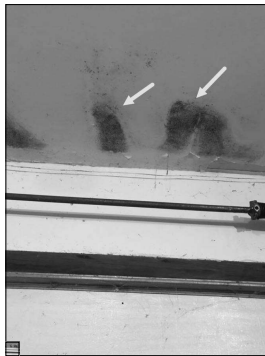
Discoloration along the ceiling. Discoloration along the ceiling is considered abnormal and a defect. An active or intermittent water source can cause discoloration, mold growth and property damage.

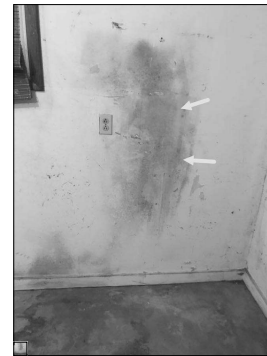
Discoloration along the wall. Discoloration along the ceiling is considered abnormal and a defect. An active or intermittent water source can cause discoloration, mold growth and property damage.

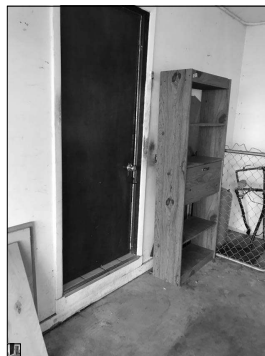
The door that separates the interior of the house from the garage is not a proper fire rated door. This is a potential safety hazard.

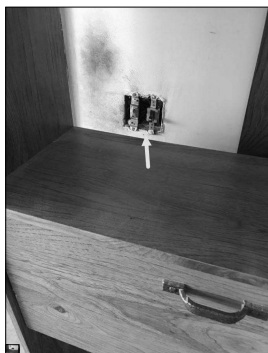
Missing switch cover.

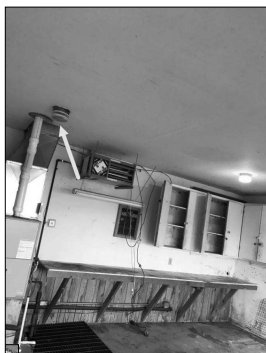
The light is inoperable.

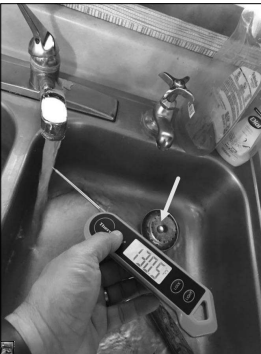
Temperature reading of the hot water during the time of the inspection. The approximate temperature of the hot water was 130 degrees Fahrenheit.

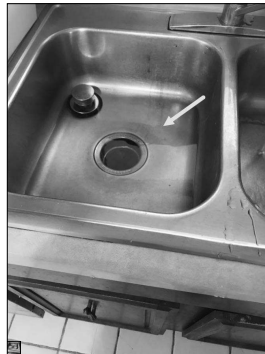
Slow sink drainage. This is considered a defect.

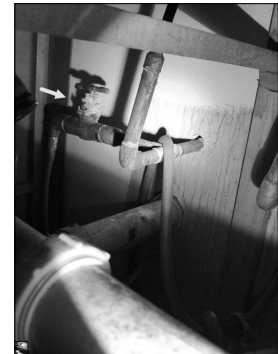
Rust/corrosion along the plumbing pipes.

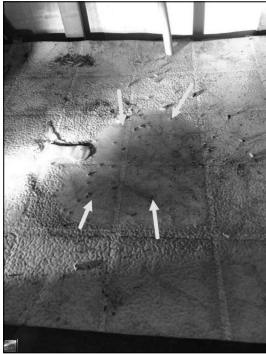
Standing water underneath the sink. This is an indication of a current plumbing leak. An active or intermittent water source can cause mold growth and property damage.

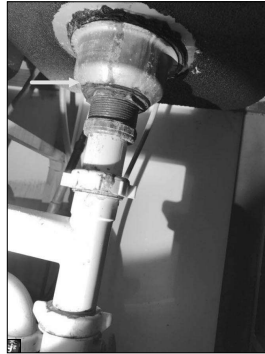
Active plumbing leak. An active or intermittent water source can cause mold growth and property damage.

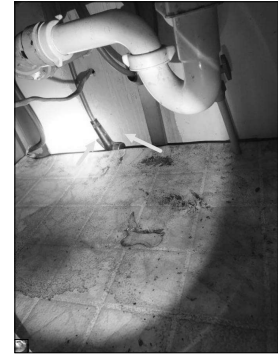
The spray hose is unconventionally located under the sink.

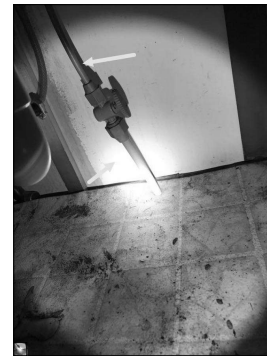
Polybutylene plumbing lines. Polybutylene pipes are prone to failure and no longer meet modern day plumbing standards. Recommend upgrading from polybutylene pipes to modern day plumbing materials, such as PEX or copper. Please note, polybutylene pipes can be concealed behind walls, ceilings, etc.

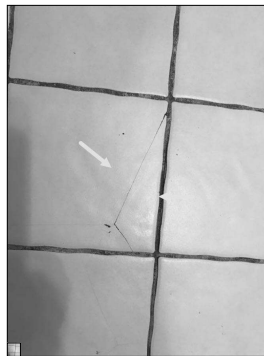
Cracked floor tiles.

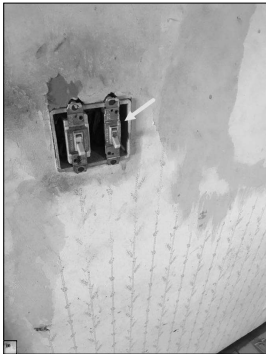
Missing switch covers.

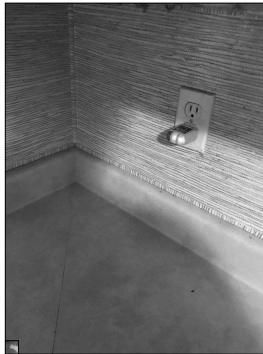
Non GFCI protected receptacles.

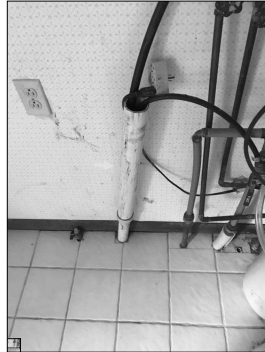
The drain line from the washing machine does not have a proper P-trap. The lack of a proper P-trap can potentially allow sewer gases into the house. Sewer gases are a potential safety hazard.

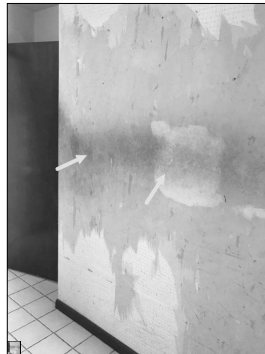
Discoloration along the wall. Discoloration along the wall is considered abnormal and a defect. An active or intermittent water source can cause discoloration, mold growth and property damage.

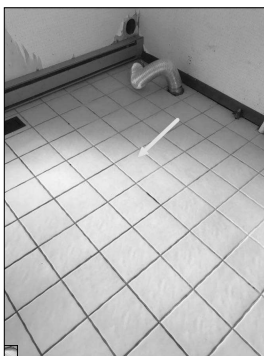
The floor slopes. This is considered abnormal and a defect.

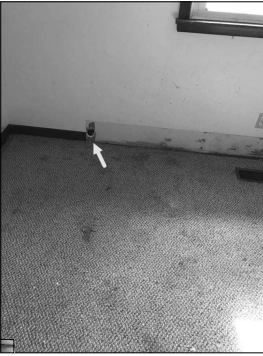
Holes/damage along the wall.

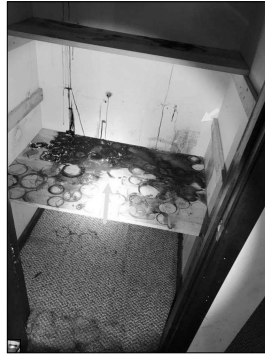
Discoloration along the wall.
Discoloration along the wall is considered abnormal and a defect. An active or intermittent water source can cause discoloration, mold growth and property damage.

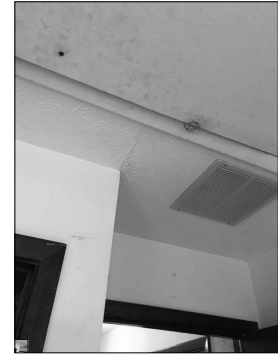
Cracks along the ceiling.

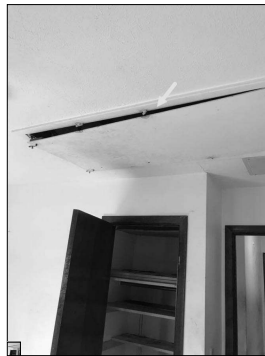
The attic access stairs sag. This is considered a defect.

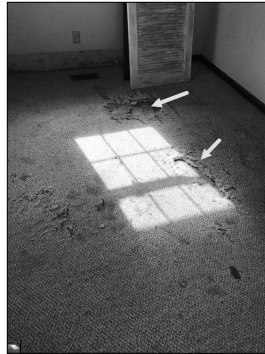
Torn floor covering.

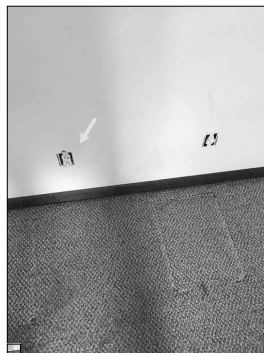
Missing receptacle covers.

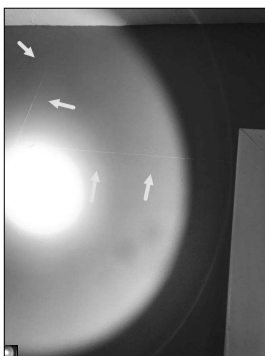
Cracks along the walls.

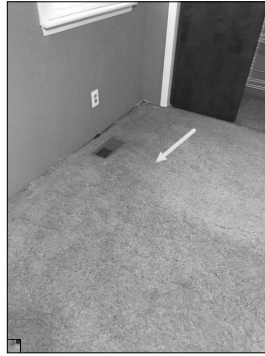
The floor slopes. This is considered abnormal and a defect.

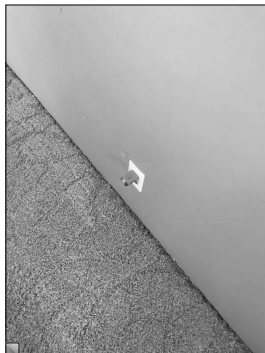
Open ground receptacles.

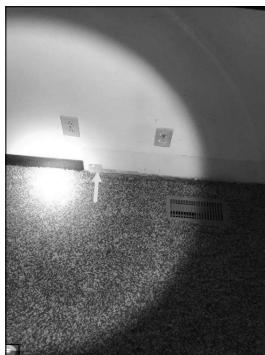
Damage along the wall.

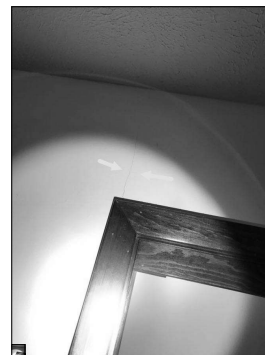
Cracks along the walls.

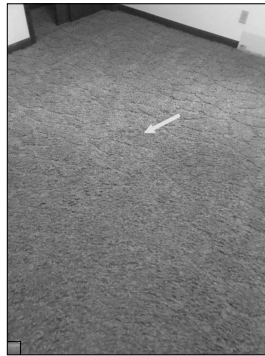
The floor slopes. This is considered abnormal and a defect.

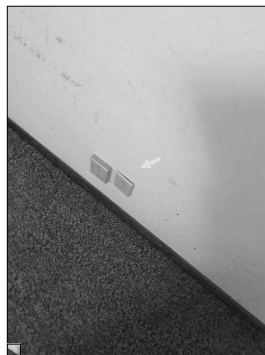
The receptacle is not flush with the wall.

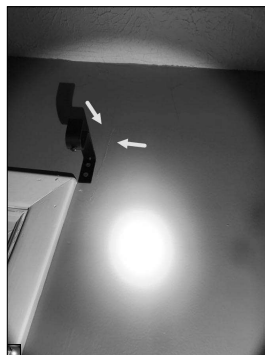
Cracks along the walls.

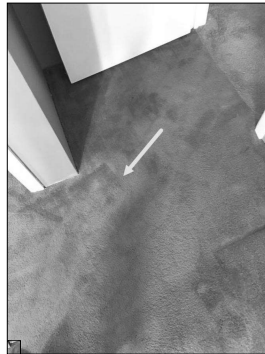
The floor slopes. This is considered abnormal and a defect.

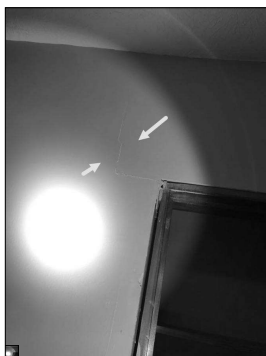
Cracks along the walls.

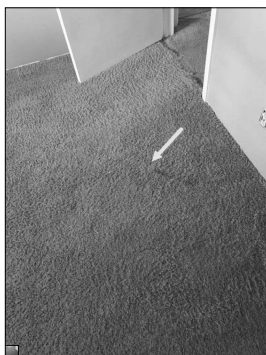
The floor slopes. This is considered abnormal and a defect.

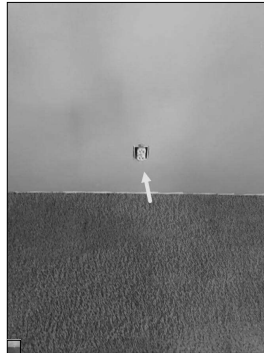
Missing receptacle covers.

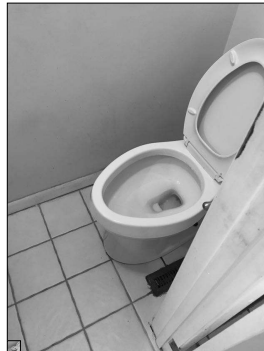
The toilet is loose. The toilet rocks back and forth. A toilet should not have any movement and be fully anchored and secured to the floor.

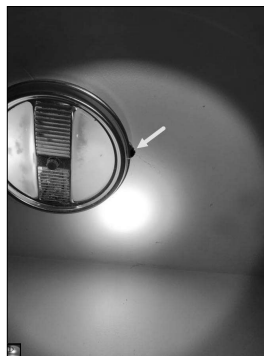
Holes/damage along the ceiling.

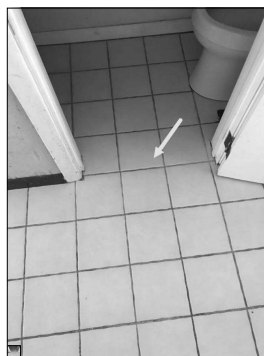
The floor slopes. This is considered abnormal and a defect.

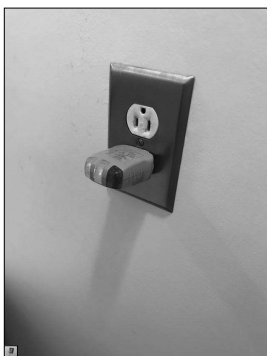
Non GFCI protected receptacles.

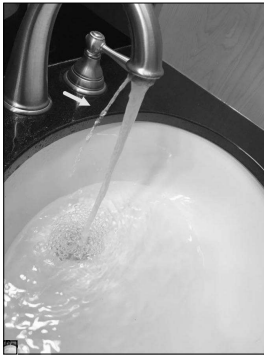
Abnormal water pressure/flow from the faucet. The abnormal water pressure/flow is causing water to splash outside the sink. An active or intermittent water source can cause property damage.

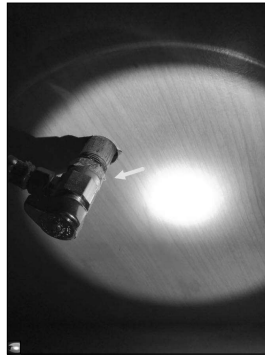
Rust/corrosion along the plumbing pipes.

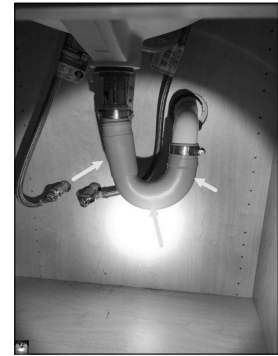
Unconventional rubber trap underneath the sink. Unconventional traps have the potential to siphon and become dry, thus creating the potential to allow sewer gases into the house. Unconventional traps have the potential to make a knocking/gurgling sound when draining.

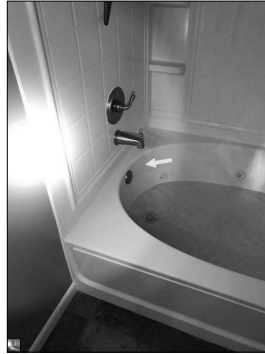
The bathtub faucet leaks while the showerhead is in operation. This is considered a defect. A properly functioning diverter will not allow any water through the bathtub faucet while the showerhead is in operation.

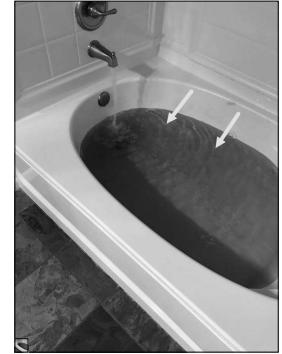
The water is unconventionally dark. This is considered abnormal and a defect.

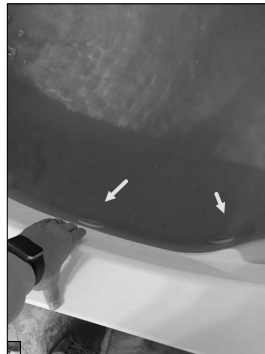
The whirlpool jets are inoperable.

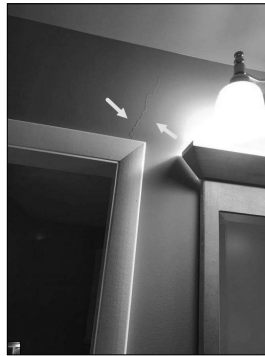
Cracks along the walls.

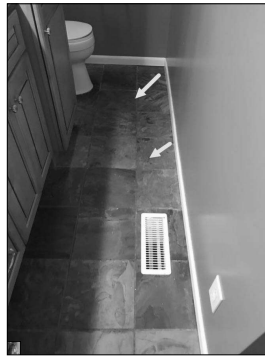
The floor slopes. This is considered abnormal and a defect.

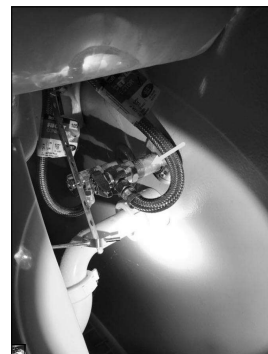
Aged galvanized water lines/pipes. Galvanized pipes no longer meet modern day plumbing standards. Galvanized pipes are prone to corroding from the inside out. Galvanized pipes are towards the end of their life expectancy. Repairs or replacement to galvanized pipes should be anticipated.

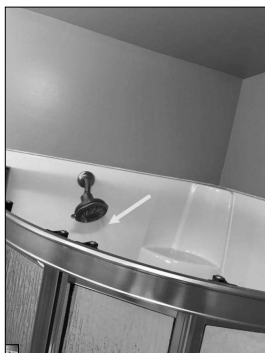
I was only able to get the water to a lukewarm temperature when operating the showerhead. This is considered abnormal and a defect.

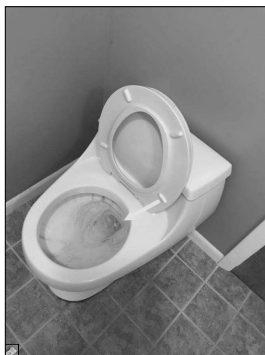
The toilet takes an unconventionally long time calling for water to fill the tank. This is considered abnormal and a defect.

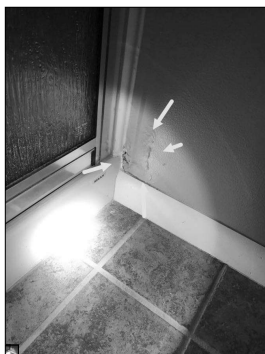
Signs of previous water damage. An active or intermittent water source can cause mold growth and property damage.

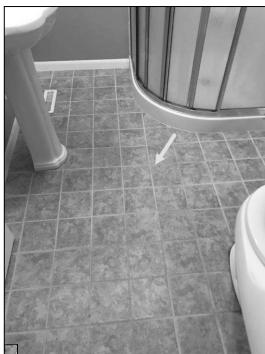
The floor slopes. This is considered abnormal and a defect.

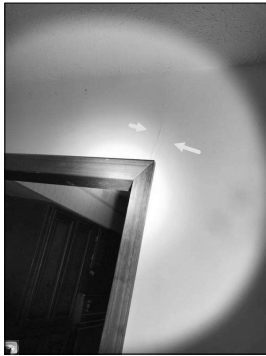
Cracks along the walls.

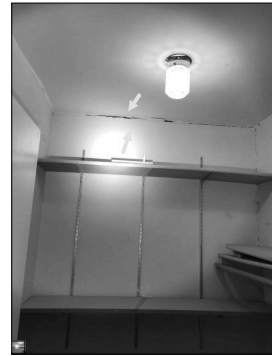
Damage along the ceiling.

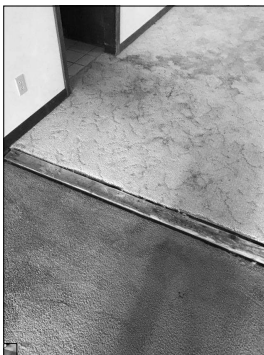
Uneven surfaces along the floor. Uneven surfaces are a potential trip hazard.

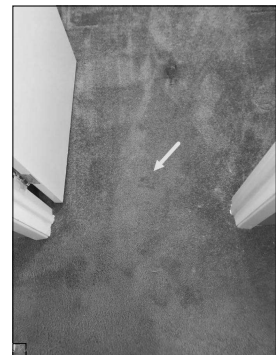
The floor slopes. This is considered abnormal and a defect.

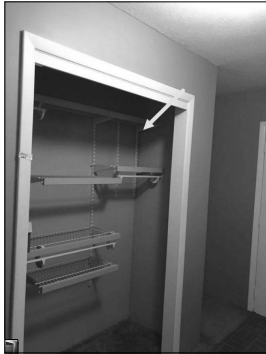
Findings:
• Aged entry door

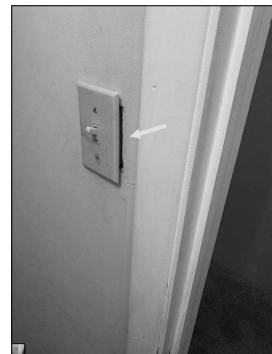
The switch cover is not flush with the wall. This is considered a defect and a potential safety hazard.

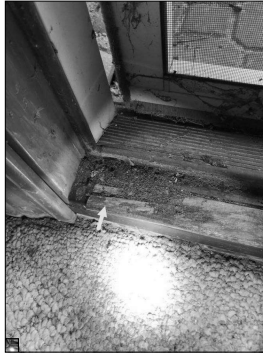
Damage along the threshold.

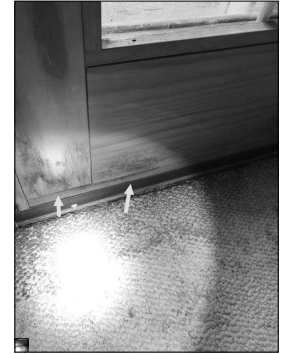
Mold like substance along the door. An active or intermittent water source can cause mold growth and property damage.

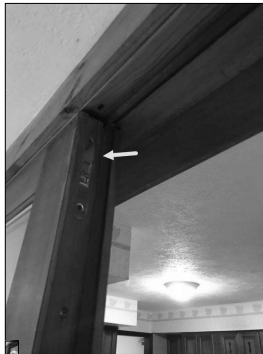
The door does not latch properly.

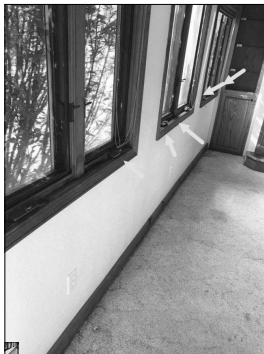
Missing window cranks, thus making the windows inoperable.

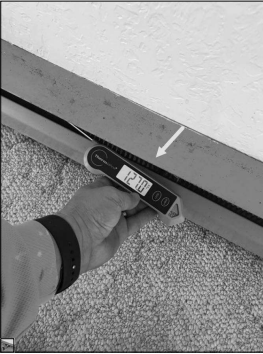
The electric baseboard is operable.

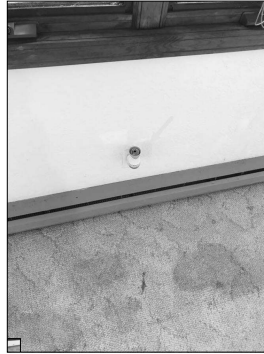
Receptacles located directly above the electric baseboard heater. This is a potential safety hazard. An electrical cord plugged into the receptacle could come in contact with the electric baseboard, thus causing overheating, arcing, spark and/or fire.

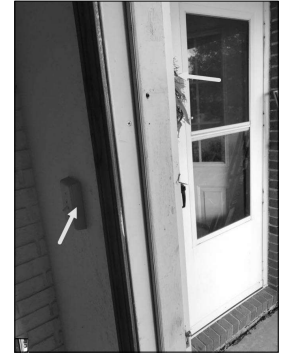
The wall switch does not turn off the adjacent exterior light. Nor does the wall switch in the laundry room either. This is considered abnormal and a defect.

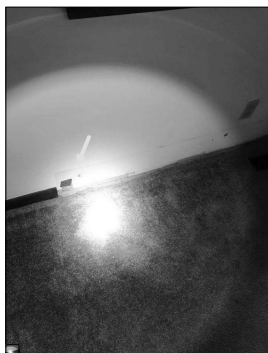
Holes/damage along the wall.

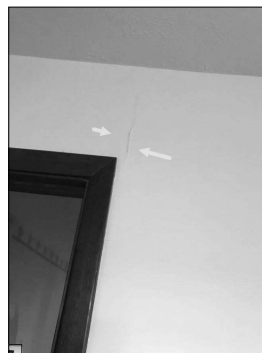
Cracks along the walls.

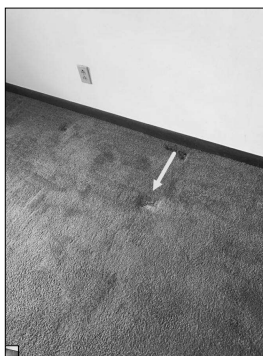
The floor is spongy and moves when walking on it. This is considered abnormal and a defect.

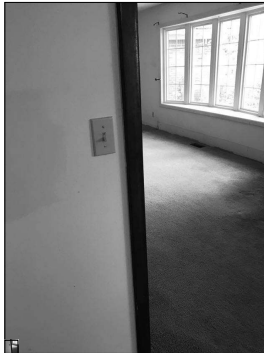
The 3 way switch is inoperable.

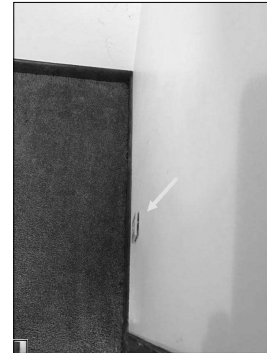
The receptacle is not flush with the wall. This is considered a defect and a potential safety hazard.

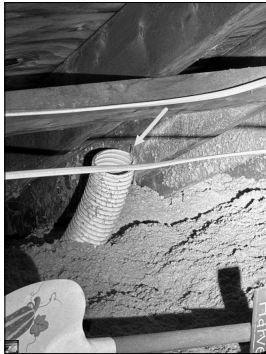
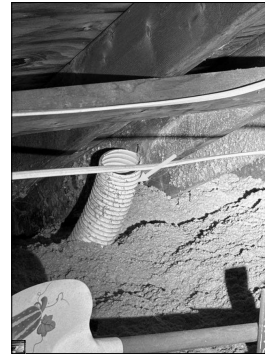
The bathroom exhaust fan vents into the attic. This is not a recommended practice. Exhaust fans venting into the attic can cause mold growth. An active or intermittent water source can cause mold growth. Exhaust fans should vent to the exterior. Exhaust fans should have their own termination and not share a termination with an attic vent, such as a roof vent or soffit. Also, the ductwork for the fan should be properly insulated so condensation does not form along it, thus potentially causing mold growth.

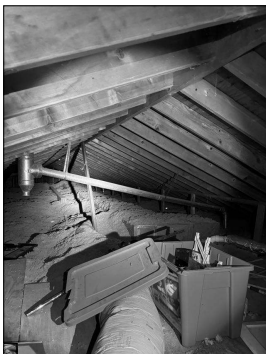
General photo of the attic.

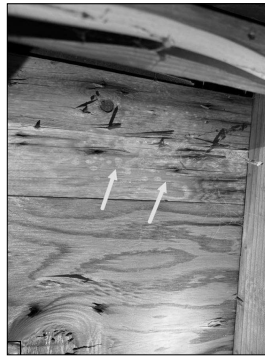
Mold like substance along the sheathing/framing. An active or intermittent water source can cause mold growth and property damage, such as wood rot damage.

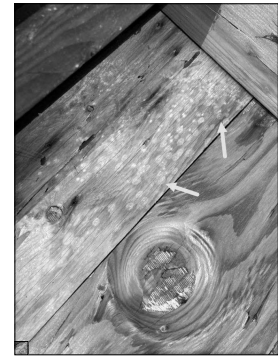
Mold like substance along the sheathing/framing. An active or intermittent water source can cause mold growth and property damage, such as wood rot damage.

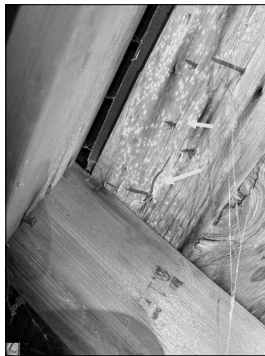
Mold like substance along the sheathing/framing. An active or intermittent water source can cause mold growth and property damage, such as wood rot damage.

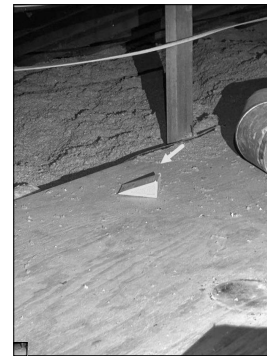
Pest control. Wildlife activity can cause property damage.

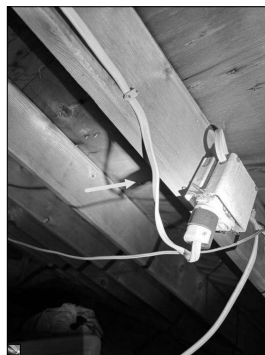
Electrical extension cords observed in the attic. Extension cords in the attic is considered a safety/fire hazard. Extension cords should not be used as permanent wiring.

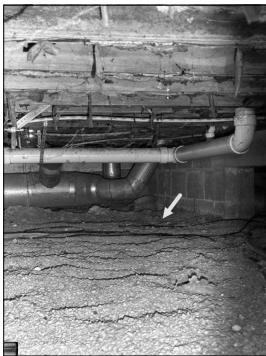
The crawl space has a gravel floor that exposes the earth. Gravel floors are not recommended. A gravel floor can allow the intrusion of moisture, insects, wood destroying insects, radon, mice, and rodents. An active or intermittent water source can cause mold growth and property damage, such as wood rot damage. It is recommended that the crawl space be properly encapsulated.

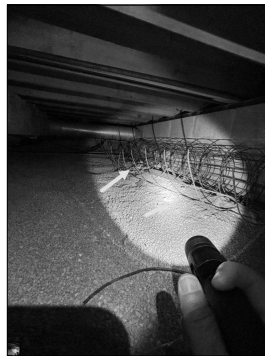
Debris and clutter within the crawl space. The debris and clutter limited visibility and accessibility.

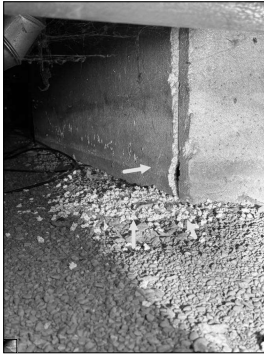
Damaged insulation. This is a sign of wildlife activity.

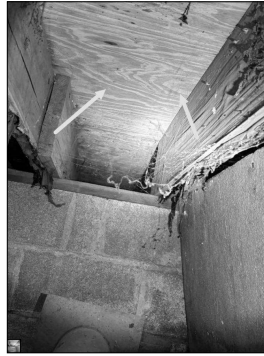
There is no insulation along the subfloor. This is not a recommend practice. The lack of insulation does not meet the industry standard. An insulated subfloor can help maintain desired room temperatures within the above living areas, thus reducing utility expenses with heating and cooling.

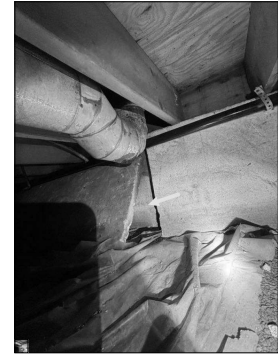
Displaced insulation.

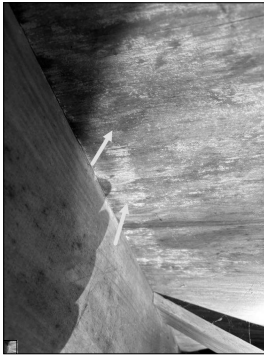
Mold like substance along the subfloor. An active or intermittent water source can cause mold growth and property damage.

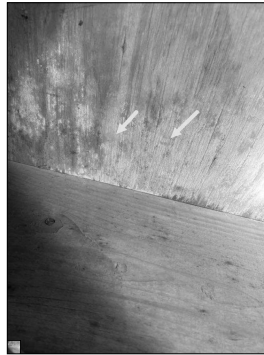
Mold like substance along the subfloor. An active or intermittent water source can cause mold growth and property damage.

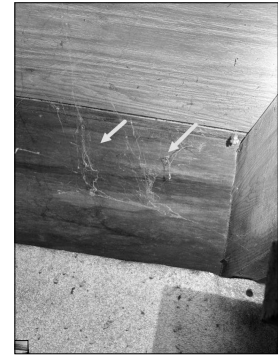
Mold like substance along the band joist. An active or intermittent water source can cause mold growth and property damage.

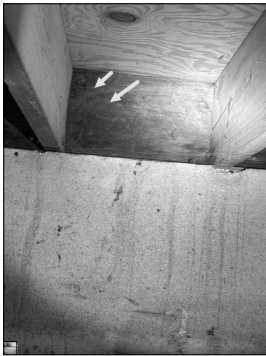
Mold like substance along the band joist. An active or intermittent water source can cause mold growth and property damage.

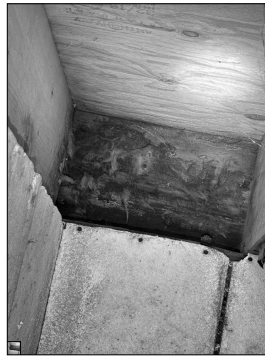
Mold like substance along the band joist. An active or intermittent water source can cause mold growth and property damage.

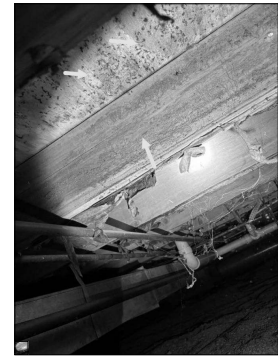
Mold like substance along the floor joists. An active or intermittent water source can cause mold growth and property damage.

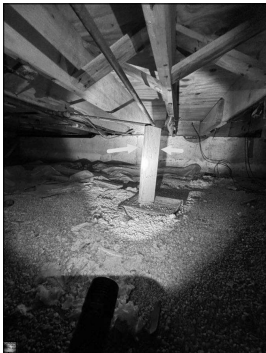
The plumbing pipe is unconventionally supported by a board wedged underneath the pipe. This is considered abnormal and amateur craftsmanship.

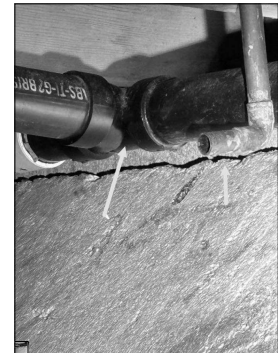
Improper horizontal plumbing transition. This is considered amateur craftsmanship. A sanitary wye should be used for horizontal plumbing transitions. The use of improper plumbing transitions can create slow drainage and potential blockage. Also, there is an open ended plumbing pipe. This is considered abnormal.

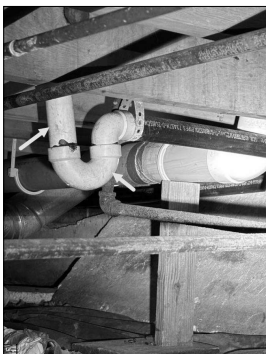
The p-trap is crooked and is not plumb. This is considered a defect.

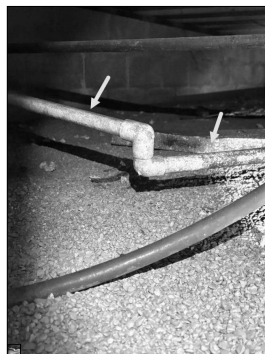
Negative slopes along the condensation drain pipe. This is not a recommended practice and does not meet the industry standard. A negative sloped drain pipe can cause slow drainage and possible blockage.

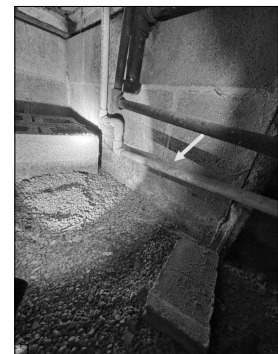
Negative slope along the condensation drain pipe. This is not a recommended practice and does not meet the industry standard. A negative sloped drain pipe can cause slow drainage and possible blockage.

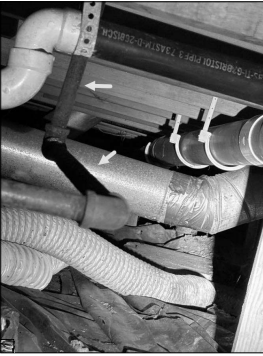
Rust and corrosion along the fuel lines. Rust and corrosion can create holes along the fuel lines, thus creating fuel leak.

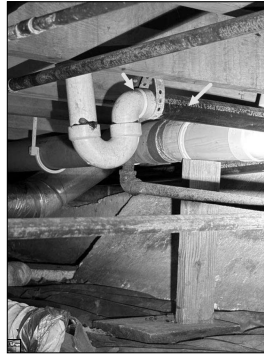
Two different types of plumbing materials joined together. This installation has ABS and PVC connected together. When difficult types of plumbing materials are glued together, they are prone to creating a poor seal, thus creating leaks.

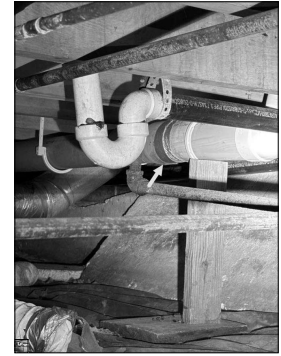
Unconventional tape along the pipe. This is considered abnormal and amateur craftsmanship. Amateur craftsmanship is prone to failure and leakage.

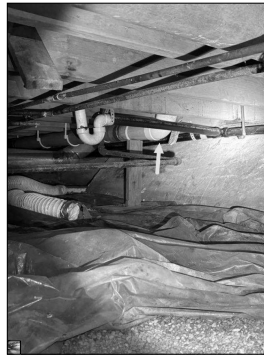
Negative sloped drain pipe. This is not a recommended practice and does not meet the industry standard. A negative sloped drain pipe can cause slow drainage and possible blockage.
