Property Inspection Report

Steven Mix HI01600075
Shamrock Home Inspections LLC

4015 Wedgewood Drive
Inspection Prepared For: Steve Weiss
Agent: Heidi Haiflich - NE Group Realty

Date of Inspection: 4/4/2025
Year Built: 1962 Size: 1960
Weather: Sunny 40 degrees

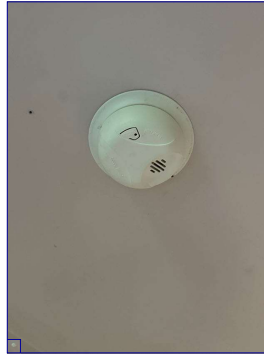
Smoke/Carbon Monoxide Detectors have an End-of-Life. For your safety it is recommended to replace detectors according to manufacturer instructions, from the mfg. date. Please note that verification of the age of smoke and carbon monoxide detectors is not part of the home inspection standards. The NFPA, National Fire Protection Association, recommends testing detectors monthly and replacing batteries when they begin to chirp - signaling they're running low.

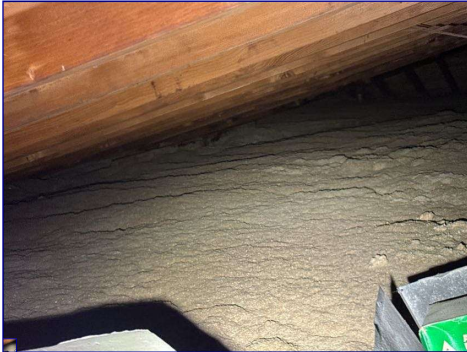
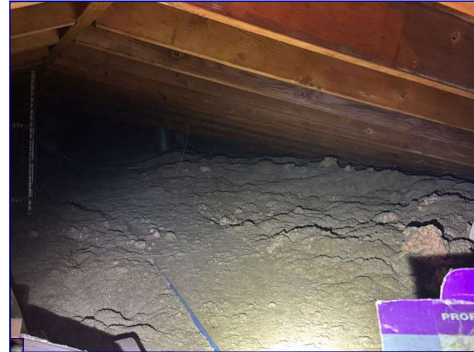
The attic insulation is sufficient for current building standards.

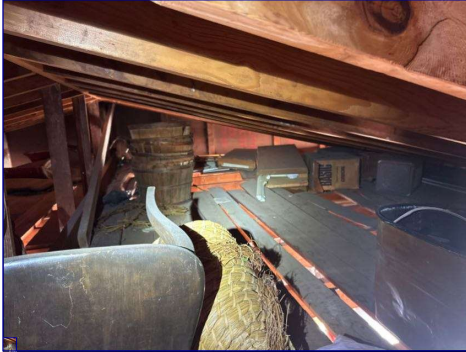
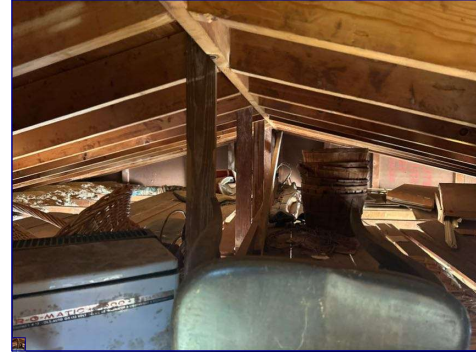
Rafters appeared to be in satisfactory condition at time of inspection with no signs of cracking or displacement.

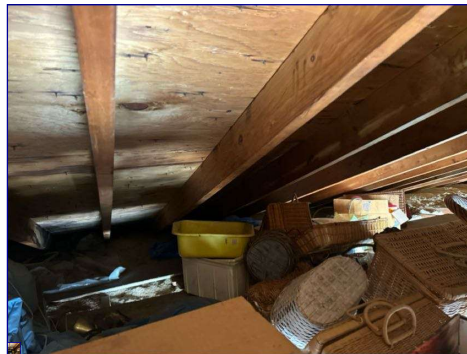
Attic sheathing appeared to be in satisfactory condition at time of inspection. No signs of moisture or mildew staining.

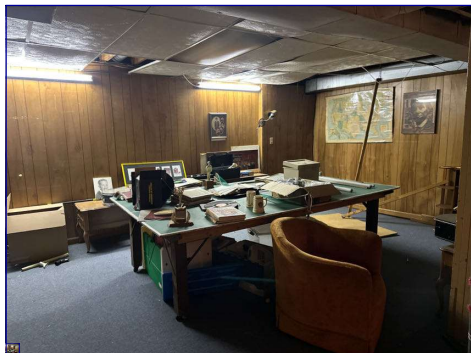
Foundation walls were covered with paneling/drywall/insulation/storage and were not visible. It is always possible that hidden damage may exist in non-visible areas. Consult a licensed contractor as needed.

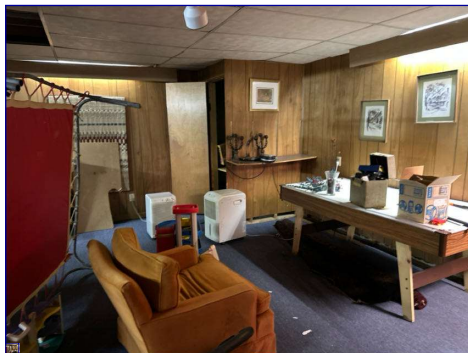
Foundation walls were covered with paneling/drywall/insulation/storage and were not visible. It is always possible that hidden damage may exist in non-visible areas. Consult a licensed contractor as needed.

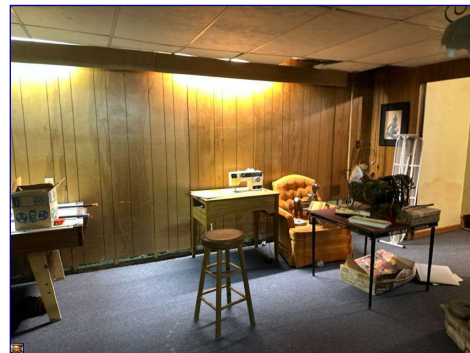
Foundation walls were covered with paneling/drywall/insulation/storage and were not visible. It is always possible that hidden damage may exist in non-visible areas. Consult a licensed contractor as needed.

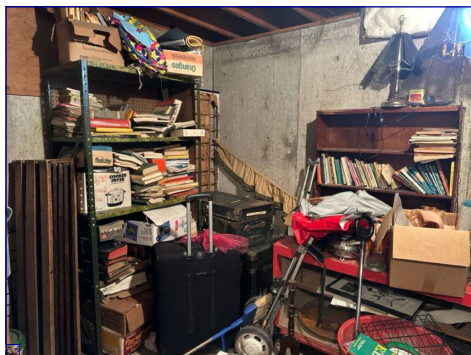
Foundation walls were covered with storage material and were not visible. It is always possible that hidden damage may exist in non-visible areas. Consult a licensed contractor as needed.

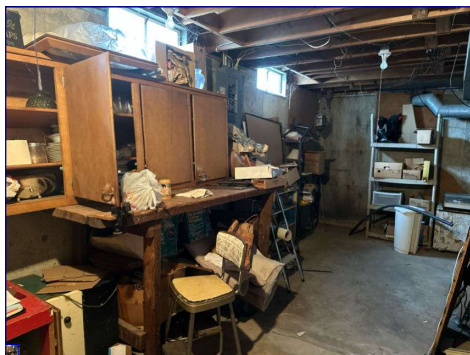
Foundation walls were covered with storage material and were not visible. It is always possible that hidden damage may exist in non-visible areas. Consult a licensed contractor as needed.

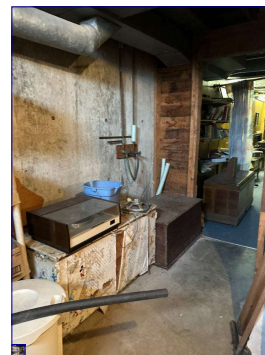
Foundation walls were covered with storage material and were not visible. It is always possible that hidden damage may exist in non-visible areas. Consult a licensed contractor as needed.

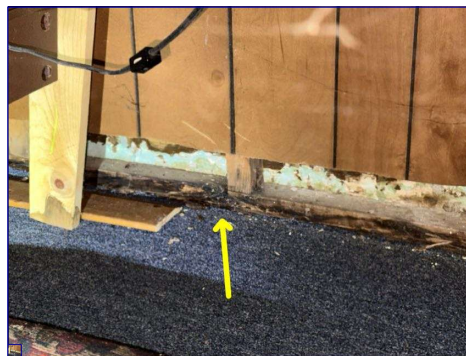
Basement floor was covered in one or more areas and was not visible. It is always possible that hidden damage may exist in non-visible areas. Consult a licensed contractor as needed.

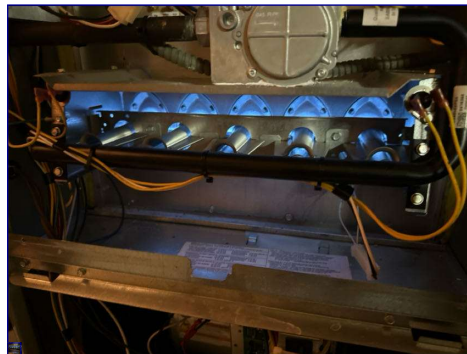
The furnace, operating

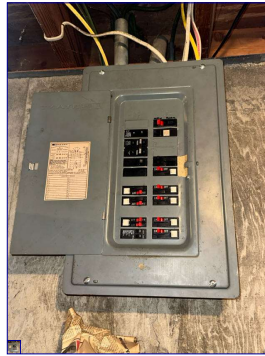
The main electrical service panel breaker locations are marked on service panel cover.

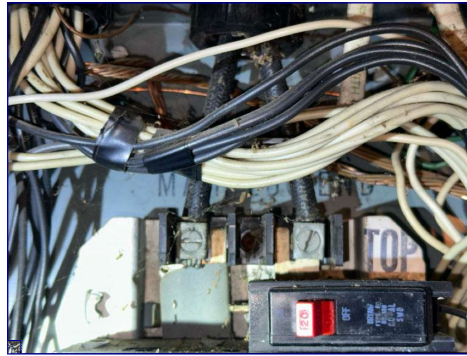
The main electric breaker showed no signs of overheating.

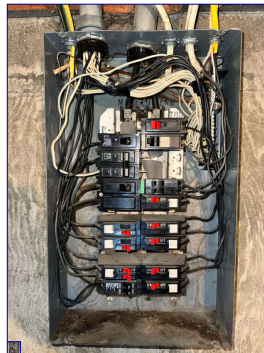
Branch service wires appeared to be in satisfactory condition at time of inspection. No signs of overheating or double tapping.
