# **FAMILYGUARD**

## **HOME INSPECTION REPORT**

**5707 Chester Blvd. Fort Wayne, IN 46819**  
**Inspection Prepared For: Seller**

**Date of Inspection: 10/5/2025**  
**Age of House: 69 Years**  
**Weather: Clear**

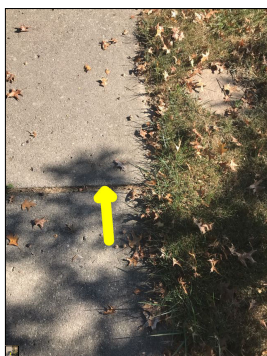
Uneven surfaces along the service walks.

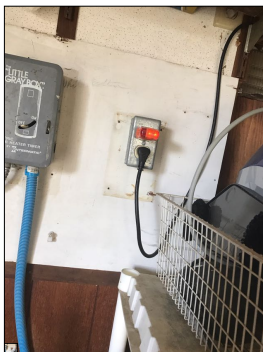
Non GFCI protected receptacles.

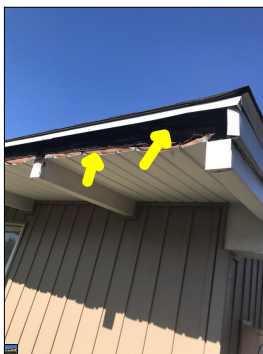
Wood rot damage along the sheathing. An active or intermittent water source can cause mold growth, wood rot, and property damage.

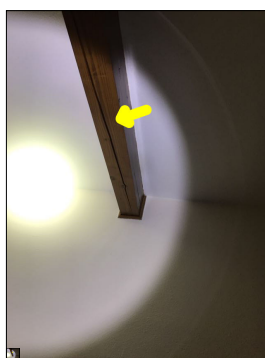
Split along the beam.

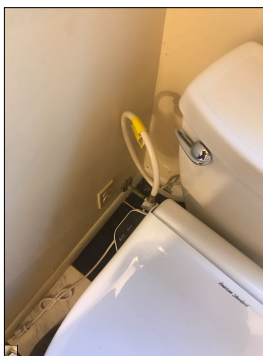
Non GFCI protected receptacles.

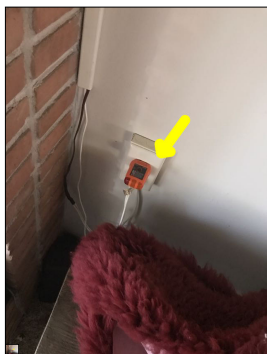
The receptacle is inoperable.
