# **FAMILYGUARD**

## **HOME INSPECTION REPORT**

**3185 S. Golden Lake Rd. Pleasant Lake, IN 46779**  
**Inspection Prepared For: Seller**

**Date of Inspection: 6/25/2026**  
**Age of House: 38 Years**  
**Weather: Clear**

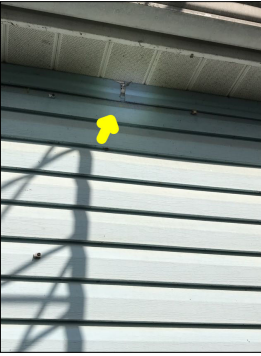
Gaps along the siding.

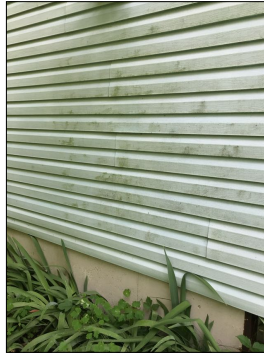
Discoloration along the siding.

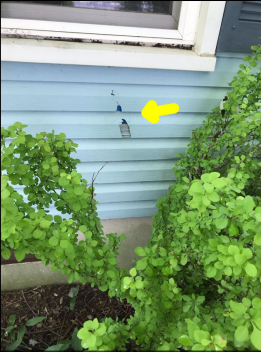
Holes along the siding.

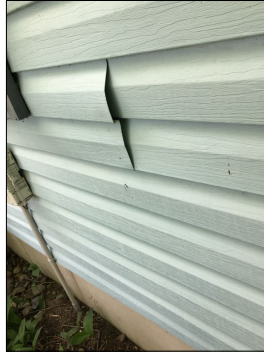
Gaps along the siding.

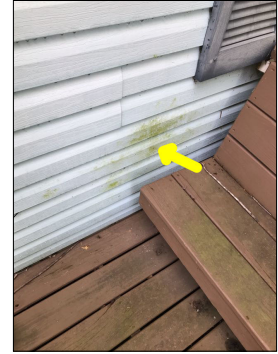
Discoloration along the siding.

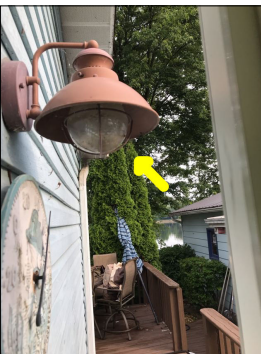
The light is inoperable.

- Recommend licensed electrician further evaluate and make necessary repairs.

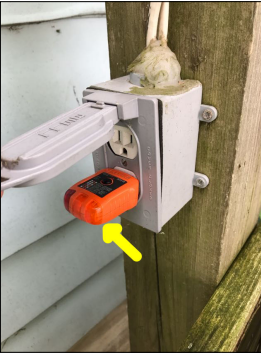
Open ground receptacle.

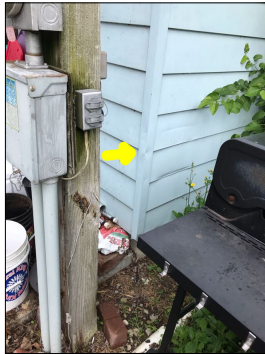
Dents along the siding.

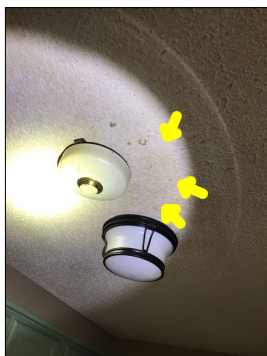
Discoloration along the ceiling.

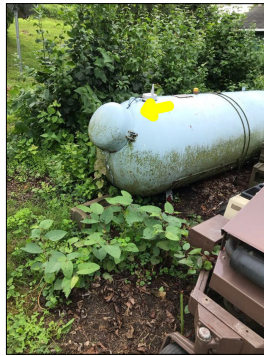
Main fuel shut off valve.

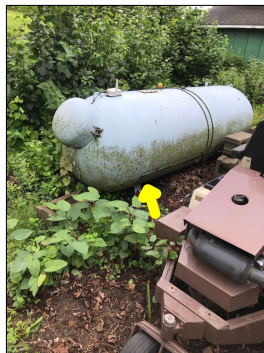
The fuel tank has rust and corrosion along it. The fuel tank is considered aged.

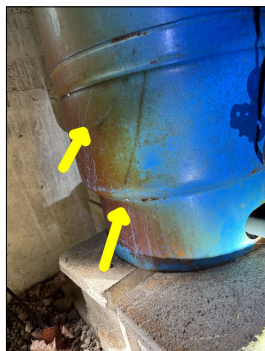
Rust/corrosion along the pressure tank.
