# **FAMILYGUARD**

## **HOME INSPECTION REPORT**

**3643 Westport Dr. New Haven, IN 46774**  
**Inspection Prepared For: Seller**

**Date of Inspection: 8/8/2026**  
**Age of House: 22 Years**  
**Weather: Overcast**

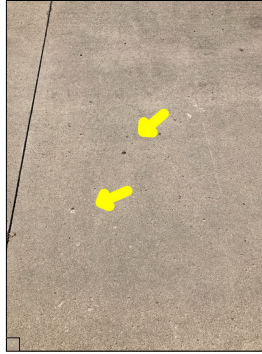
Pitting along the driveway.

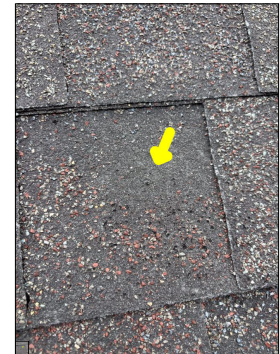
Granule loss along the roof shingles

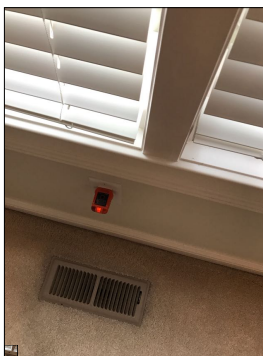
Open ground receptacles.

- Recommend licensed electrician further evaluate and make necessary repairs.
