# **FAMILYGUARD**

## **HOME INSPECTION REPORT**

**4110 Stillwood Dr. Fort Wayne, IN 46815**  
**Inspection Prepared For: Seller**

**Date of Inspection: 8/11/2026**  
**Age of House: 33**  
**Weather: Raining**

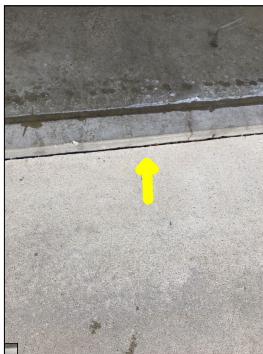
Uneven surfaces along the driveway.

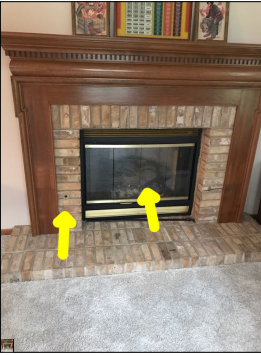
The fireplace is a gas fireplace. There is no apparent electronic ignition. It is beyond the scope of a general home inspection to light fuel burning appliances. Doing so could cause property damage. Recommend a licensed chimney/fireplace professional further evaluate to make sure the fireplace is in good working condition and is safe to use.

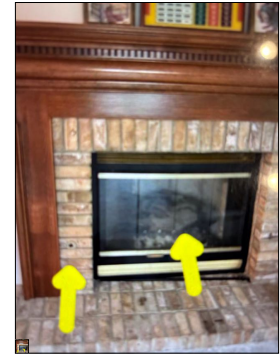
The fireplace is a gas fireplace. There is no apparent electronic ignition. It is beyond the scope of a general home inspection to light fuel burning appliances. Doing so could cause property damage. Recommend a licensed chimney/fireplace professional further evaluate to make sure the fireplace is in good working condition and safe to use.

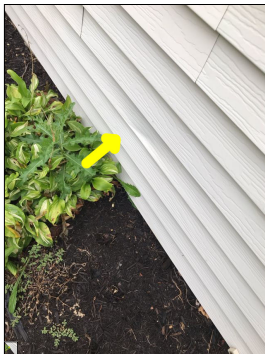
Dents along the siding.

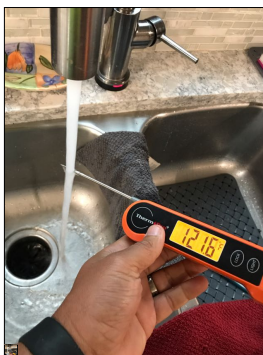
Temperature reading of the hot water during the time of the inspection. The approximate temperature of the hot water was 121 degrees Fahrenheit.

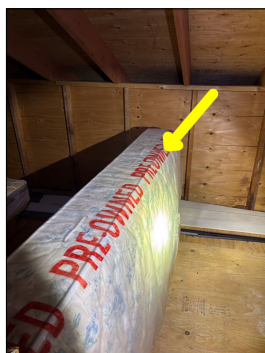
Debris and clutter within the attic. Visibility and accessibility were limited.

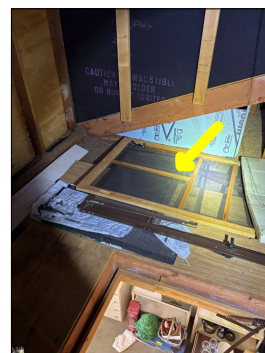
Debris and clutter within the attic. Visibility and accessibility were limited.

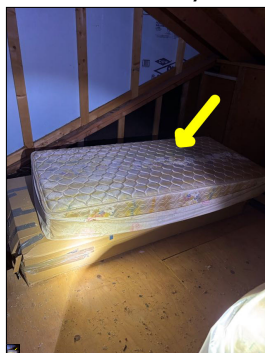
Debris and clutter within the attic. Visibility and accessibility were limited.

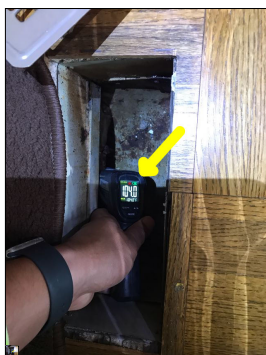
The photo identifies the temperature of the supply air while the furnace was in operation. The approximate temperature of the supply air was 104 degrees Fahrenheit.

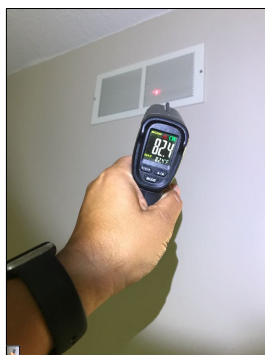
The photo identifies the temperature of the return air while the furnace was in operation. The approximate temperature of the return air was 82 degrees Fahrenheit.
