# **FAMILYGUARD**

## **HOME INSPECTION REPORT**

**6340 Langwood Blvd. Fort Wayne, IN 46835**  
**Inspection Prepared For: Seller**

**Date of Inspection: 8/5/2026**  
**Age of House: 40 Years**  
**Weather: Clear**

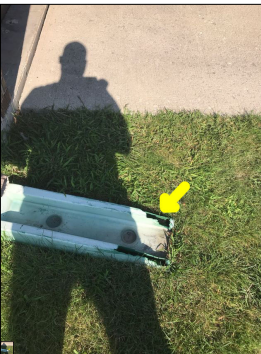
Damaged splash block.

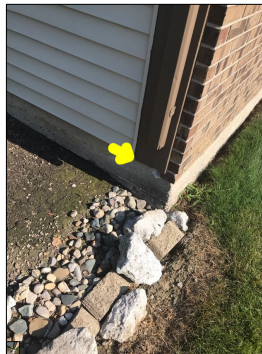
Missing downspout elbows.

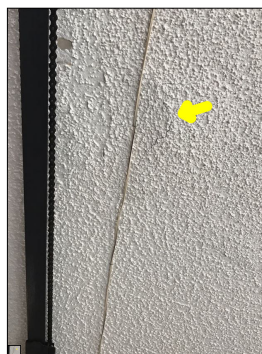
Cracks along the ceiling.

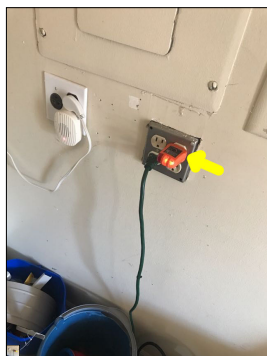
Non GFCI protected receptacles.

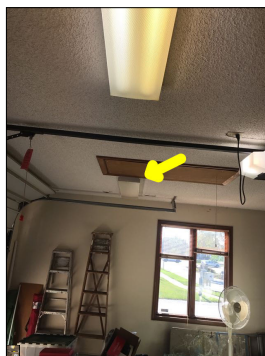
The light is inoperable.

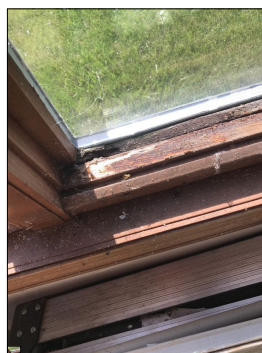
Wood rot damage along the window.

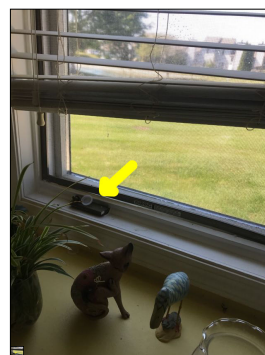
Detached window crank. The window is inoperable.

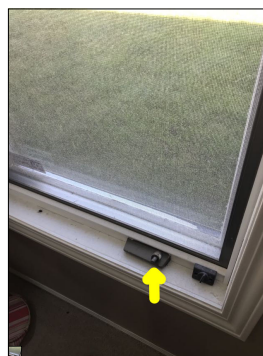
Detached window crank. The window is inoperable.

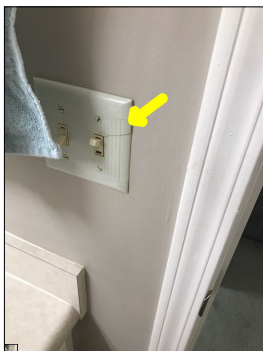
Cracked switch cover.

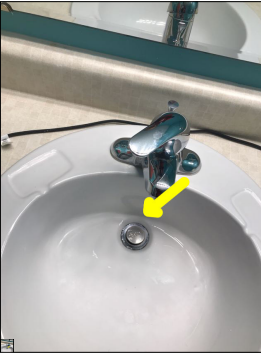
Inoperable drain stopper.

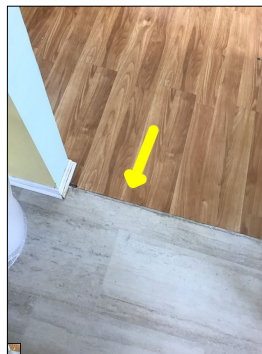
Missing trim pieces along the floor.

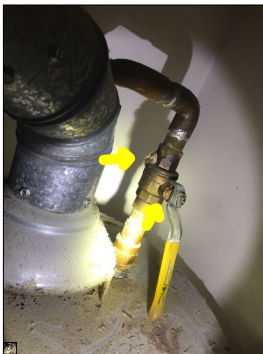
Corrosion along the water supply lines.
