# **FAMILYGUARD**

## **HOME INSPECTION REPORT**

**11378 S. State Rd. 13 La Fontaine, IN 46940**  
**Inspection Prepared For: Seller**

**Date of Inspection: 8/5/2026**  
**Age of House: 120+ Years**  
**Weather: Clear**

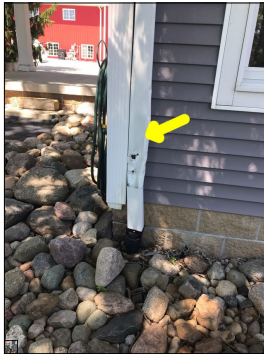
Dents/damage along the gutter system.

- Recommend general contractor further evaluate and make necessary repairs
- A defective gutter/drainage system can cause excessive water to accumulate around the house, thus potentially causing water intrusion into the house or potential foundation problems due to excessive hydrostatic pressure. Also, a defective gutter/drainage system can cause excessive water to flow along the exterior walls, which could allow water to get behind the siding, soffit and fascia. An active or intermittent water intrusion source can cause mold growth and property damage.

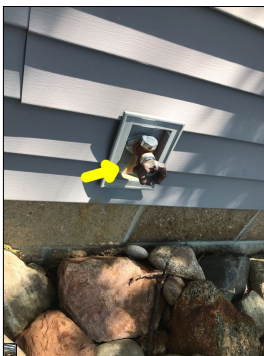
Discoloration along the siding.

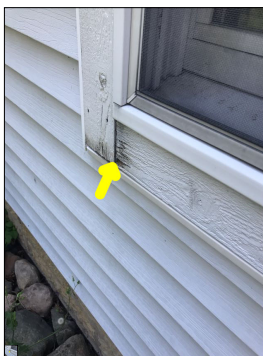
Wood rot damage.

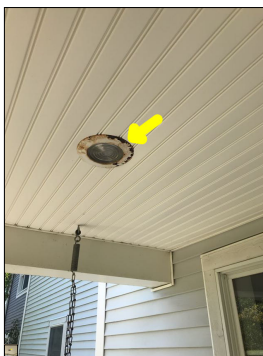
Rust and corrosion along the exterior lights.

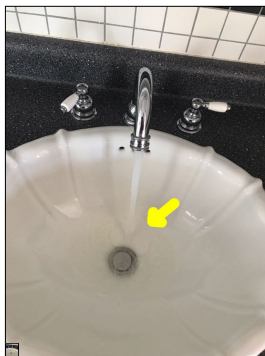
Inoperable drain stopper.

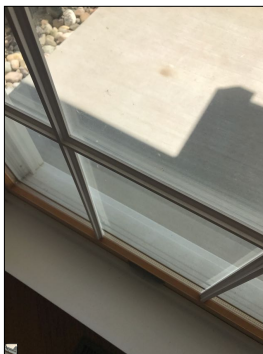
Missing window screens.

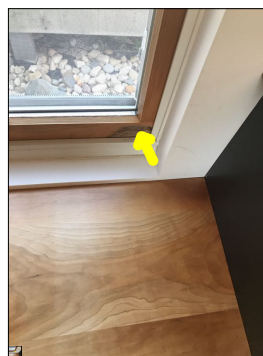
Discoloration along the window. An active or intermittent water source can cause discoloration, mold, and property damage.

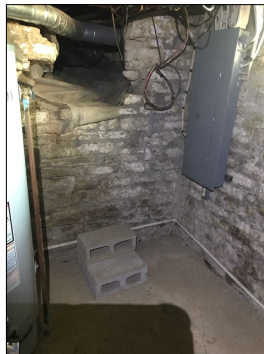
Field stone foundation observed in some areas. Field stone foundations no longer meet modern day structural standards. Field stone foundations are considered aged. Potential repairs to stone foundations and water intrusion from field stone foundations should not be a surprise.

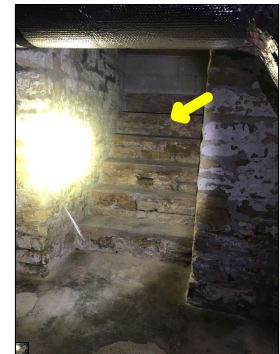
Old stair case observed.

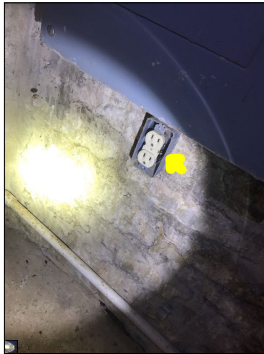
Missing receptacle cover.

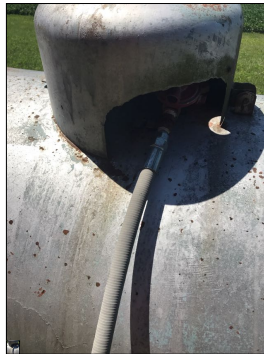
Rust and corrosion along the fuel tank. Rust and corrosion can create holes along the tank, thus creating a fuel leak.

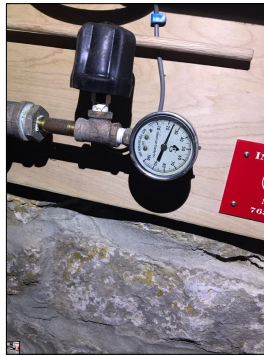
The well pressure was approximately 25 PSI during the inspection.

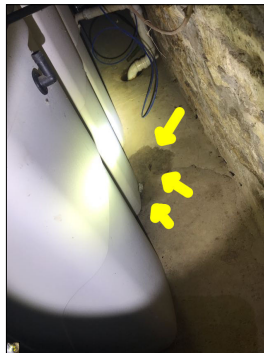
Moisture/dampness observed under the water softener. An active or intermittent water source can cause damage, mold, water damage. No active leaks in this area observed on the day of the inspection. Recommend licensed plumber further evaluate and make necessary repairs.

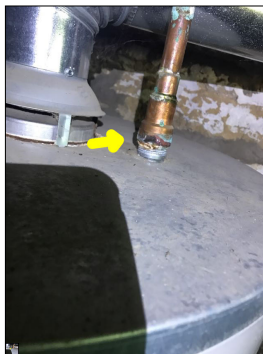
Corrosion along the water supply lines.

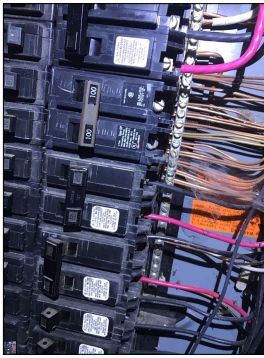
Unused circuit breaker.

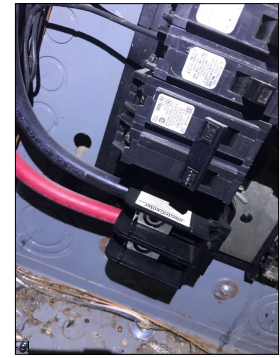
Unused circuit breaker.
