Inspection report for the property at  
1406 E Gump Rd, Fort Wayne, IN 46845

This report is prepared exclusively for **Becky Skurner / Christy Hire**  
Inspected On: **08-28-2026**

Peak To Pillar Home Inspectors LLC  
2604359278

Peter Fennig , Indiana State License  
#HI02500018

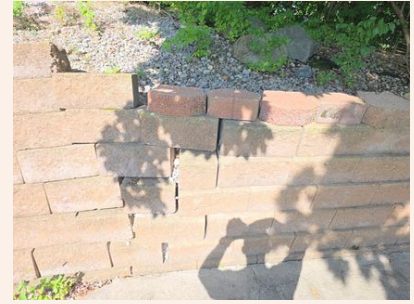
**GAD-2 ■ Grounds And Drainage:** Retaining Wall Summary:

The rear southeast retaining wall has minor localized movement and displacement. Most of the wall appeared solid, with only a handful of blocks, primarily along the top course, found to be loose. Recommend monitoring and repairing the affected section as needed to prevent further movement.

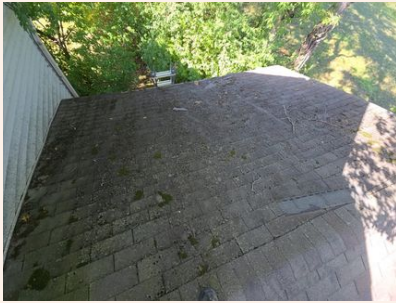
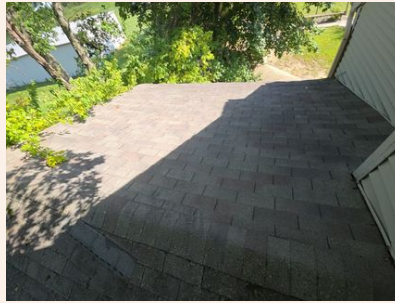
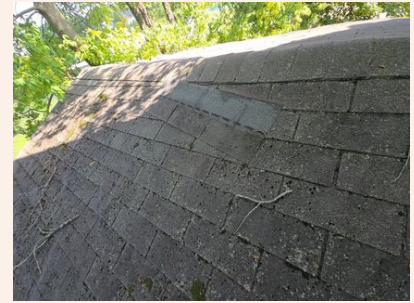
#### **ES-1 ■ Exterior Structures:** Roof Summary:

The roof over the attached shed on the east side of the house is in poor condition, particularly along the north side. Multiple damaged and missing shingles, soft spots, and deterioration of the roof decking and eaves were observed.

Replacement of this roof section is recommended due to the extent of deterioration.

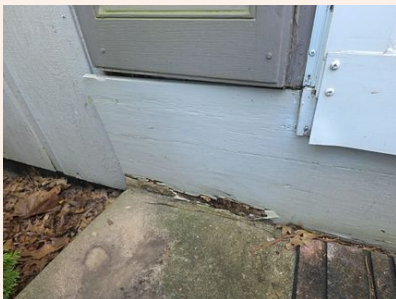
Problem: The corner trim below the front entry door is rotted.

*Rotted corner trim just below the front entrance Door*

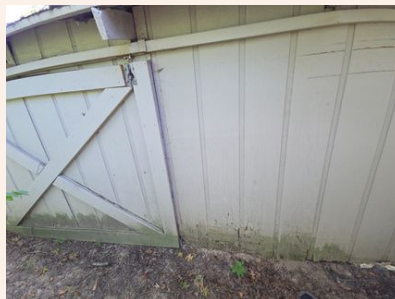
*T11 siding on the northeast exterior of the house on the attached storage shed has signs of rot and damage primarily along the bottom Edge of the siding but additionally along the inside of the eaves as well*

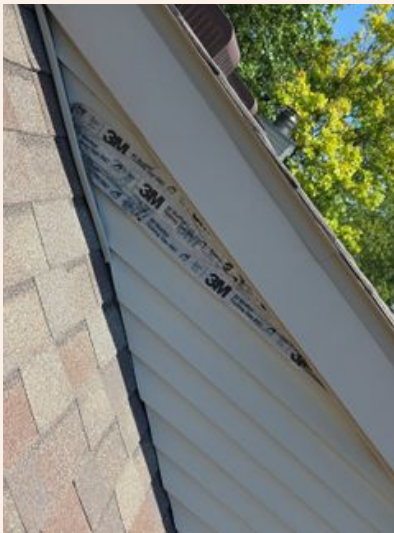
*Damage or missing piece of siding that has been covered up with tape on the upper west side of the rear Dormer*

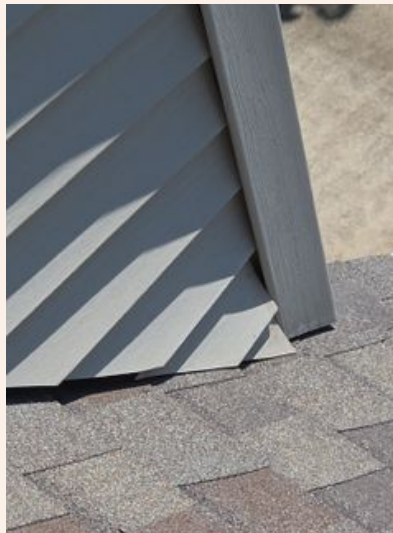
*Vinyl siding has come untucked from the outside vinyl corner post on the Lower West rear Dormer*

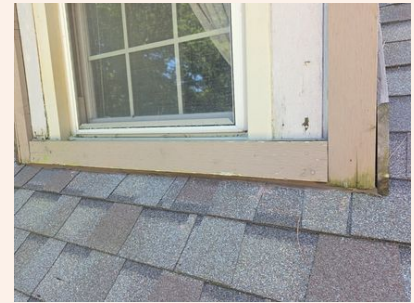
*Wood trim board around the front North facing Dormers as well as the Dormers fascia board are in need of maintenance and sealing*

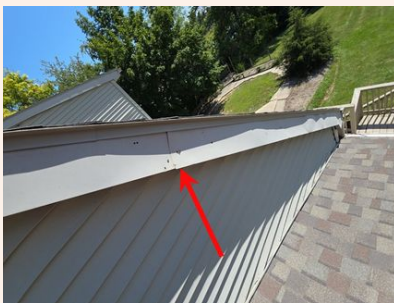
Effect: Improper flashing overlap can allow water intrusion behind the fascia.

*Fascia flashing on the Second Story West rake towards the back is overlapping the wrong way*

Recommendation: Have a licensed contractor reinstall the fascia flashing correctly as needed.

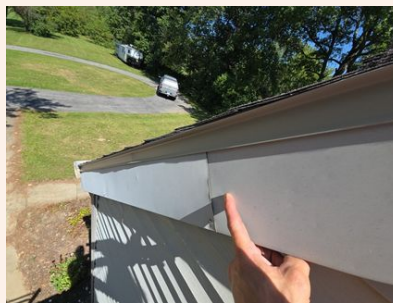
*Fascia flashing on the Second Story West rake towards the front is overlapping the wrong way*

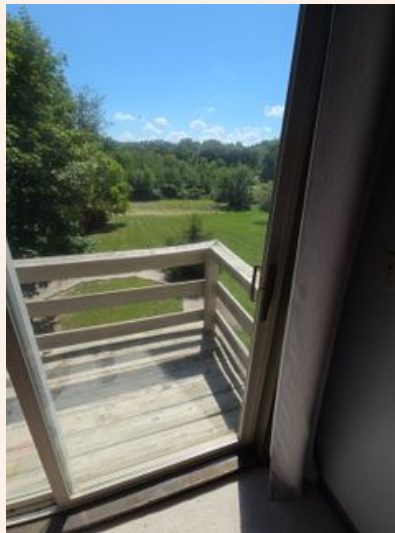
*Second floor balcony sliding patio door does not lock*

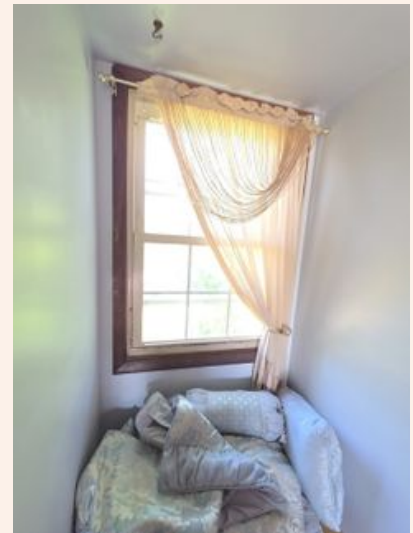
*Was unable to open the front facing north window in the East Dormer*

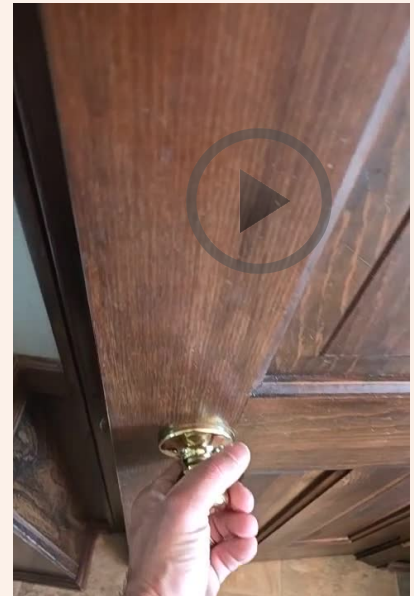
*(This video is only viewable online.)  
Kitchen pantry door does not latch*

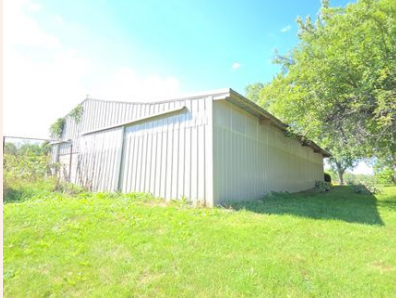
*Barn is missing gutters and downspouts on both sides*

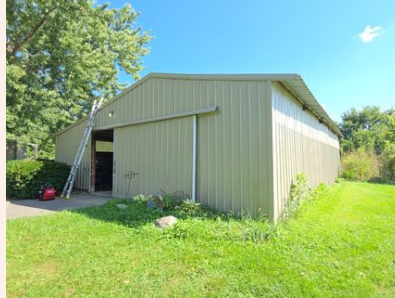
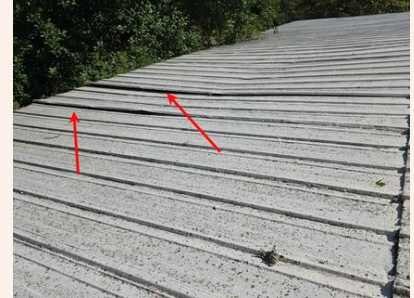
Effect: Loose panels are susceptible to wind damage and may allow water intrusion into the structure.

*Metal roofing panels that have come loose on the east ends of the barn roof*

Recommendation: Have a licensed contractor secure or replace the affected roofing panels as needed.

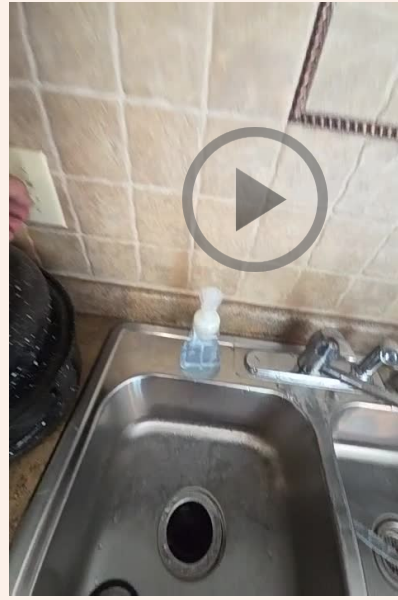
*Garbage disposal was not working at the time of the inspection*

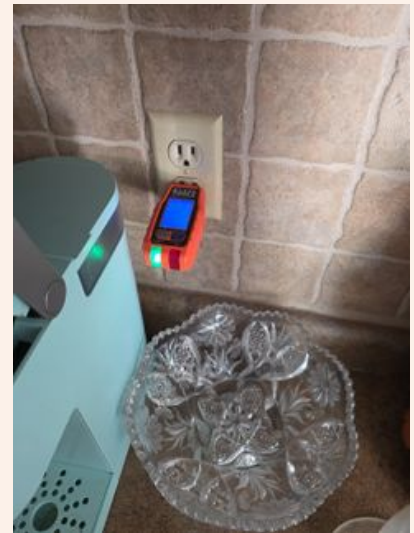
*Three kitchen countertop Outlets were not GFCI protected*

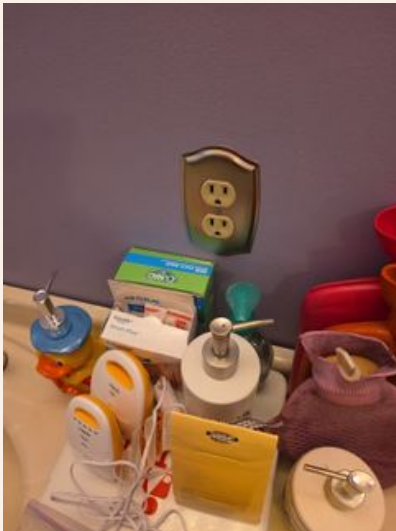
*Main floor hallway bathroom outlet is not GFCI protected*

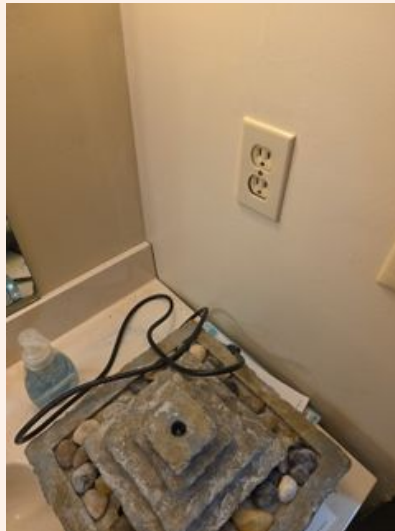
*Half bathroom basement Outlet not GFCI protected*

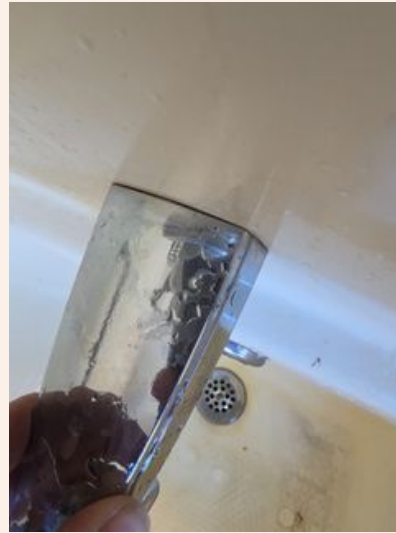
*Second floor bathroom tub  
spout needs sealant between it  
and the wall or a small Gap can  
be seen*

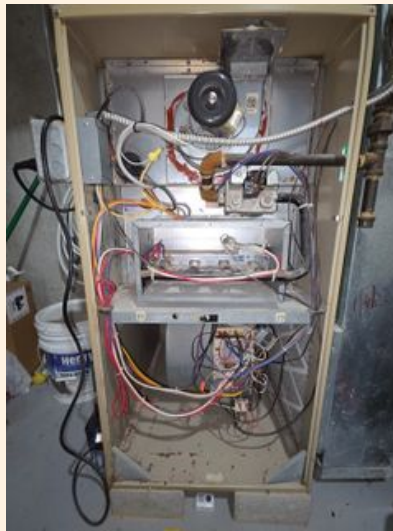
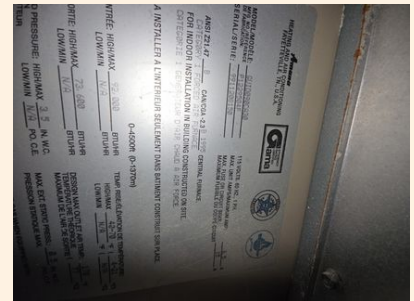
**S-2** ■ **Systems:** Heating System Summary:

The forced-air gas furnace was manufactured in 1999 and is well beyond its typical service life expectancy. It was operating as intended and producing heat at the time of the inspection. Recommend budgeting for replacement while continuing routine maintenance.

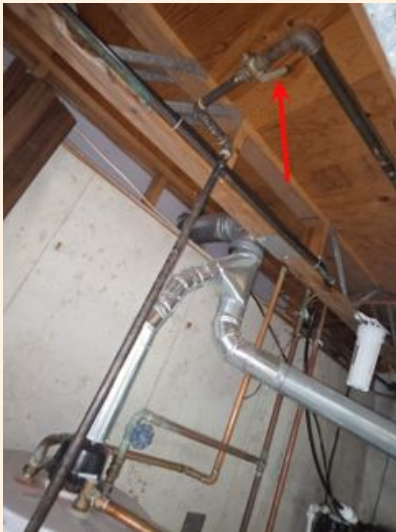
*Gas supply shut off to the water heater*

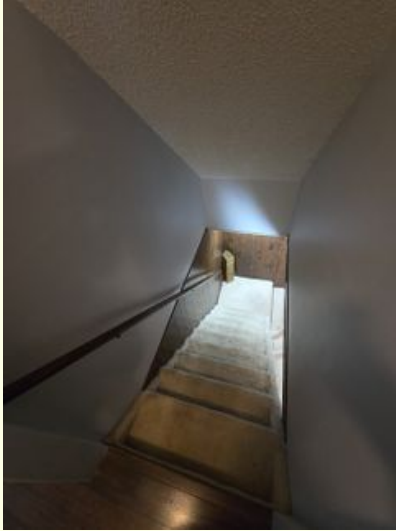
*Basement stairs*

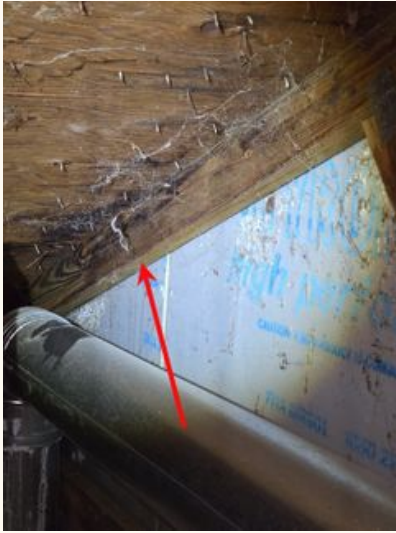
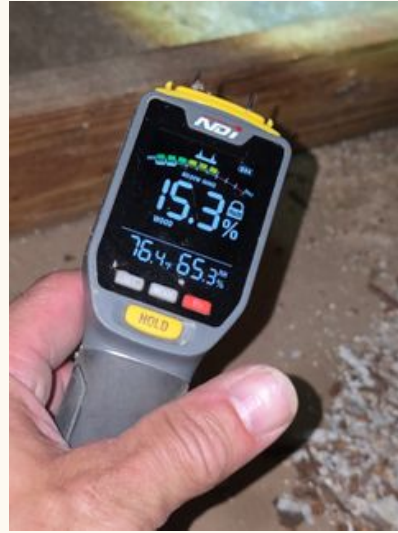
Elevated moisture levels were detected in the roof framing where the garage roof intersects the front of the house. This area showed higher moisture content than the surrounding framing, indicating possible water intrusion. The condition is consistent with the section below where the fascia flashing appears to be installed backwards.

Recommend monitoring this area after the fascia flashing has been repaired to confirm the

moisture levels return to normal and no additional water intrusion is occurring.

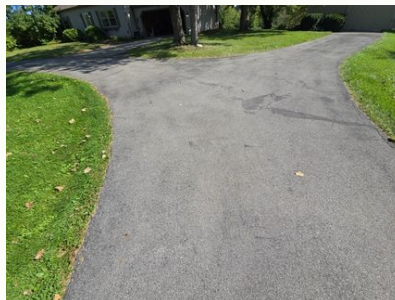
*Main asphalt driveway*

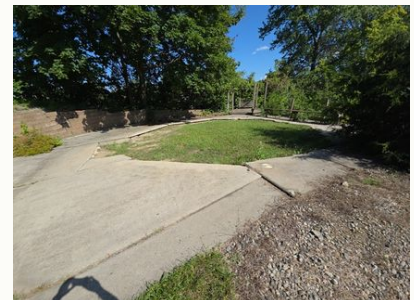
The backyard concrete walkways and patio exhibit minor deferred maintenance, including areas of surface / edge chipping and cracking. Recommend routine maintenance and repairs as needed to help prevent further deterioration and extend their service life.

*Rear walkway and Patio*

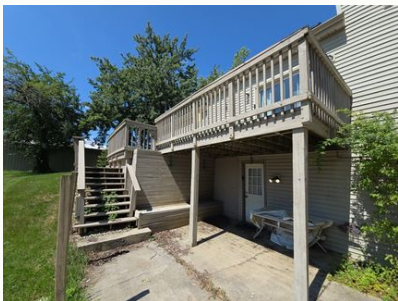
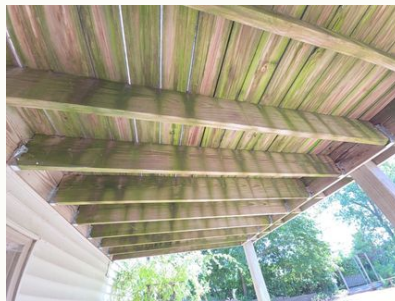
The backyard deck is in generally serviceable condition but is in need of routine maintenance. The guardrails are loose and should be stiffened, the stair railing is separating from the main deck railing and is very loose, and the deck and railings would benefit from cleaning, power washing, and resealing. Recommend completing these maintenance items to improve safety and help extend the life of the deck.

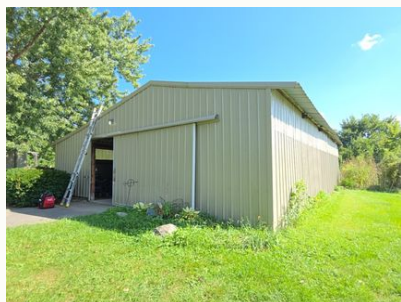
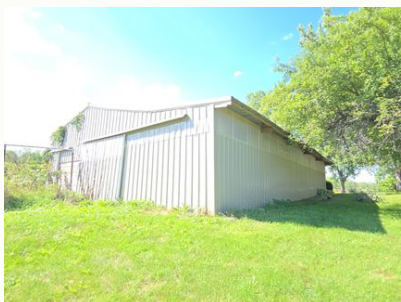
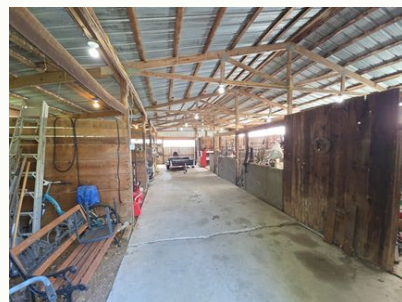
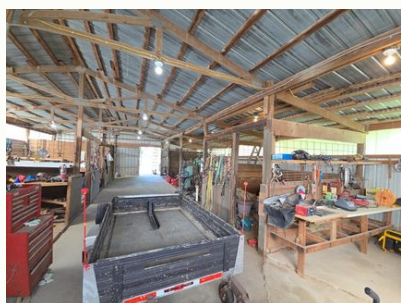
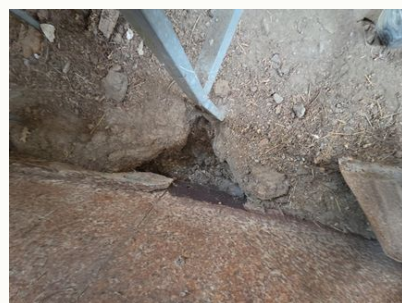
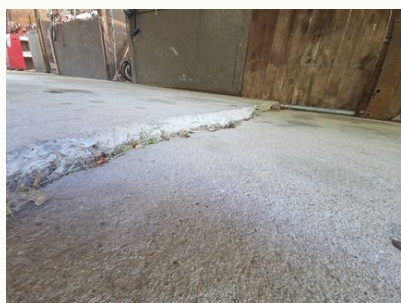
The detached garage/horse barn is a pole barn constructed with ribbed metal siding and metal roofing over pole barn framing with engineered roof trusses. Large sliding doors are located on both the north and south ends. The interior was in generally typical condition for a structure of this

type. A large concrete slab extends down the center of the barn, covering approximately one-third of the floor area, while the remaining stable areas consist primarily of dirt floors, with some sections covered with OSB panels for workbench areas. The concrete slab exhibits numerous cracks, including a significant crack near the north end where a large section has settled approximately 2 inches below the adjacent slab, along with additional moderate cracking concentrated near the southeast corner. Electrical service and lighting were installed throughout the barn, and all accessible receptacles tested were GFCI protected and functioning as intended at the time of the inspection. Recommend routine maintenance of the structure, sealing and monitoring concrete cracks as needed, and addressing the active groundhog burrows around and beneath the barn to help prevent additional soil erosion and settlement.

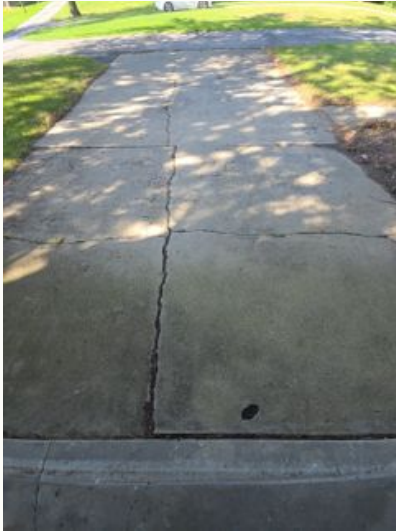
*Attached garage driveway*

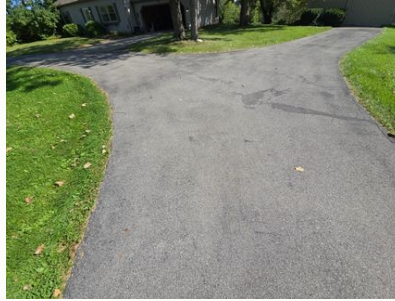
*Main asphalt driveway*

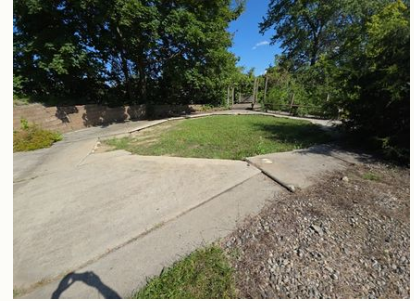
The backyard concrete walkways and patio exhibit minor deferred maintenance, including areas of surface / edge chipping and cracking. Recommend routine maintenance and repairs as needed to help prevent further deterioration and extend their service life.

*Rear walkway and Patio*

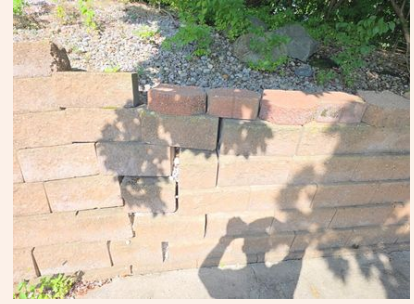
### **(GAD-2) Repair:** Retaining Wall Summary:

The rear southeast retaining wall has minor localized movement and displacement. Most of the wall appeared solid, with only a handful of blocks, primarily along the top course, found to be loose. Recommend monitoring and repairing the affected section as needed to prevent further movement.

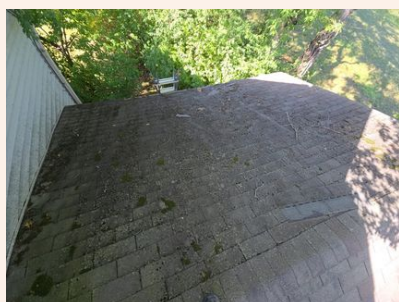
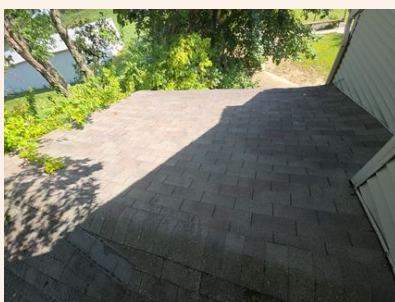
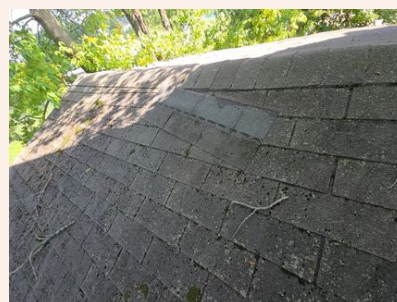
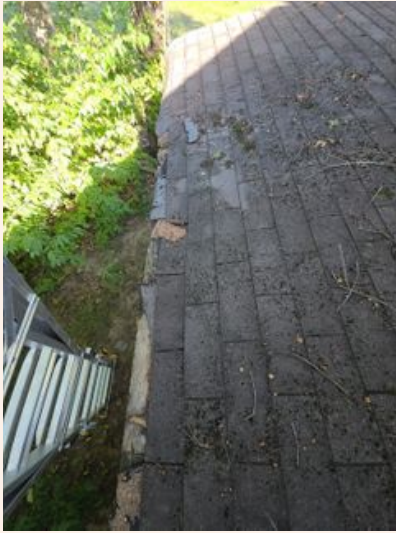
### (ES-1) Repair: Roof Summary:

The roof over the attached shed on the east side of the house is in poor condition, particularly along the north side. Multiple damaged and missing shingles, soft spots, and deterioration of the roof decking and eaves were observed.

Replacement of this roof section is recommended due to the extent of deterioration.

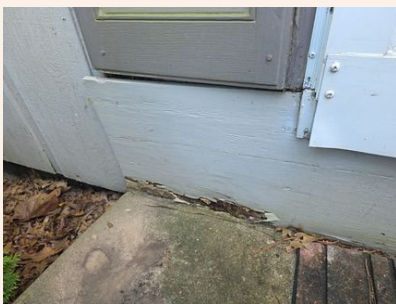
Effect: Rotted wood can allow moisture intrusion and continue to deteriorate.

*Rotted corner trim just below the front entrance Door*

Recommendation: Have a licensed contractor evaluate and repair as needed.

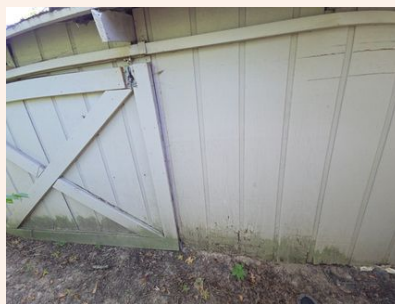
2 - Deteriorated T1-11 Siding

Problem: The T1-11 siding on the northeast side of the attached storage shed shows rot and deterioration, primarily along the bottom edge and inside the eaves.

Effect: Deteriorated siding is susceptible to continued moisture damage.

*T11 siding on the northeast exterior of the house on the attached storage shed has signs of rot and damage primarily along the bottom Edge of the siding but additionally along the inside of the eaves as well*

Recommendation: Have a licensed contractor evaluate and repair or replace the affected siding as needed.

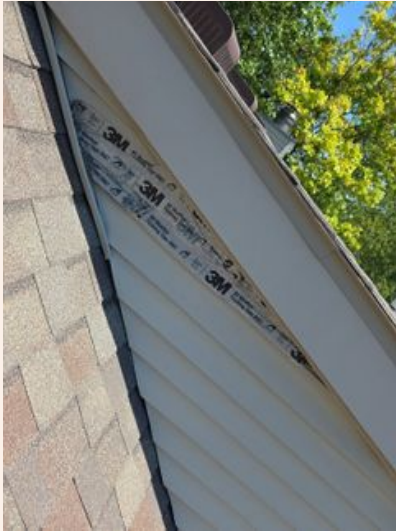
### 3 - Damaged Dormer Siding

Problem: A damaged or missing section of siding on the upper west side of the rear dormer has been covered with tape.

Effect: The temporary repair may allow moisture intrusion and further deterioration.

*Damage or missing piece of siding that has been covered up with tape on the upper west side of the rear Dormer*

Recommendation: Have a licensed contractor permanently repair the damaged siding as needed.

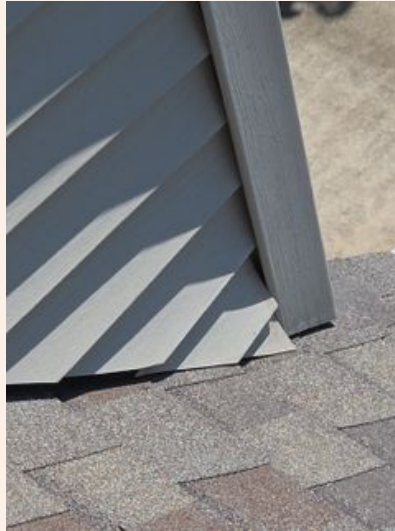
### 4 - Loose Vinyl Siding

Problem: Vinyl siding has come loose from the corner post on the lower west rear dormer.

Effect: Loose siding can allow moisture and pests to enter behind the exterior cladding.

*Vinyl siding has come untucked from the outside vinyl corner post on the Lower West rear Dormer*

Recommendation: Have a licensed contractor evaluate and repair as needed.

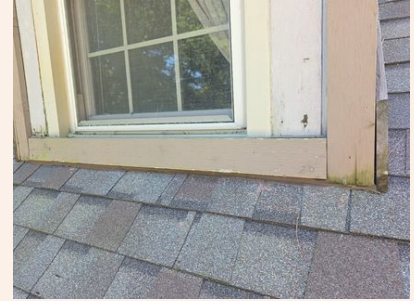
Effect: Unprotected wood is more susceptible to moisture damage and deterioration.

*Wood trim board around the front North facing Dormers as well as the Dormers fascia board are in need of maintenance and sealing*

Recommendation: Scrape, prepare, seal, and repaint the affected areas as part of routine exterior maintenance.

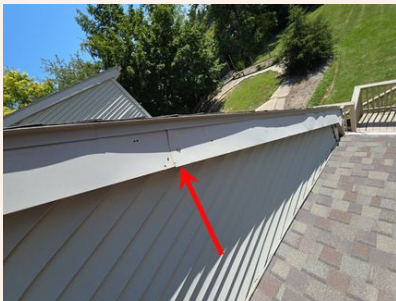
### 6 - Improper Fascia Flashing Overlap

Effect: Improper flashing overlap can allow water intrusion behind the fascia.

*Fascia flashing on the Second Story West rake towards the back is overlapping the wrong way*

Recommendation: Have a licensed contractor reinstall the fascia flashing correctly as needed.

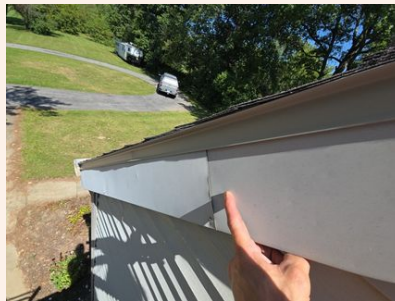
*Fascia flashing on the Second Story West rake towards the front is overlapping the wrong way*

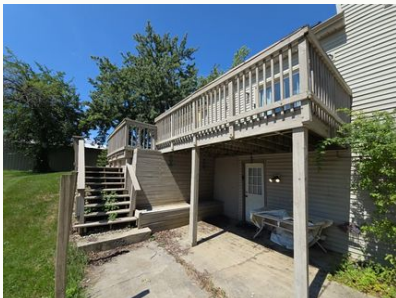
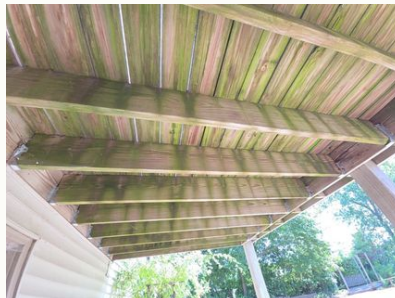
#### **(ES-8) Maintenance:** Deck Maintenance Summary:

The backyard deck is in generally serviceable condition but is in need of routine maintenance. The guardrails are loose and should be stiffened, the stair railing is separating from the main deck railing and is very loose, and the deck and railings would benefit from cleaning, power washing, and resealing. Recommend completing these maintenance items to improve safety and help extend the life of the deck.

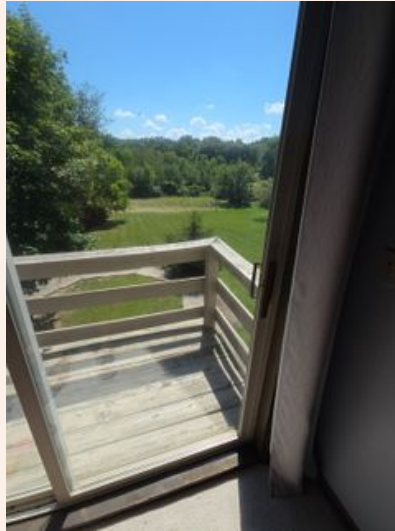
*Second floor balcony sliding patio door does not lock*

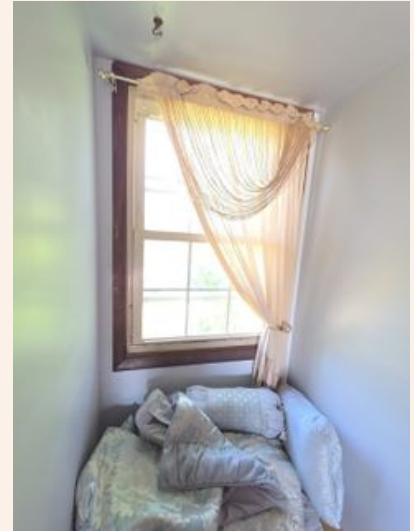
*Was unable to open the front facing north window in the East Dormer*

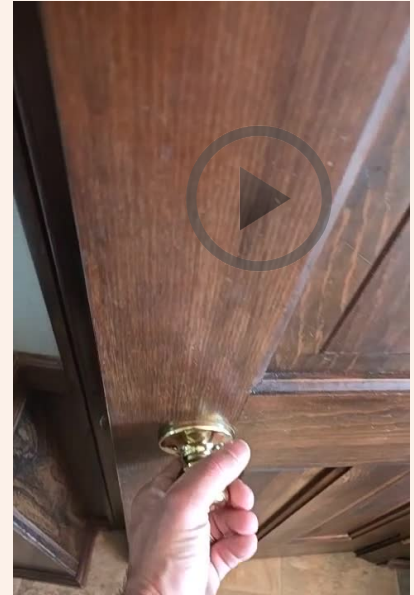
*Main floor hallway bathroom door does not close*

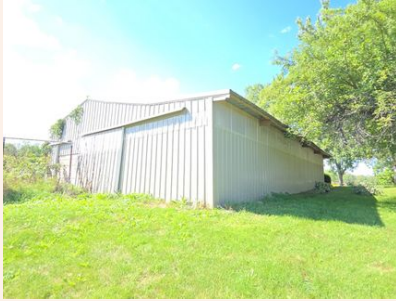
Problem: The barn is missing gutters and downspouts on both sides.

*Barn is missing gutters and downspouts on both sides*

Recommendation: Install gutters and downspouts to help direct water away from the structure.

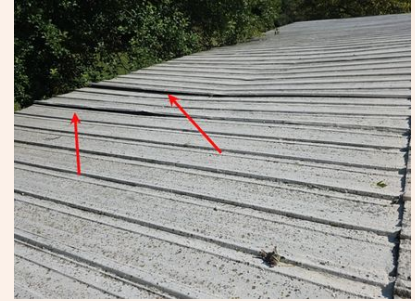
Effect: Loose panels are susceptible to wind damage and may allow water intrusion into the structure.

*Metal roofing panels that have come loose on the east ends of the barn roof*

Recommendation: Have a licensed contractor secure or replace the affected roofing panels as needed.

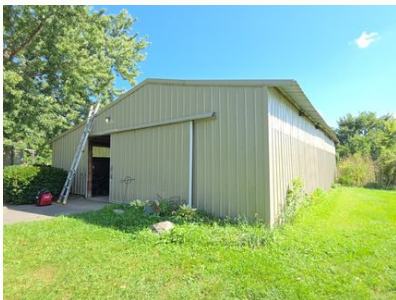
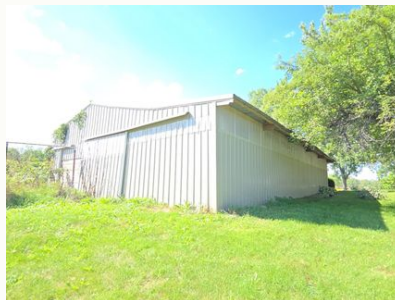
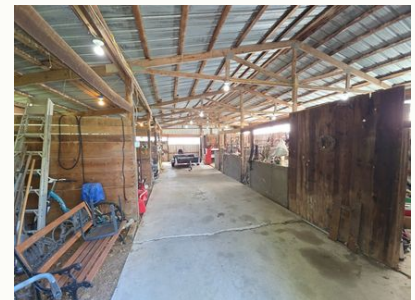
The detached garage/horse barn is a pole barn constructed with ribbed metal siding and metal roofing over pole barn framing with engineered roof trusses. Large sliding doors are located on both the north and south ends. The interior was in generally typical condition for a structure of this type. A large concrete slab extends down the center of the barn, covering approximately one-third of the floor area, while the remaining stable areas consist primarily of dirt floors, with some sections covered with OSB panels for workbench areas. The concrete slab exhibits numerous cracks, including a significant crack near the north end where a large section has settled approximately 2 inches below the adjacent slab, along with additional moderate cracking concentrated near the southeast corner. Electrical service and lighting were installed throughout the barn, and all accessible receptacles tested were GFCI protected and functioning as intended at the time of the inspection. Recommend routine maintenance of the structure, sealing and monitoring concrete cracks as needed, and addressing the active groundhog burrows around and beneath the barn to help prevent additional soil erosion and settlement.

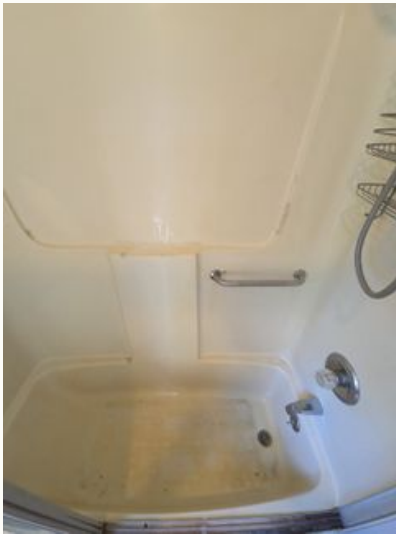
### (I-2) Maintenance: Cosmetic Bathtub and Surround Wear

Problem: The second-floor bathtub and surround exhibit multiple chips and signs of cosmetic wear.

Effect: No evidence of active leakage was observed at the time of the inspection; however, the damaged finish detracts from the appearance and may continue to deteriorate over time.

Recommendation: Repair or refinish the affected areas as needed for cosmetic improvement and monitor for any future signs of leakage.

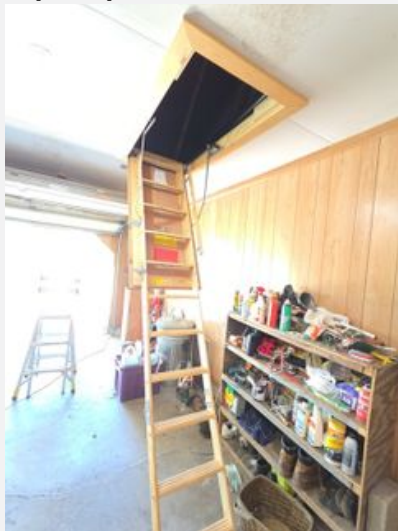
*Pull down attic stairs to access  
above the garage*

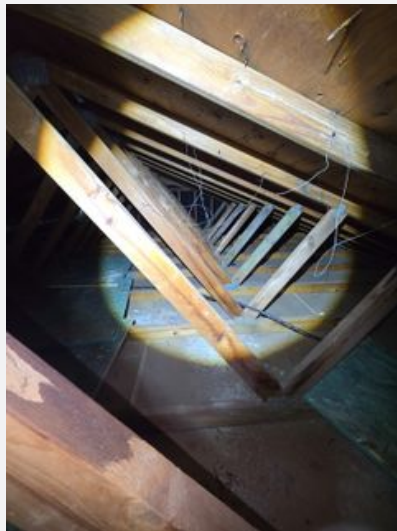
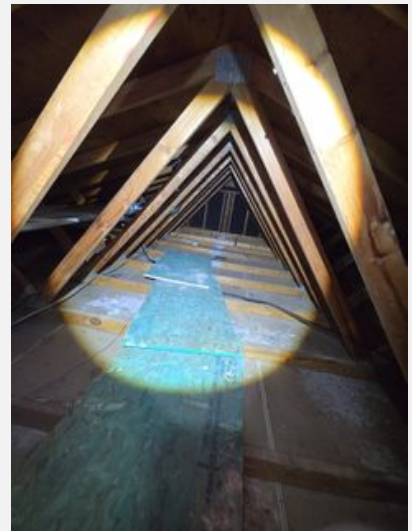
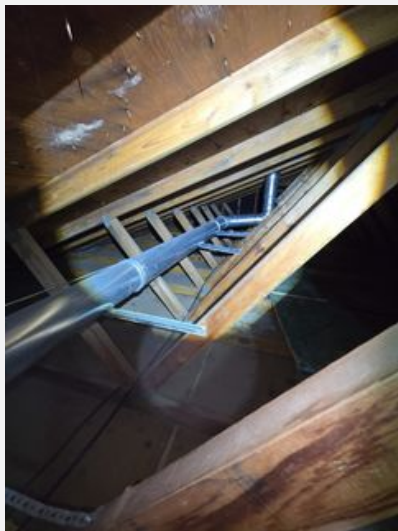
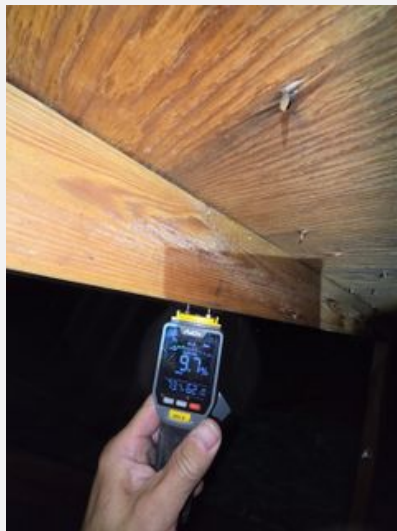
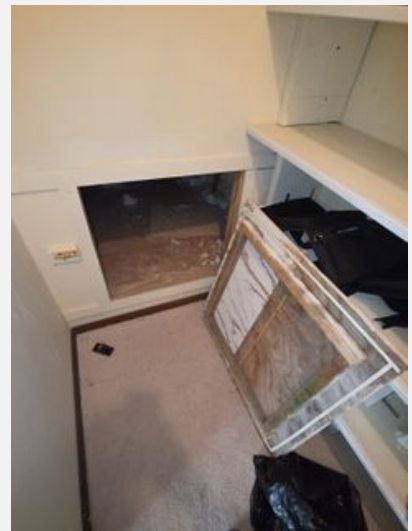
*Attic entrance inside second  
floor West bedroom closet knee  
wall*

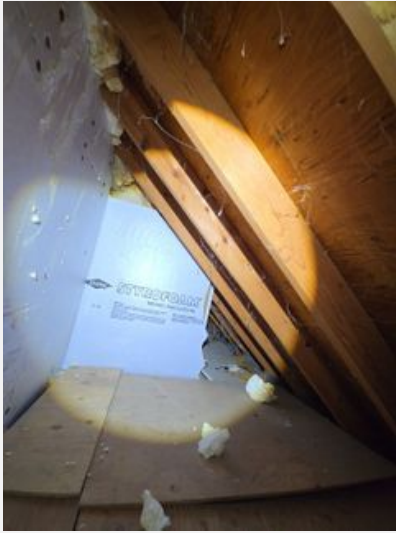
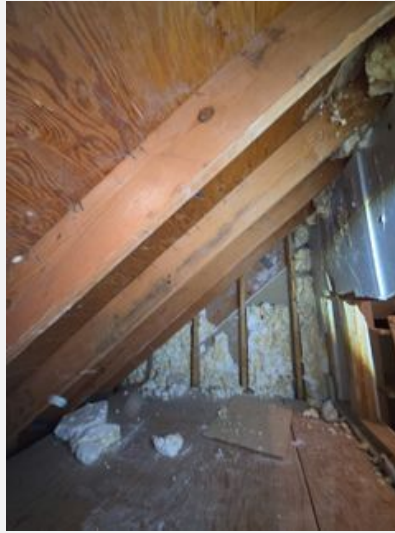
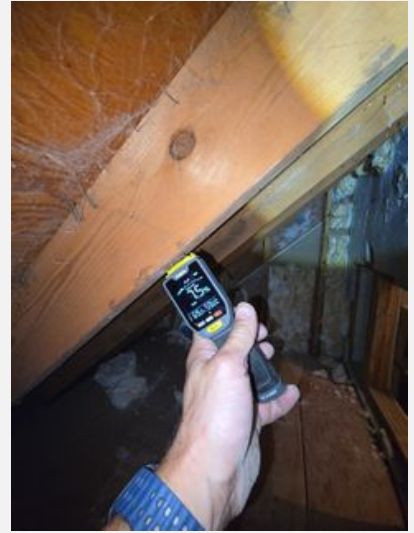
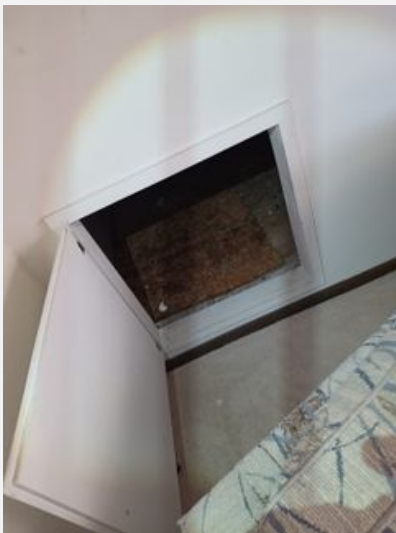
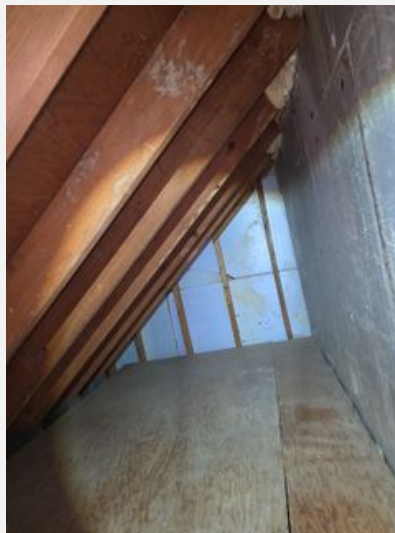
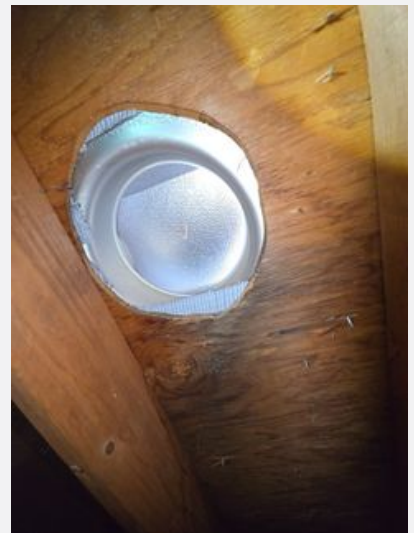
*Attic entrance from second floor  
West bedroom knee wall on the  
South Wall*

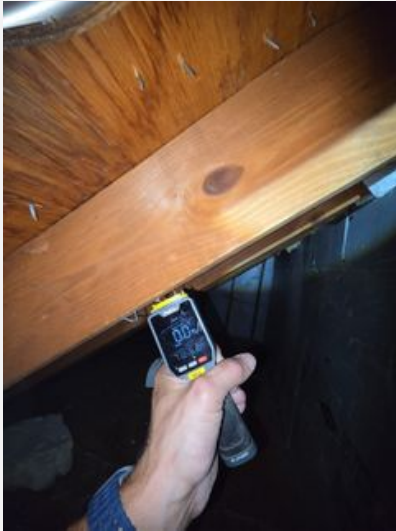
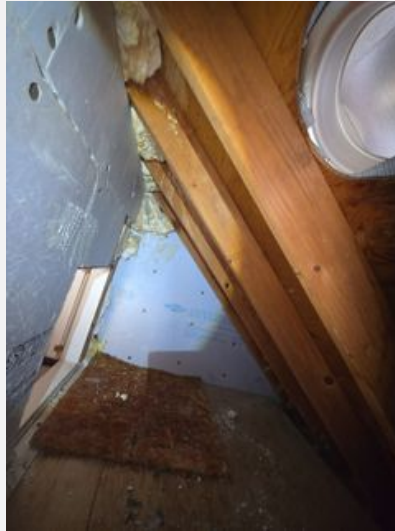
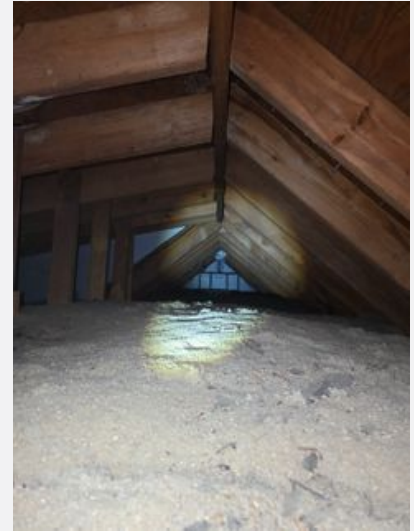
*Attic entrance/view from small 12-in X 12-in door in the Second floor east bedroom*

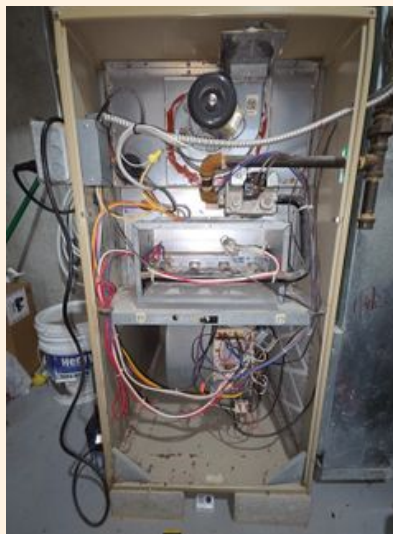
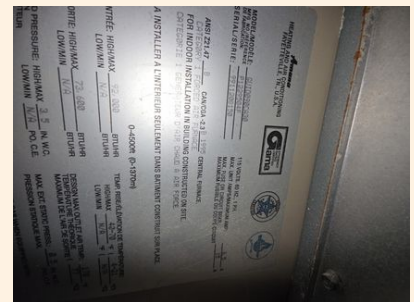
The forced-air gas furnace was manufactured in 1999 and is well beyond its typical service life expectancy. It was operating as intended and producing heat at the time of the inspection. Recommend budgeting for replacement while continuing routine maintenance.

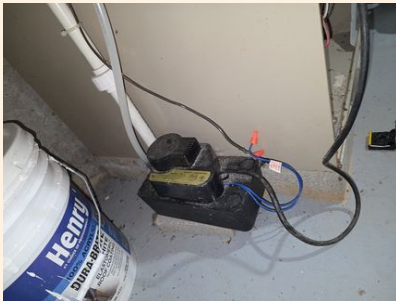
Condensate pump

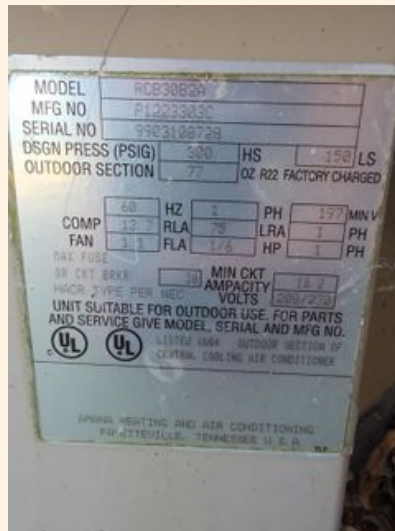
The central air conditioning system was manufactured in 1999 and is well beyond its typical service life expectancy. It was operating as intended at the time of the inspection, with a normal temperature drop confirmed using thermal imaging. Recommend budgeting for replacement while continuing routine maintenance.

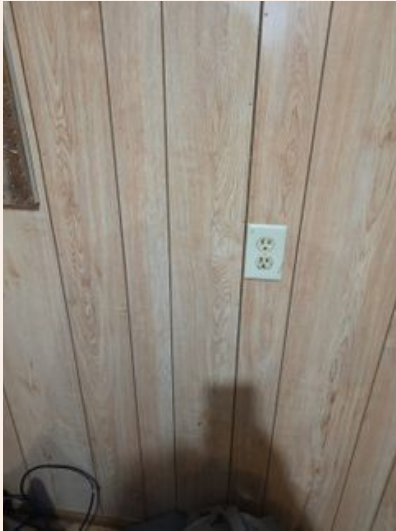
**(S-4) Repair:** 1 - Garage Receptacles Not GFCI Protected

*Attached garage Outlets are not GFCI protected*

Recommendation: Have a licensed contractor evaluate and repair as needed.

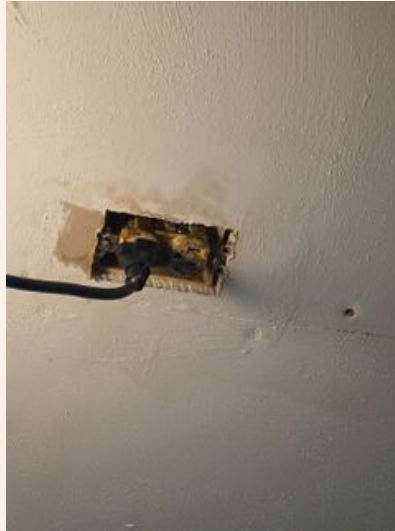
Problem: The garage door opener receptacle in the attached garage is missing its cover plate.

Effect: Exposed electrical components present a potential electrical safety hazard.

*Outlet for the garage door opener in the attached garage is missing a cover*

Recommendation: Have a licensed contractor evaluate and repair as needed.

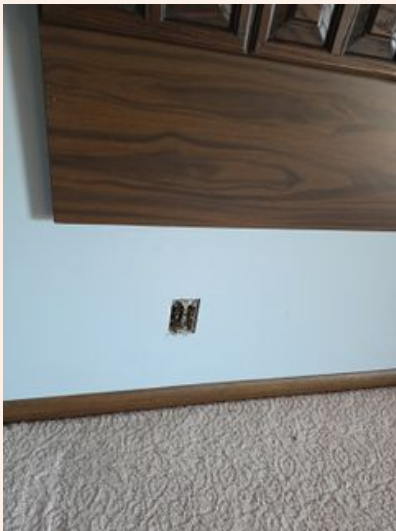
Problem: The receptacle on the east wall of the second-floor east bedroom is damaged and missing its cover plate.

Effect: Exposed and damaged electrical components present a potential electrical safety hazard.

*Damaged Outlet and missing cover in the second floor east bedroom on the East wall*

Recommendation: Have a licensed contractor evaluate and repair as needed.

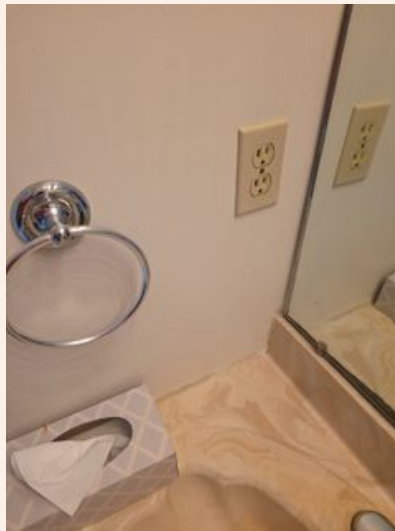
*Two outlets not GFCI protected in the second floor bathroom*

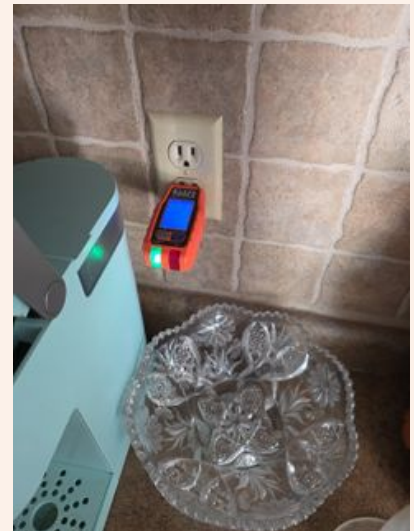
*Three kitchen countertop Outlets were not GFCI protected*

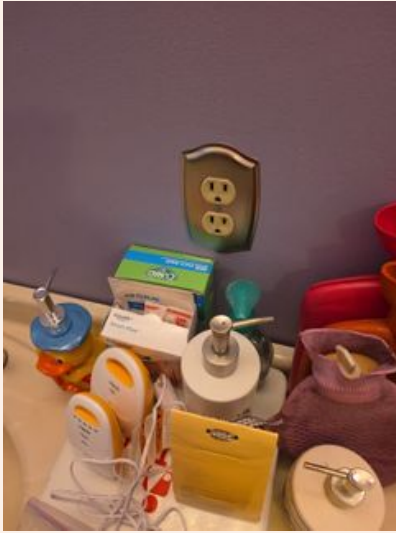
*Main floor hallway bathroom outlet is not GFCI protected*

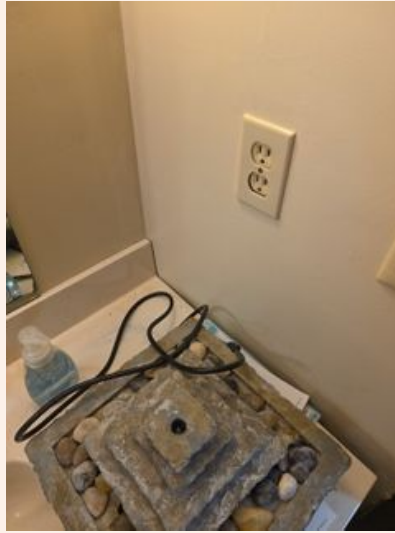
*Half bathroom basement Outlet not GFCI protected*

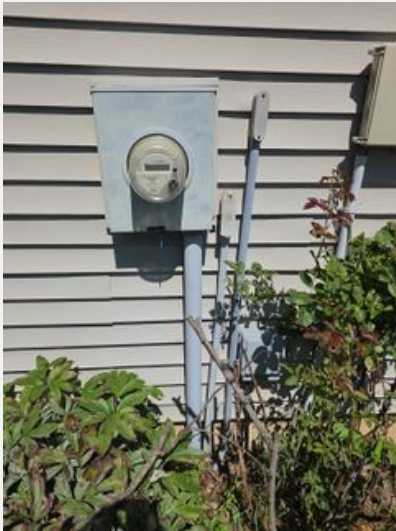
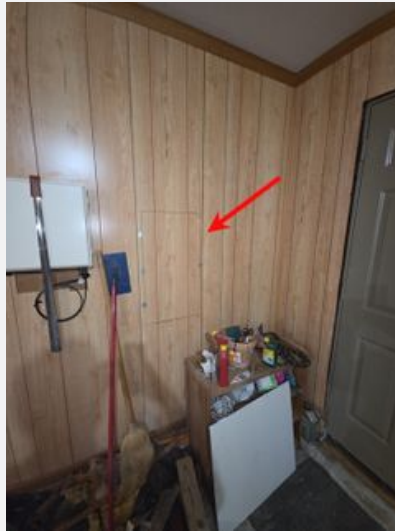
*Main Electric panel is hidden behind paneling door in the southwest corner of the attached garage*

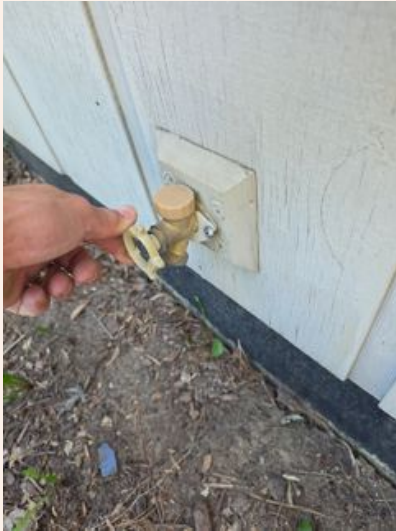
*Exterior water spigot on the front of the house was not working at the time of the inspection*

Recommendation: Have a licensed contractor evaluate and repair as needed.

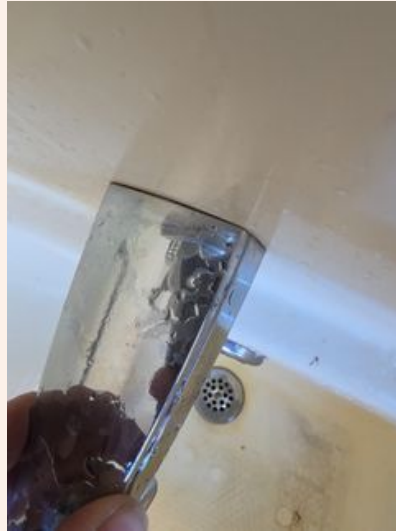
Effect: Water may enter the wall cavity, potentially causing concealed moisture damage.

*Second floor bathroom tub spout needs sealant between it and the wall or a small Gap can be seen*

Recommendation: Have a licensed contractor properly seal the gap as needed.

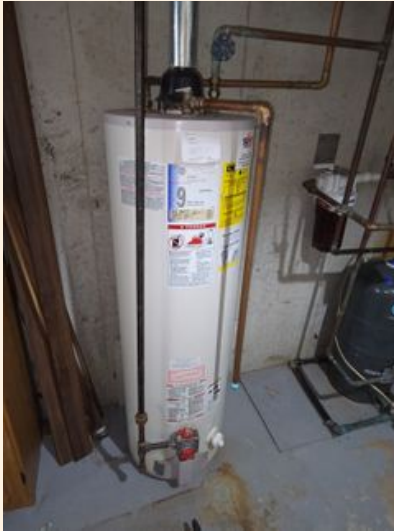
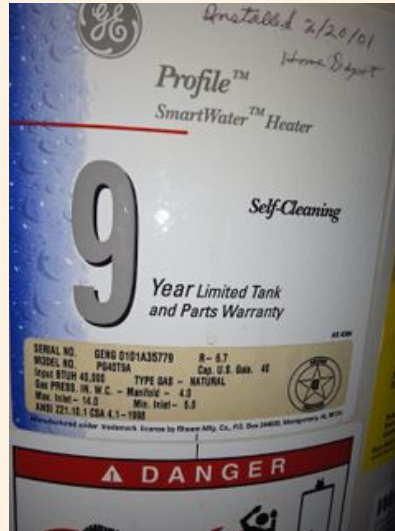
The gas water heater was manufactured in 2001 and is well beyond its typical service life expectancy. At the time of the inspection, it was operating as intended and supplying hot water. Although functional, its advanced age increases the likelihood of future repairs or replacement. Recommend budgeting for replacement while continuing to monitor the unit for signs of leakage or declining performance.
