FAMILYGUARD

HOME INSPECTION REPORT

2524 Lincroft Dr. Fort Wayne, IN 46845
Inspection Prepared For: Seller

Date of Inspection: 4/25/2023
Age of House: 27 Years
Weather: Recent Rain

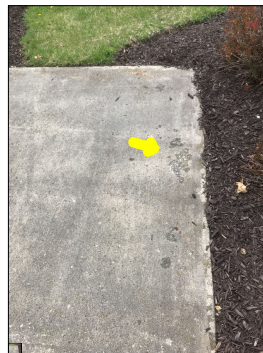
Pitting along the service walks.

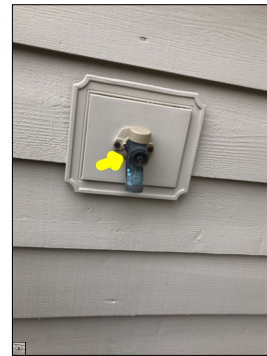
Inoperable hose bib.

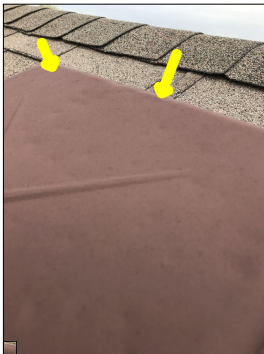
Dents along the roof vents. This is an indication of previous hail damage.

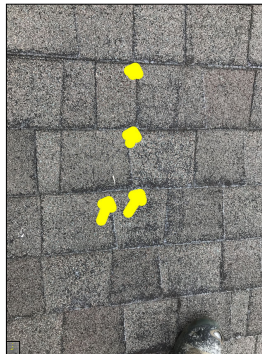
Granule loss along the roof shingles

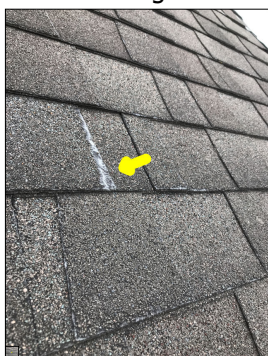
Granule loss along the roof shingles

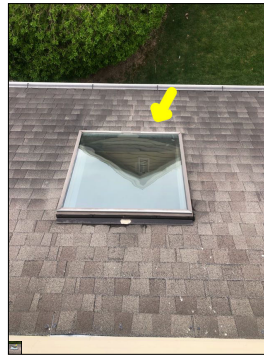
Please note - while skylights are an attractive feature for a home because of their ability to allow natural light into the house, skylights carry some disadvantages. Skylights are prone to leakage. Skylights are poor insulators. Skylights are prone to breaking/cracking during heavy storms, such as a hail storm. Skylights are prone to breaking/cracking from falling debris, such as a falling tree limb. Skylights are also prone to condensation during winter months because the warm air from within the house comes in contact with the cold surface of the skylight, thus creating condensation. An intermittent or active water source can cause mold growth. Homeowners sometimes mistake condensation along a skylight for a leak. FamilyGuard recommends annual maintenance on all skylights and unexpected repairs should be anticipated.

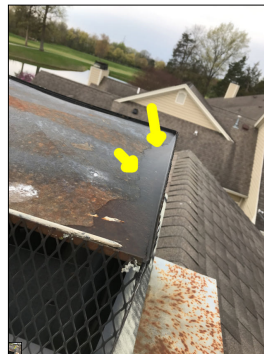
The top plate is holding water. Chimney top plates should be properly sloped, so they shed water. Failure to properly shed water can cause the top plate to prematurely deteriorate due to rust and corrosion. Also, leak points can arise due to a top plate not being sloped properly.

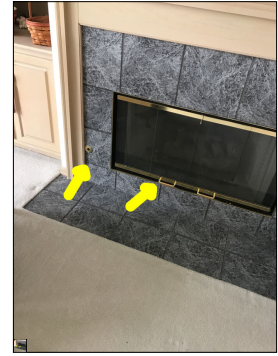
The fireplace is a gas fireplace. There is no apparent electronic ignition. It is beyond the scope of a general home inspection to light fuel burning appliances. Doing so could cause property damage. Recommend a licensed chimney/fireplace professional further evaluate to make sure the fireplace is in good working condition and safe to use.

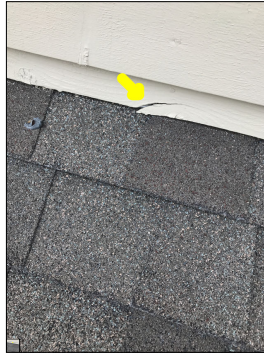
Gaps along the siding.

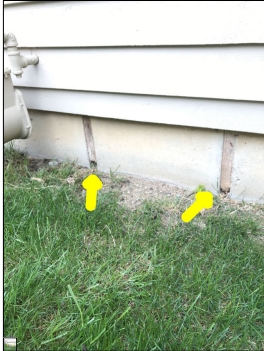
Wood to soil contact. This is not a recommended practice. Water and moisture from the soil/earth can wick up along the exterior and the water can be absorbed by interior building materials. Interior building material includes, but not limited to, drywall, insulation and framing. An active or intermittent water source can cause property damage, such as wood rot damage. Also, the wood to soil contact can enable the infestation of wood destroying insects, such as termites or powderpost beetles.

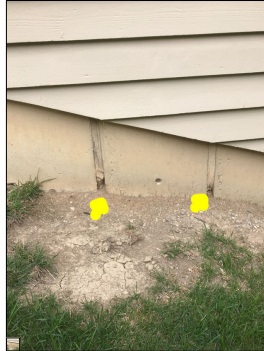
Wood to soil contact. This is not a recommended practice. Water and moisture from the soil/earth can wick up along the exterior and the water can be absorbed by interior building materials. Interior building material includes, but not limited to, drywall, insulation and framing. An active or intermittent water source can cause property damage, such as wood rot damage. Also, the wood to soil contact can enable the infestation of wood destroying insects, such as termites or powderpost beetles.

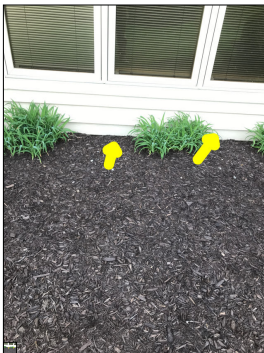
The siding is in proximity to the ground. Siding should have at least 6 to 8 inches of clearance above the ground. Maintaining proper clearances reduces access to wood structures behind the siding and helps preserve the house. The proper clearances help restrict access from wood destroying insects and/or moisture/water that might find its way behind the siding.

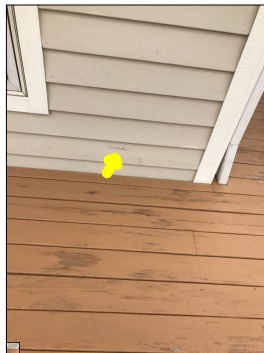
Damaged siding.

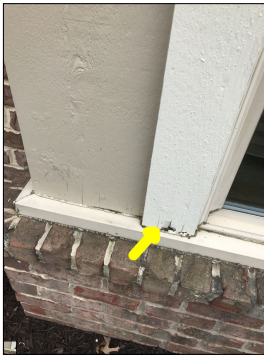
Gaps along the siding.

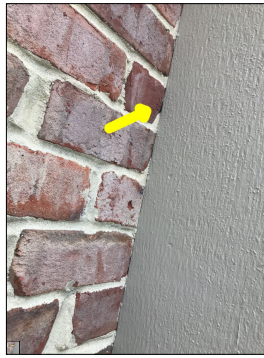
Gaps along the siding.

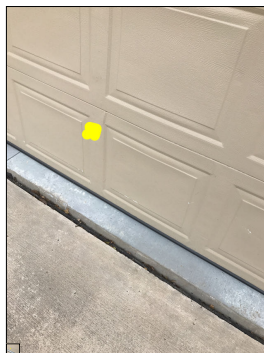
Dents/damage along the overhead garage door.

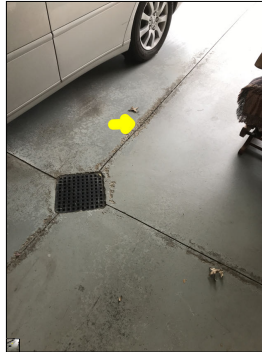
Pitting and deterioration along the floor.

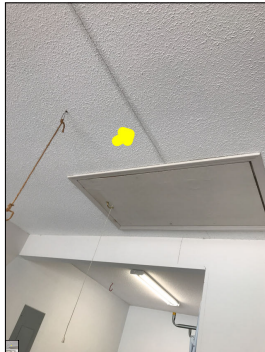
Cracks along the ceiling.

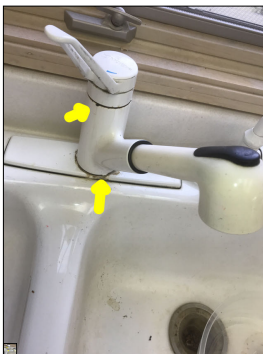
Corrosion along the faucet.

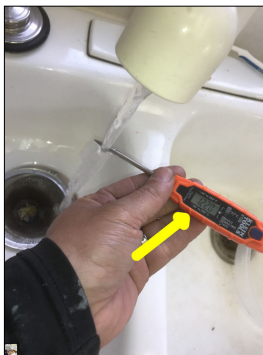
Temperature reading of the hot water during the time of the inspection. The approximate temperature of the hot water was 122 degrees Fahrenheit.

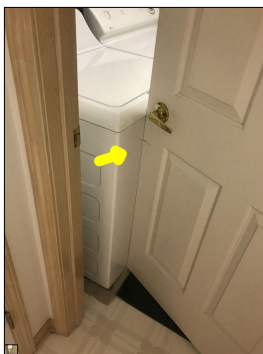
The washer restricts the door from closing.

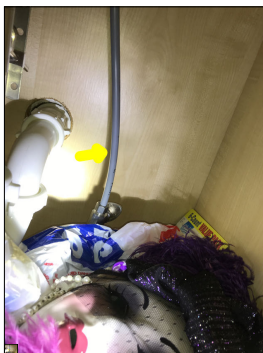
Polybutylene plumbing lines. Polybutylene pipes are prone to failure and no longer meet modern day plumbing standards. Recommend upgrading from polybutylene pipes to modern day plumbing materials, such as PEX or copper.

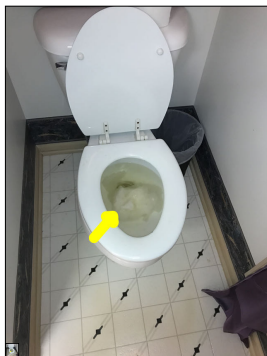
The toilet is clogged.

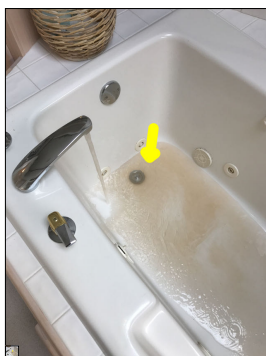
Discolored water. This is considered abnormal. The water cleared up after running for a few minutes.

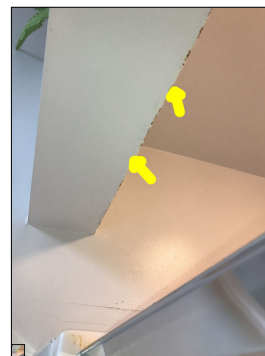
Discoloration along the ceiling.

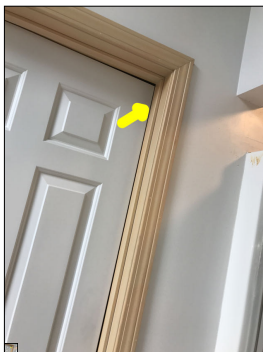
The door rubs the frame during operation.

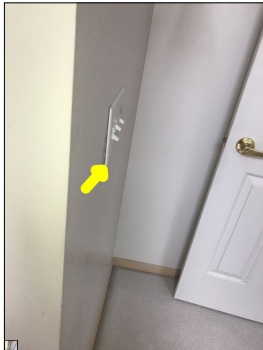
- GFCI protected receptacles
- Switch cover not flush with the wall

The switch cover is not flush with the wall. This is considered a defect and a potential safety hazard.

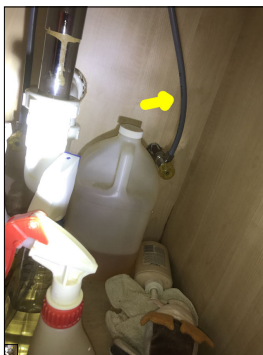
2. Sinks/Plumbing

Polybutylene plumbing lines. Polybutylene pipes are prone to failure and no longer meet modern day plumbing standards. Recommend upgrading from polybutylene pipes to modern day plumbing materials, such as PEX or copper. Please note, polybutylene pipes can be concealed behind walls, ceilings, etc.

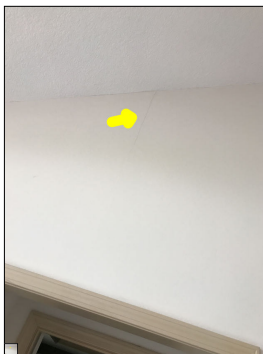
Findings:
• Cracks

Cracks along the walls.

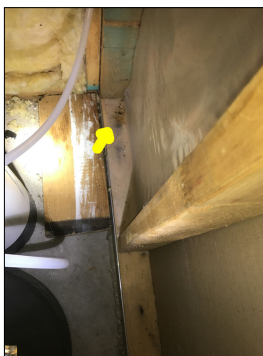
Mice/rodent droppings observed. Wildlife activity can cause property damage.

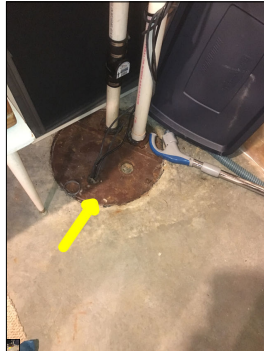
Rust/corrosion along the ejector pit lid. Rust and corrosion is considered a defect. An active or intermittent water source can cause rust and corrosion. Rust and corrosion can create holes in the lid, thus allowing sewer gases into the house. Sewer gases into the house is a potential safety hazard.

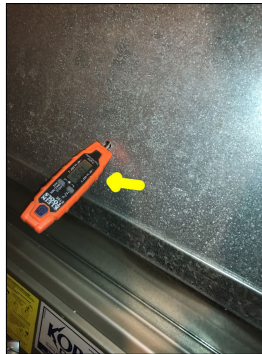
The photo identifies the temperature of the supply air while the furnace was in operation. The approximate temperature of the supply air was 135 degrees Fahrenheit.

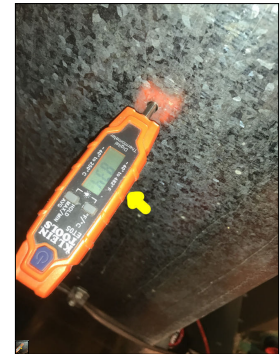
The photo identifies the temperature of the return air while the furnace was in operation. The approximate temperature of the return air was 83 degrees Fahrenheit.

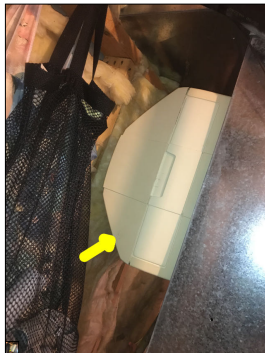
The whole house humidifier is inoperable. It never called for water.
