HOME INSPECTION REPORT

Inspector: Alex Bishop
License #: HI01600042

4942 Co Rd 100 E Anderson, IN 46013
Inspection Prepared For: Seller

Date of Inspection: 8/31/2025
Age of House: 55 Years
Weather: Clear

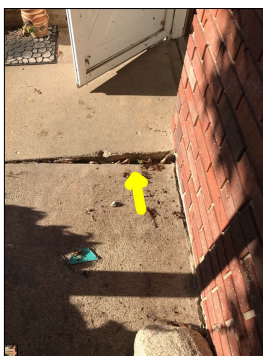
Uneven surfaces along the service walks.

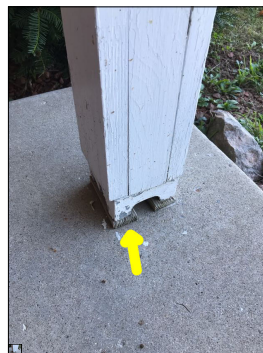
Unconventional shims underneath the column.

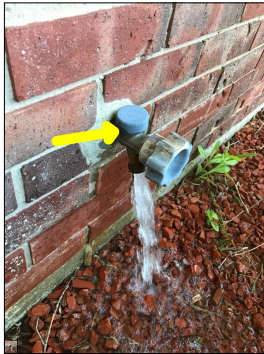
The hose bib leaks during operation. This is considered a defect.

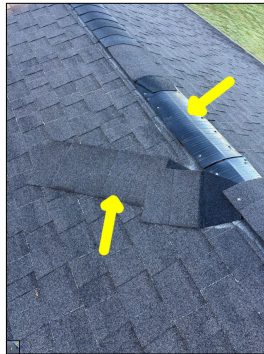
- Loose/detached roof shingles. This is considered a defect and a potential leak point.

Loose/detached roof shingles. This is considered a defect and a potential leak point.

- Displaced shingles
- Deterioration
- Recommend licensed roofer further evaluate and make necessary repairs

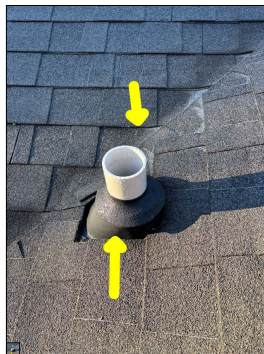
Unconventional flashing/roof penetration along the **valley**. This is considered abnormal and a potential leak point. The roof penetration is too close to the valley for modern day roofing standards. There should be at least 18 inches from side to side from the middle of the valley. Due to the unconventional location of the roof penetration, this area is a potential leak point.

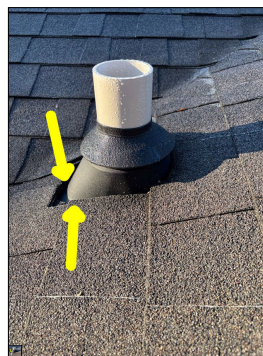
The flashing is unconventionally tucked underneath the shingles. The current installation of flashing is considered amateur craftsmanship. Amateur craftsmanship is prone to failure and leakage.

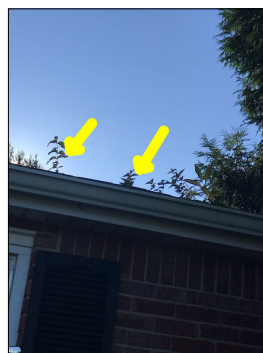
The gutter system is dirty and needs to be cleaned. A dirty gutter system can cause excessive water to accumulate around the house, thus potentially causing water intrusion into the house or potential foundation problems due to excessive hydrostatic pressure. Also, a dirty gutter system can cause excessive water to flow along the siding which could allow water to get behind the siding. An active or intermittent water intrusion source can cause mold growth and property damage.

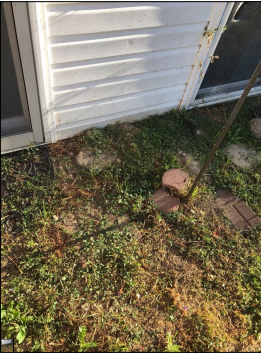
The siding is in proximity to the ground. Siding should have at least 6 to 8 inches of clearance above the ground. Maintaining proper clearances reduces access to wood structures behind the siding and helps preserve the house. The proper clearances help restrict access from wood destroying insects and/or moisture/water that might find its way behind the siding.

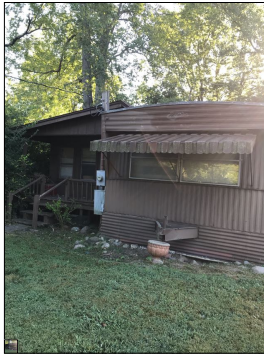
A trailer was observed on the property. The trailer appears to have been neglected for an extended period of time and its overall current condition is rated poor.

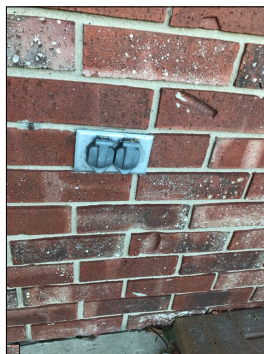
Non **GFCI** protected receptacles.

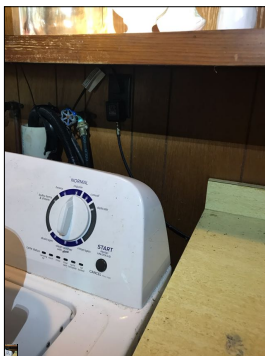
Non GFCI protected receptacles.

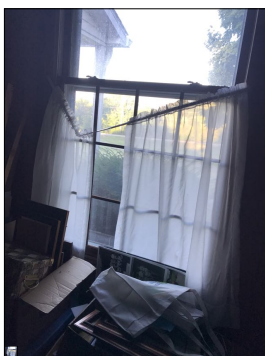
Aged windows.

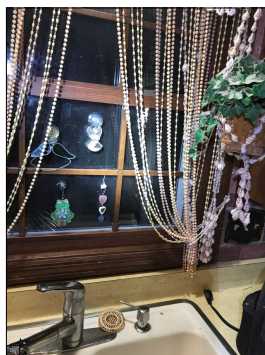
Inoperable window. The window might open with excessive force. Please note, a properly functioning window should be able to easily open.

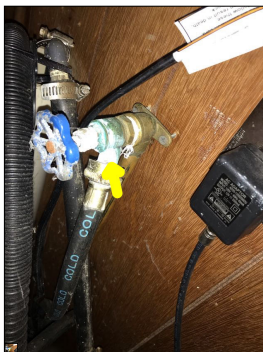
Rust/corrosion along the washer hook up lines.

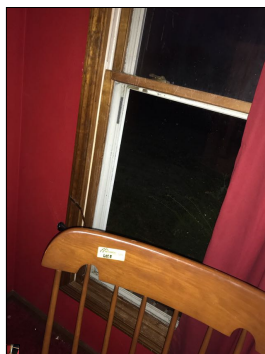
Aged windows.

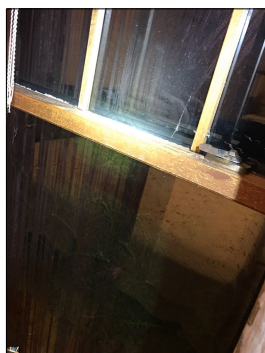
Aged windows.

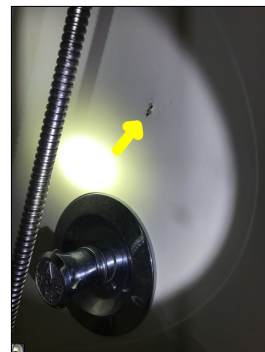
Damage along the bathtub.

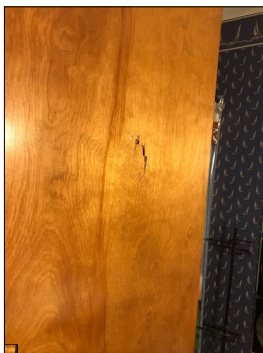
Damage/dents along the door.

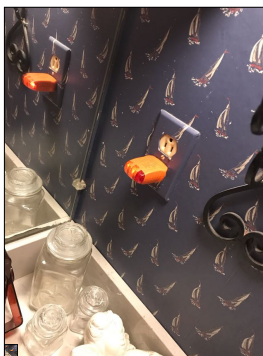
Non GFCI protected receptacles.

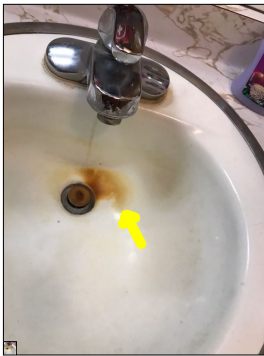
Discoloration along the sink.

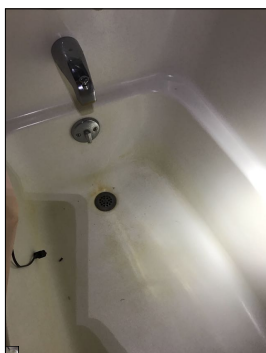
Discoloration along the bathtub.

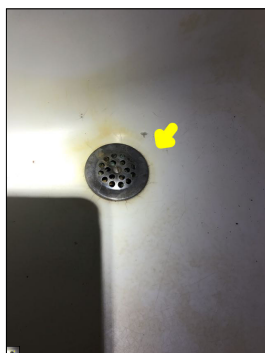
Cracks along the bathtub.

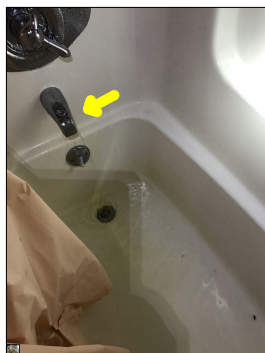
The diverter rod does not drop when the showerhead is turned off. This is considered abnormal and a defect. Unless the diverter rod is manually disengaged when turning the showerhead off, the next person to turn the bathtub faucet on will receive water from the showerhead.

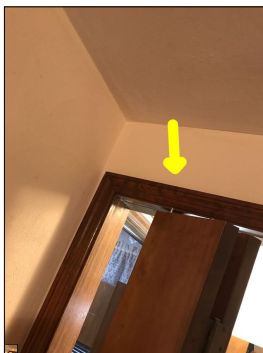
The door is detached.

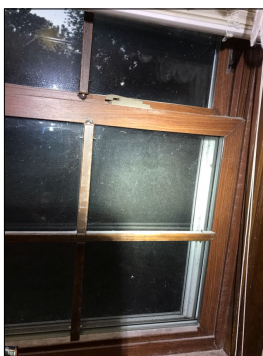
The window grids are loose/detached.

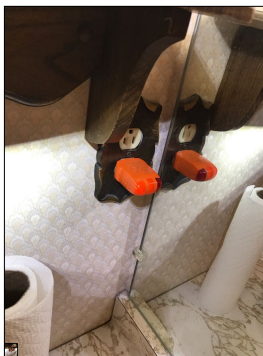
Non GFCI protected receptacles.

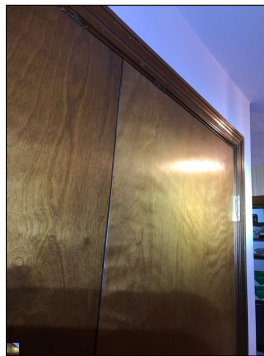
The doors rubs each other during operation.

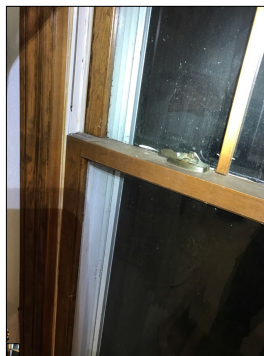
Aged windows.

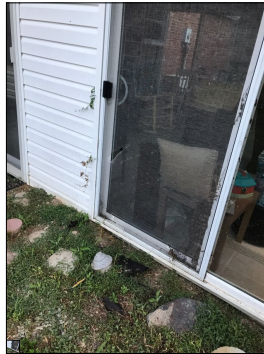
Torn screen along the door.

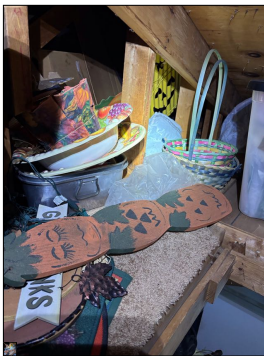
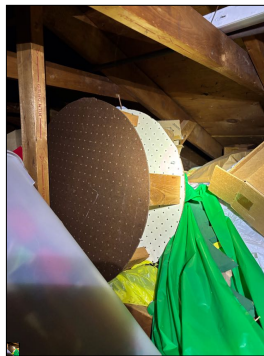
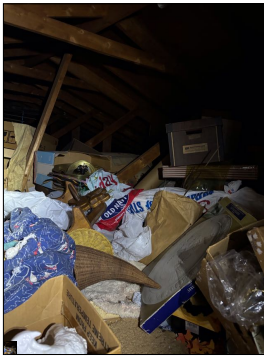
Debris and clutter within the attic. Visibility and accessibility were limited.

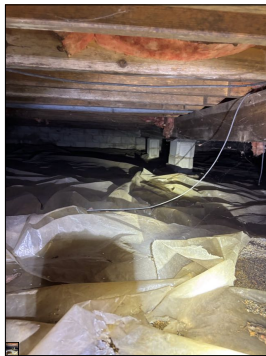
- Water/moisture observed in the crawl space.

General photo of the crawl space.

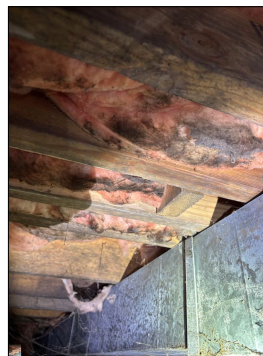
Discoloration along the insulation. Discoloration can potentially be a mold like substance.

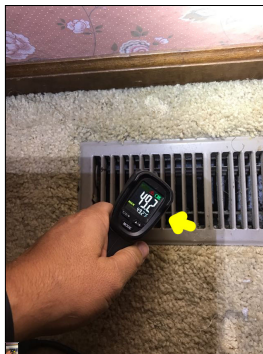
- The temperature drop for the air conditioning was approximately 17 degrees Fahrenheit.
- Needs cleaning/serviced
- No current service record
- Service recommended

The photo identifies the temperature of the supply air while the air conditioner was in operation. The approximate temperature of the supply air was 49 degrees Fahrenheit.

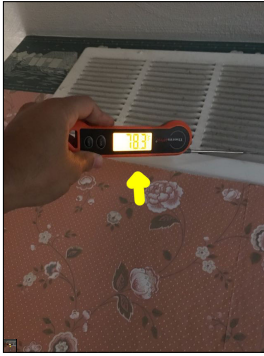
The photo identifies the temperature of the return air while the heat pump was in operation. The approximate temperature of the return air was 78 degrees Fahrenheit.

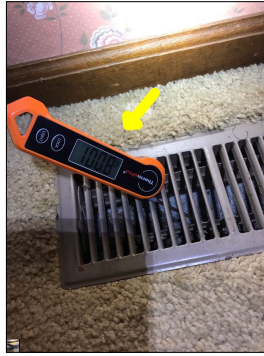
- The temperature rise for the furnace was approximately 18 degrees Fahrenheit.
- No current service record
- Service recommended
- Furnace needs cleaning
- Ductwork needs cleaning
- The temperature rise for the heat pump was approximately 18 degrees Fahrenheit.

The photo identifies the temperature of the supply air while the furnace was in operation. The approximate temperature of the supply air was 100 degrees Fahrenheit.

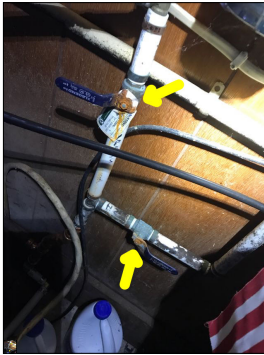
Corrosion and rust along the valves.

- Limited visibility
- Rust/Corrosion
- Hot water present
- Please review entire report
- Recommend licensed plumber further evaluate and make necessary repairs.

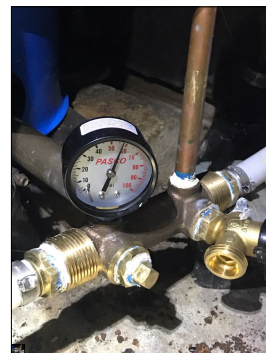
The well pressure was approximately 58 PSI during the inspection.

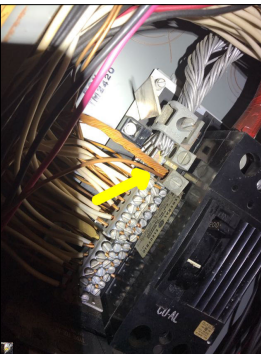
Different gauge wires within the same terminal. This is a potential safety hazard. The different size wires within the terminal can create a poor connection, thus causing spark, arcing and/or fire.

- Recommend licensed electrician further evaluate and make necessary repairs
