# **FAMILYGUARD**

## **HOME INSPECTION REPORT**

**5707 Chester Blvd. Fort Wayne, IN 46819**  
**Inspection Prepared For: Seller**

**Date of Inspection: 10/5/2025**  
**Age of House: 69 Years**  
**Weather: Clear**

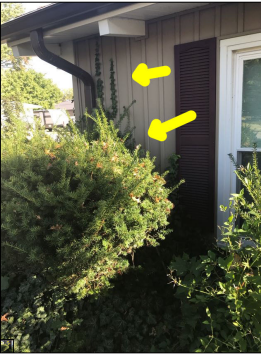
Vegetation against the siding/in proximity of the siding. This is not a recommended practice. Vegetation has the potential to harbor insects, wood destroying insects, rodents and hold moisture. Insects, wood destroying insects, rodents and moisture have the potential to create future problems for a house, such as structural damage, pest infestation and wood rot damage.

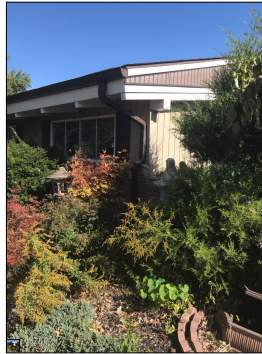
Vegetation against the siding/in proximity of the siding. This is not a recommended practice. Vegetation has the potential to harbor insects, wood destroying insects, rodents and hold moisture. Insects, wood destroying insects, rodents and moisture have the potential to create future problems for a house, such as structural damage, pest infestation and wood rot damage.

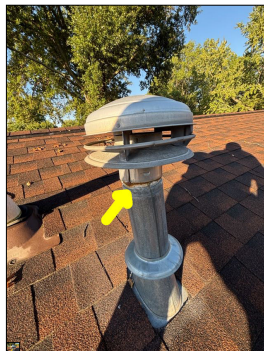
Rust and corrosion along the flue. Rust and corrosion can create holes along the flue, thus creating potential leak points.

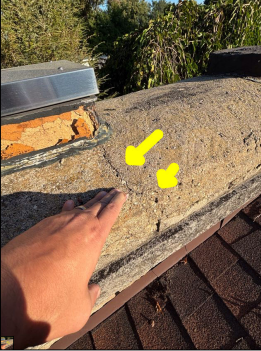
Cracks along the chimney. Cracks are considered defects and potential leak points.

- Recommend chimney professional further evaluate and make necessary repairs
- Before using the fireplace, it is recommended that a licensed chimney/fireplace professional further evaluate to ensure the fireplace is in good working condition and is safe for usage.

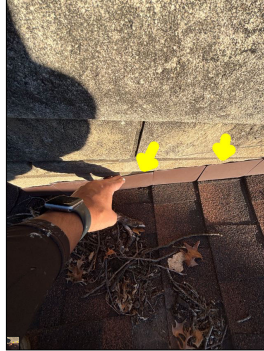
The flashing is not properly cut into the chimney. The flashing should be cut into the chimney and sealed to prevent leakage. The current flashing along the chimney is considered subpar and amateur craftsmanship. Amateur craftsmanship is prone to failure and leakage.

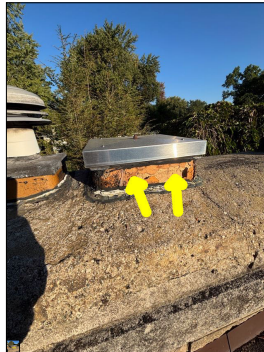
Cracks along the clay tile. Cracks along the clay tiles are a potential safety hazard. Cracked tiles can cause the chimney to not draft properly, thus potentially causing carbon monoxide to enter the house or potentially cause a fire.

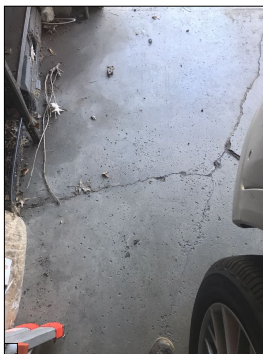
Cracks and deterioration along the floor.

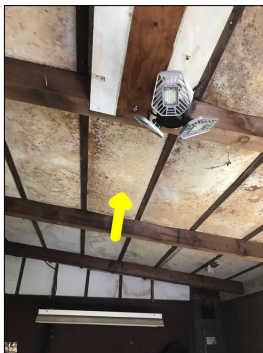
Discoloration along the ceiling. Discoloration along the ceiling is considered abnormal and a defect. An active or intermittent water source can cause discoloration, mold growth and property damage.

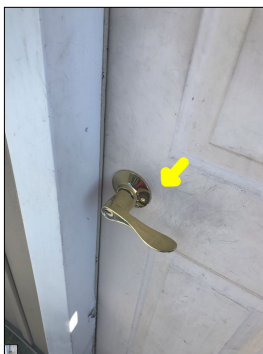
The handle is loose.

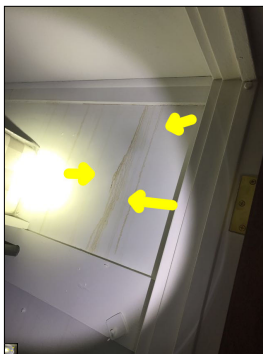
Discoloration along the wall and signs of previous water damage. An active or intermittent water source can cause mold growth and property damage.

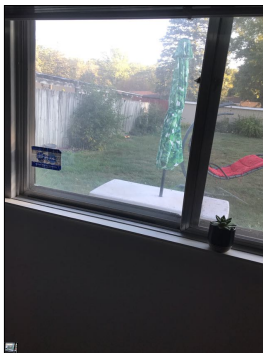
Aged windows.

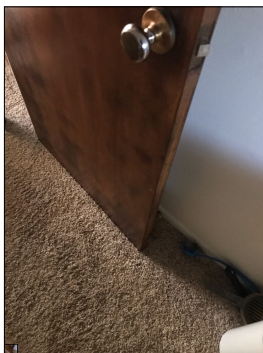
The door drags the floor during operation.

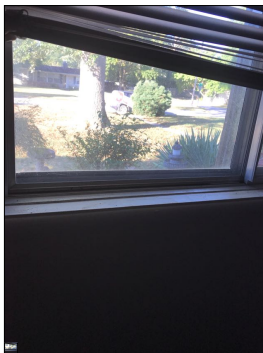
Aged windows.

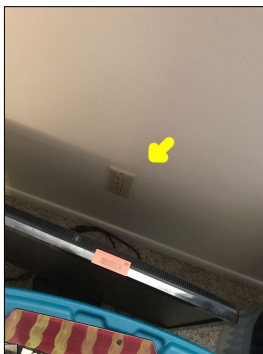
Two prong receptacles. Two prong receptacles are not grounded.

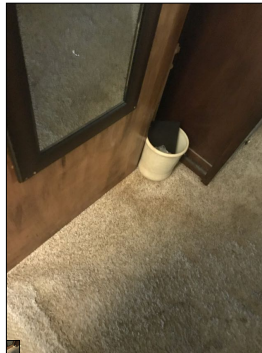
The door drags the floor during operation.

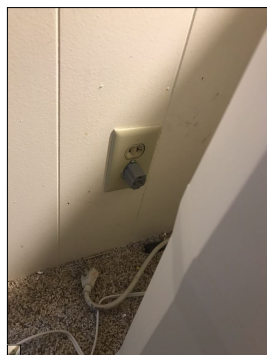
Two prong receptacles. Two prong receptacles are not grounded.

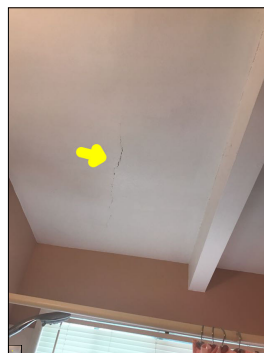
Discoloration along the ceiling.

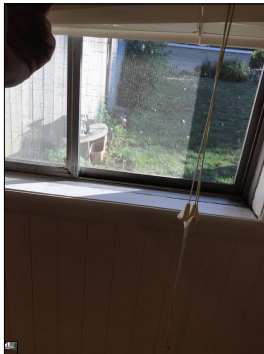
Aged window.

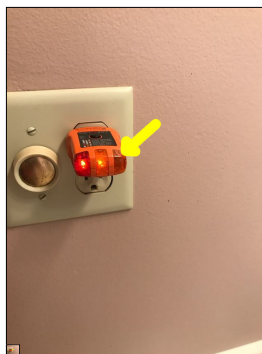
The receptacle has reverse polarity.

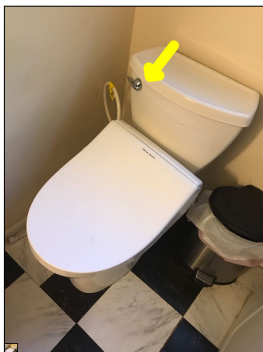
Inoperable toilet.

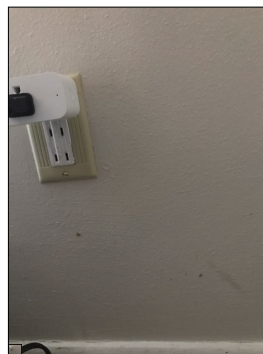
Two prong receptacles. Two prong receptacles are not grounded.

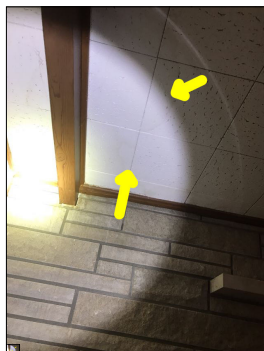
Discoloration along the ceiling and signs of previous water damage. An active or intermittent water source can cause mold growth and property damage.

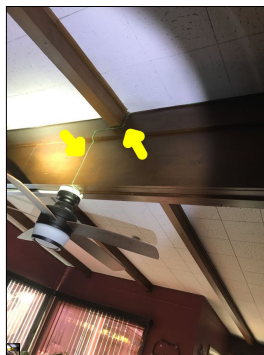
Unconventional exposed wires routed to the ceiling fan. This is considered abnormal and amateur craftsmanship. Wires should be wrapped in conduit or be concealed behind building materials, such as drywall.

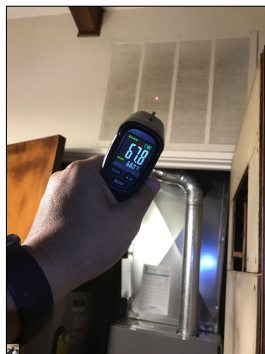
The photo identifies the temperature of the return air while the air conditioner was in operation. The approximate temperature of the return air was 67 degrees Fahrenheit.

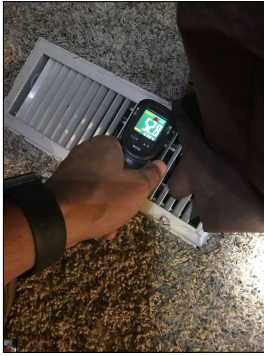
The photo identifies the temperature of the supply air while the air conditioner was in operation. The approximate temperature of the supply air was 52 degrees Fahrenheit.

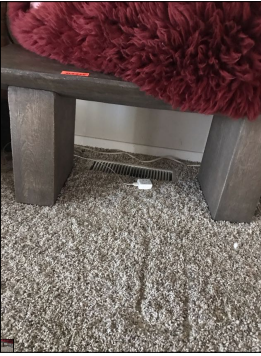
Please note, the house has sub slab HVAC ductwork. Sub slab ductwork can potentially allow water intrusion from the ground. Ground water entering into the ductwork can cause air quality problems and can hinder the performance of the heating and cooling systems. Also, sub slab ductwork can potentially increase indoor radon levels, allow the intrusion of insects, allow the intrusion of wood destroying insects and the intrusion of mice and other rodents.
