FAMILYGUARD

HOME INSPECTION REPORT

1780 S 11th St. Albion, IN 46701
Inspection Prepared For: Seller

Date of Inspection: 12/5/2025
Age of House: 53 Years
Weather: Recent Snow

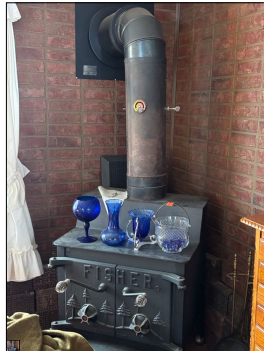
- Needs cleaning/serviced
- Before using the fireplace, it is recommended that a licensed chimney/fireplace professional further evaluate to ensure the fireplace is in good working condition and is safe for usage.

General photo of the fireplace .

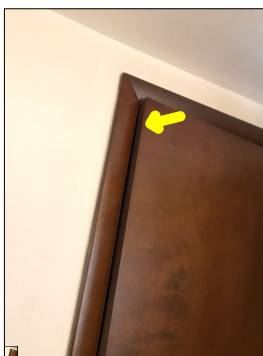
The door does not properly close.

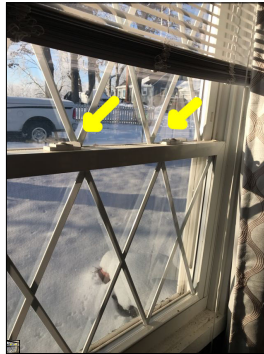
The window latches do not unlock. Therefore, making the window inoperable.

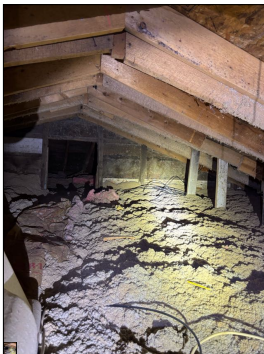
- **Mold like substance along the sheathing/framing. An active or intermittent water source can cause mold growth and property damage, such as wood rot damage.**

General photo of the attic.

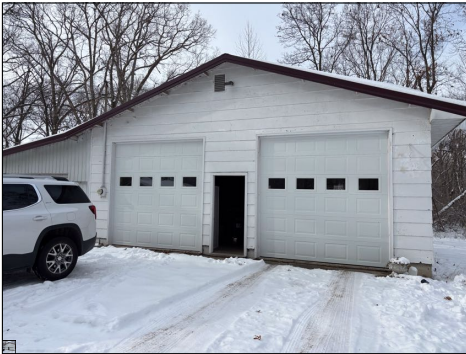
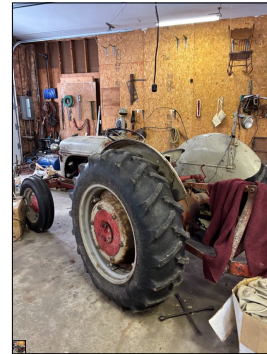
Photo 1A. Interior view of the pole barn.

General photo of the pole barn. Pole barns are not thoroughly inspected as they are not considered part of the house and are outside the scope of a general home inspection. However, an informal walk around was conducted through the pole barn. Nothing the inspector observed within the pole barn was worthy of notating it in the home inspection report. On the day of the inspection, the furnace within the pole barn was in good working condition and the electricity was in good working condition. Please see photo 1A for an interior view of the pole barn.

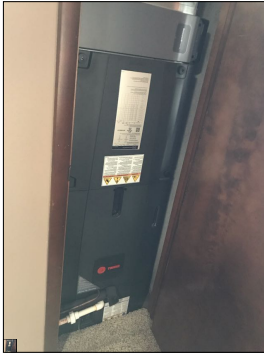
- The temperature rise for the furnace was approximately 14 degrees Fahrenheit.
- The temperature rise for the heat pump was approximately 10 degrees Fahrenheit.
- No current service record
- Service recommended
- Ductwork needs insulation
- Please note, there is no indication that the furnace or air conditioning has experienced annual routine preventative maintenance. It is recommended that appliances have annual maintenance to prolong the life of the appliance, ensure the appliances are operating at optimal performance, keep warranties valid and help avoid unexpected/costly repairs.

Furnace.

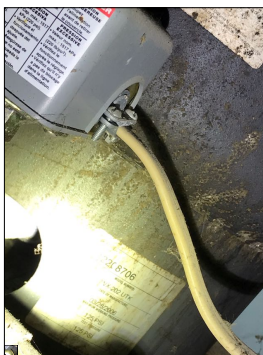
The approximate manufacture date of the pressure tank is 2006
