HOME INSPECTION REPORT

615 Whitelock St. Huntington, IN 46750
Inspection Prepared For: Seller

Date of Inspection: 12/13/2025
Age of House: 125 Years
Weather: Cold & Dry

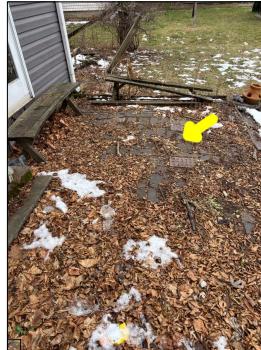
4. Patio/Deck

Uneven surfaces along the patio.

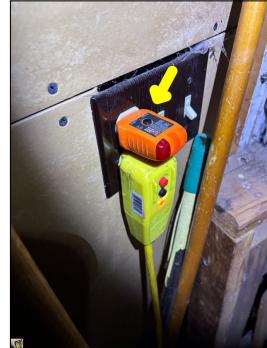
Non GFCI protected receptacles.

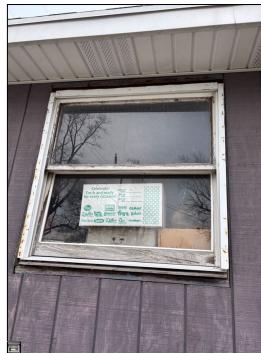
10. Windows

Aged windows.

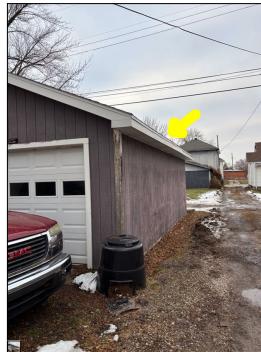
11. Gutters

The gutter system is missing. The lack of a gutter system can allow excessive water to accumulate around the foundation. Excessive water around the foundation can cause water intrusion into the house and potential foundation problems due to excessive hydrostatic pressure.

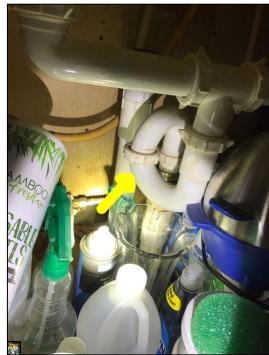
Unconventional trap underneath the sink. Unconventional traps have the potential to siphon and become dry, thus creating the potential to allow sewer gases into the house.

Unconventional traps have the potential to make a knocking/gurgling sound when draining.

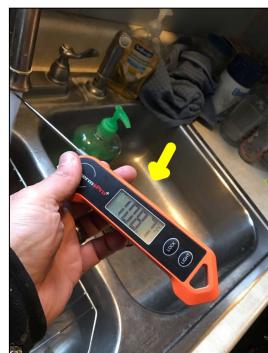
Temperature reading of the hot water during the time of the inspection. The approximate temperature of the hot water was 108 degrees Fahrenheit.

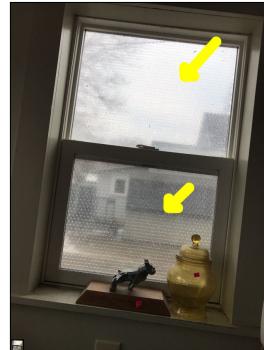
8. Windows

Unconventional bubble wrap along the windows. This is considered abnormal.

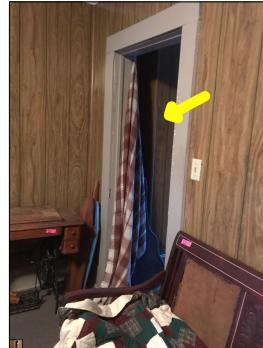
4. Doors

Missing doors.

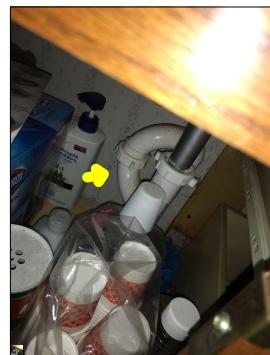
Unconventional trap underneath the sink. Unconventional traps have the potential to siphon and become dry, thus creating the potential to allow sewer gases into the house. Unconventional traps have the potential to make a knocking/gurgling sound when draining.

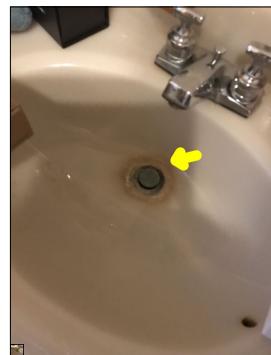
Discoloration along the sink.

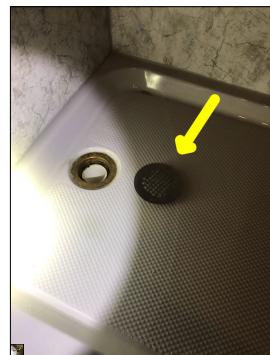
The grate is detached.

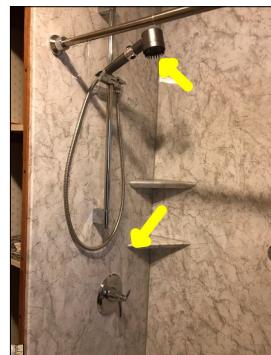
The showerhead is inoperable.

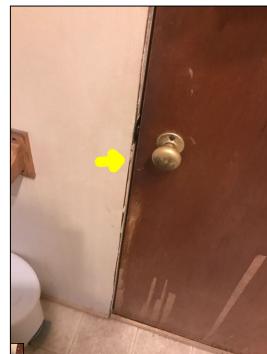
7. Doors

The door does not latch properly.

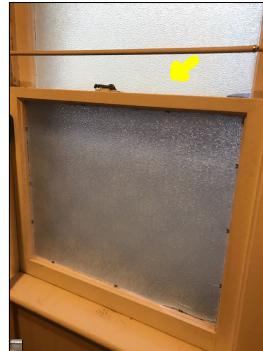
8. Windows

Aged window.

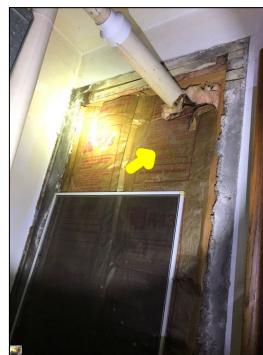
2. Walls/Ceiling

Unfinished walls.

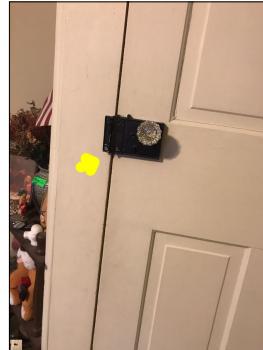
5. Doors

The door does not latch properly.

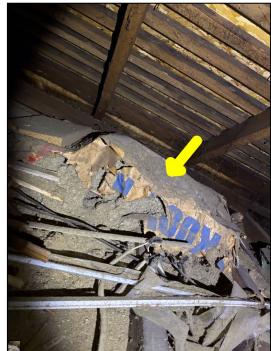
Debris and clutter within the attic. Visibility and accessibility were limited.

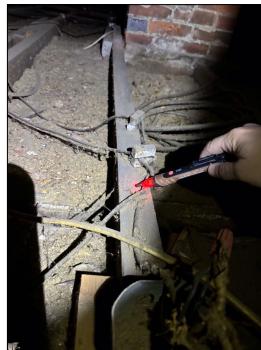
Page 32 Item: 7	Electrical	<ul style="list-style-type: none">• Traces of knob and tube wiring with voltage detected. Knob and tube wiring is a potential safety hazard and does not meet modern day electrical standards. Upgrading from knob and tube wiring is recommended. Please note, additional knob and tube wiring can be concealed behind walls, ceilings, etc. Recommend licensed electrician further evaluate and make necessary repairs.
-----------------	------------	---

Traces of knob and tube wiring with voltage detected. Knob and tube wiring is a potential safety hazard and does not meet modern day electrical standards. Upgrading from knob and tube wiring is recommended. Please note, additional knob and tube wiring can be concealed behind walls, ceilings, etc. Recommend licensed electrician further evaluate and make necessary repairs.

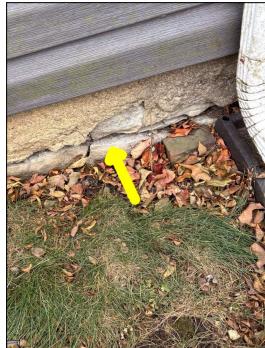
Field stone foundation. Field stone foundation are considered aged and no longer meet modern day standards.

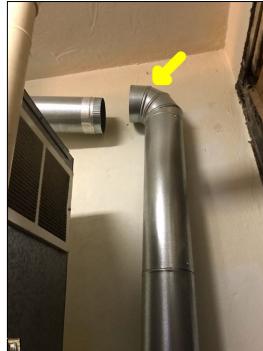
Detached ductwork.

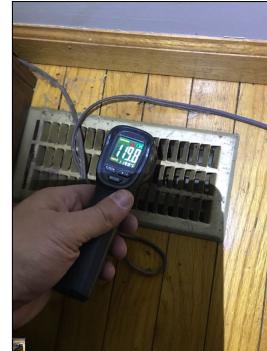
- The temperature rise for the furnace was approximately 45 degrees Fahrenheit.

The photo identifies the temperature of the supply air while the furnace was in operation. The approximate temperature of the supply air was 118 degrees Fahrenheit.

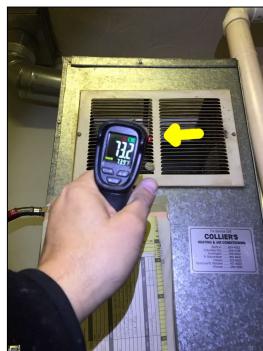
The photo identifies the temperature of the return air while the furnace was in operation. The approximate temperature of the return air was 73 degrees Fahrenheit.

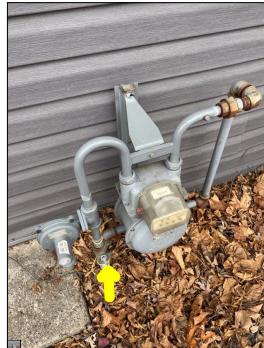
Main fuel shut off valve.

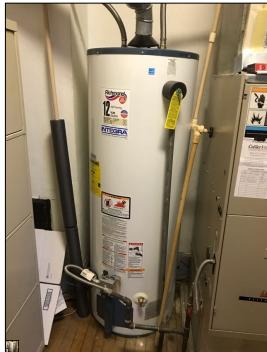
Water heater.

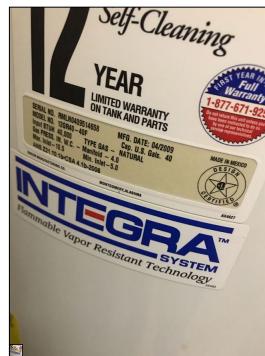
Water heater data plate.
