# **FAMILYGUARD**

## **HOME INSPECTION REPORT**

**3185 S. Golden Lake Rd. Pleasant Lake, IN 46779**  
**Inspection Prepared For: Seller**

**Date of Inspection: 6/25/2026**  
**Age of House: 38 Years**  
**Weather: Clear**

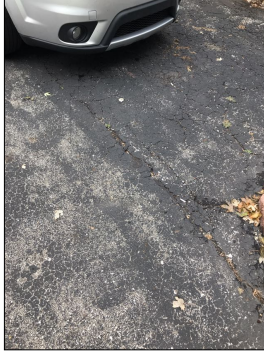
Cracks and deterioration along the driveway.

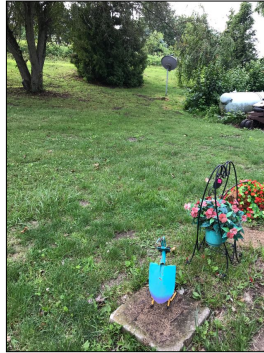
Negative sloped grade. A negative sloped grade is not a recommended practice. A negative sloped grade can cause excessive water to flow towards the house. Excessive water towards the house can cause water intrusion into the house and potential foundation problems due to excessive hydrostatic pressure.

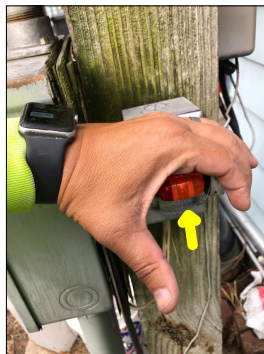
Reverse polarity receptacle.

- Recommend licensed electrician further evaluate and make necessary repairs.

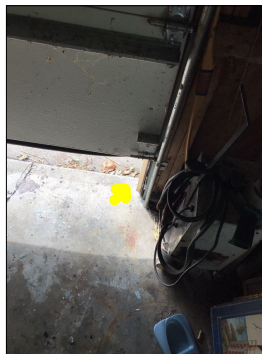
No photo eye sensors. The lack of photo eye sensors is a potential safety hazard.

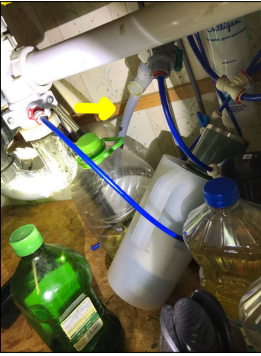
Polybutylene plumbing lines. Polybutylene pipes are prone to failure and no longer meet modern day plumbing standards. Recommend upgrading from polybutylene pipes to modern day plumbing materials, such as PEX or copper. Please note, polybutylene pipes can be concealed behind walls, ceilings, etc.

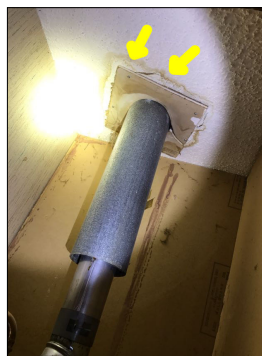
Discoloration along the ceiling and signs of previous water damage. An active or intermittent water source can cause mold growth and property damage.

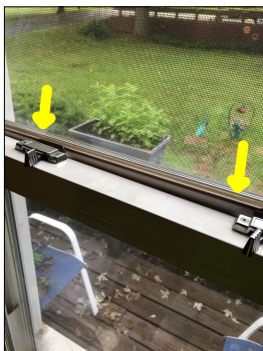
The lock does not catch the latch keeper.

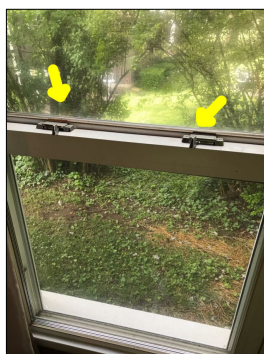
The lock does not catch the latch keeper.

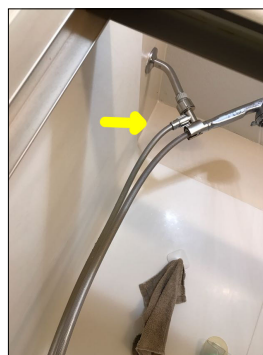
The showerhead leaks during operation.

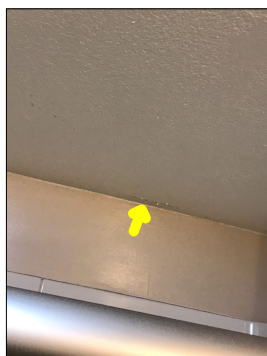
Flaking and peeling along the ceiling.

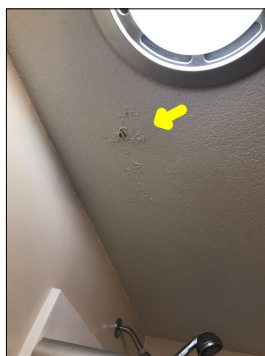
Flaking and peeling along the ceiling.

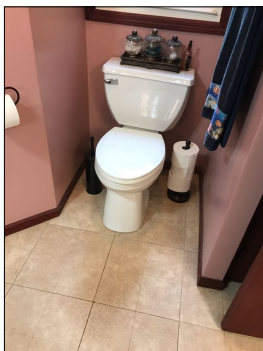
The toilet is loose. The toilet rocks back and forth. A toilet should not have any movement and be fully anchored and secured to the floor.

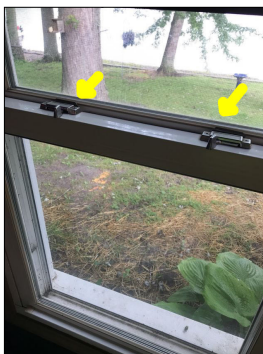
The lock does not catch the latch keeper.

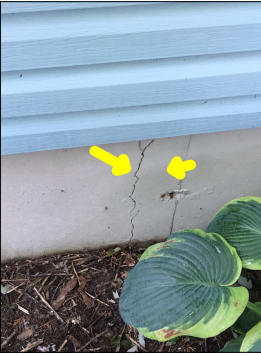
Crack along the foundation. Cracks are considered a defect. Cracks should be repaired/sealed to prevent the intrusion of moisture, insects, wood destroying insects, mice, and radon.

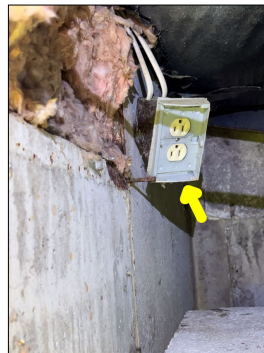
Loose electrical components. This is considered abnormal and a defect. Electrical components should be properly mounted and secured.

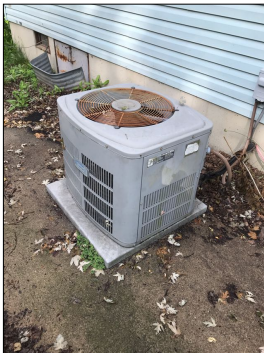
Condenser.

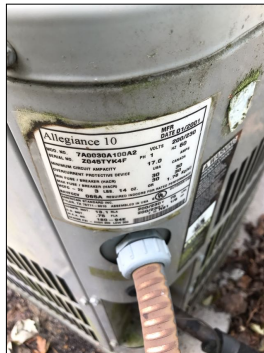
Condenser data plate.

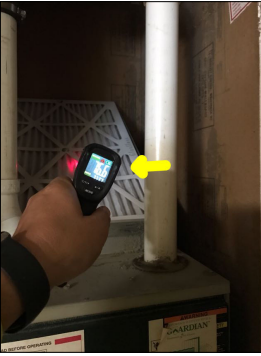
The photo identifies the temperature of the return air while the furnace was in operation. The approximate temperature of the return air was 76 degrees Fahrenheit.

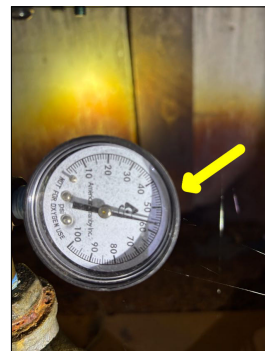
The well pressure was approximately 55 PSI during the inspection.

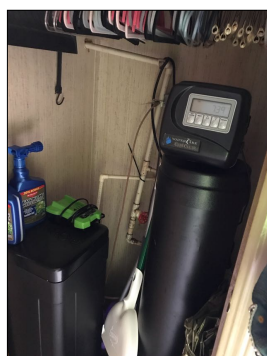
Water softener.

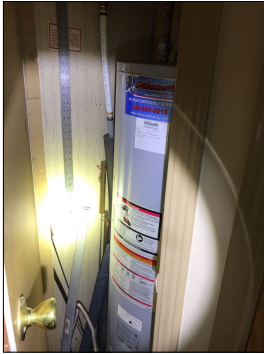
Water heater.

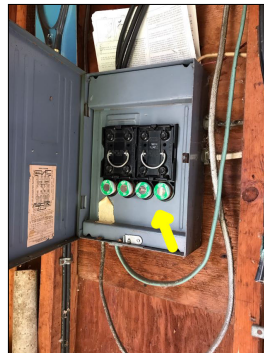
The electrical panel is an aged fuse panel. Fuse panels no longer meet modern day electrical standards and are considered a safety hazard due to their age. Recommend upgrading from the fuse panel to a modern day circuit breaker panel.
