# **FAMILYGUARD**

## **HOME INSPECTION REPORT**

**3643 Westport Dr. New Haven, IN 46774**  
**Inspection Prepared For: Seller**

**Date of Inspection: 8/8/2026**  
**Age of House: 22 Years**  
**Weather: Overcast**

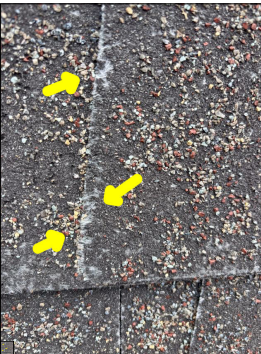
Exposed fiberglass mat along the shingles. This is a sign of deterioration along the roof.

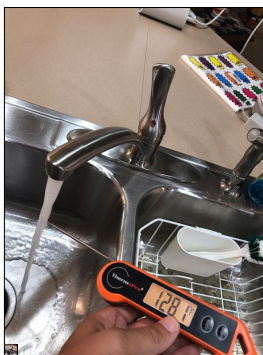
Temperature reading of the hot water during the time of the inspection. The approximate temperature of the hot water was 128 degrees Fahrenheit.

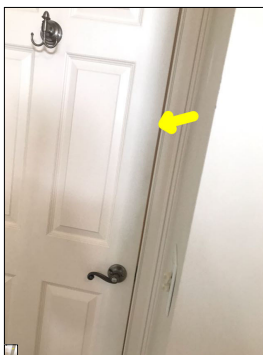
The door rubs the frame during operation.

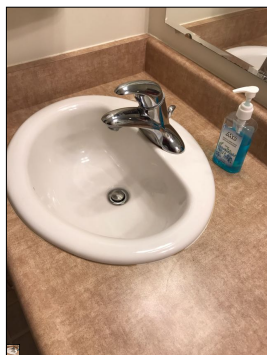
Inoperable drain stopper. The lever does not properly release the drain stopper. To release the drain stopper, it has to be pushed up from underneath the sink.

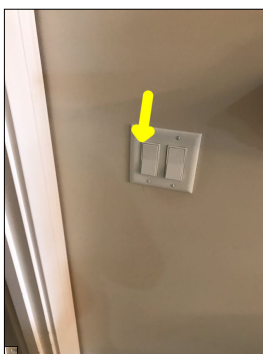
I was unable to find a function for the switch. There are no apparent lights or receptacles that are linked to the switch.

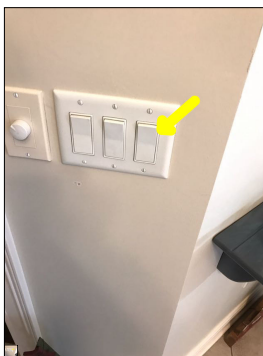
I was unable to find a function for the switch. There are no apparent lights or receptacles that are linked to the switch.

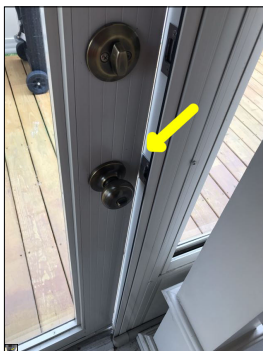
The door does not latch properly.

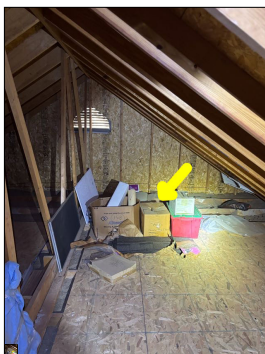
Debris and clutter within the attic. Visibility and accessibility were limited.

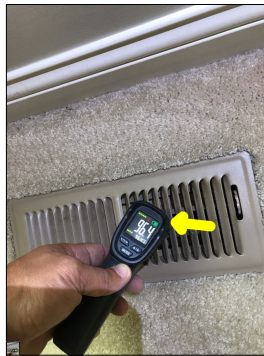
The photo identifies the temperature of the supply air while the furnace was in operation. The approximate temperature of the supply air was 96 degrees Fahrenheit.

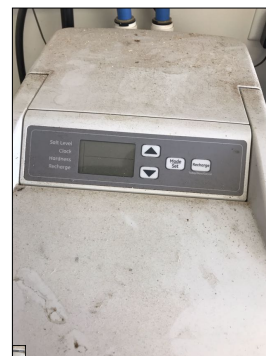
The digital display is inoperable.

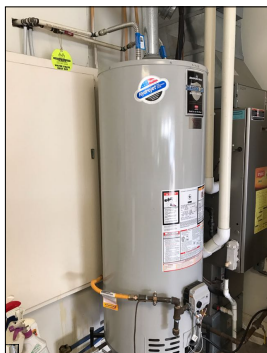
Water heater.
