# **FAMILYGUARD**

## **HOME INSPECTION REPORT**

**6340 Langwood Blvd. Fort Wayne, IN 46835**  
**Inspection Prepared For: Seller**

**Date of Inspection: 8/5/2026**  
**Age of House: 40 Years**  
**Weather: Clear**

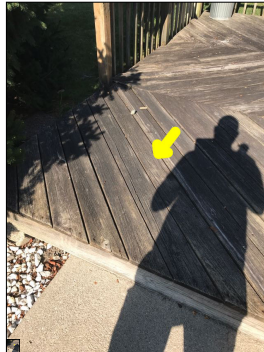
The deck unconventionally slopes.

- Recommend refinishing

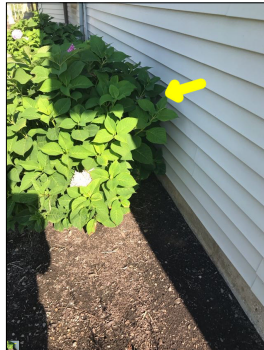
Vegetation against the siding/in proximity of the siding. This is not a recommended practice. Vegetation has the potential to harbor insects, wood destroying insects, rodents and hold moisture. Insects, wood destroying insects, rodents and moisture have the potential to create future problems for a house, such as structural damage, pest infestation and wood rot damage.

- Trim back trees/shrubberies

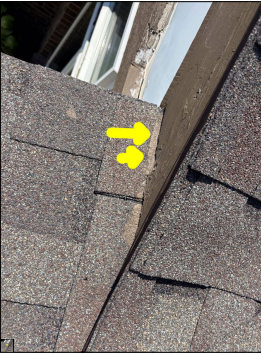
Unconventional application of sealant along the roof. This is considered abnormal and amateur craftsmanship. Amateur craftsmanship is prone to failure and leakage.

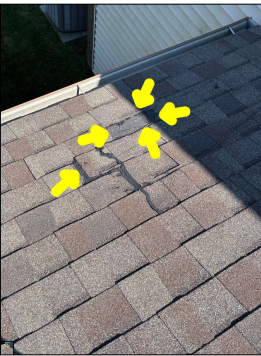
Unconventional application of sealant along the roof. This is considered abnormal and amateur craftsmanship. Amateur craftsmanship is prone to failure and leakage. Also, missing shingle.

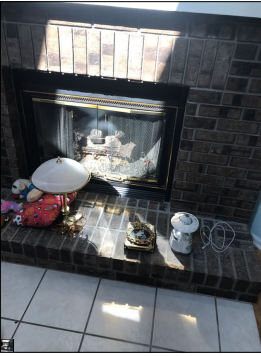
The fireplace is a gas fireplace. There is no apparent electronic ignition. It is beyond the scope of a general home inspection to light fuel burning appliances. Doing so could cause property damage. Recommend a licensed chimney/fireplace professional further evaluate to make sure the fireplace is in good working condition and safe to use.

- Rust/corrosion
- Needs cleaning/serviced
- Before using the fireplace, it is recommended that a licensed chimney/fireplace professional further evaluate to ensure the fireplace is in good working condition and is safe for usage.

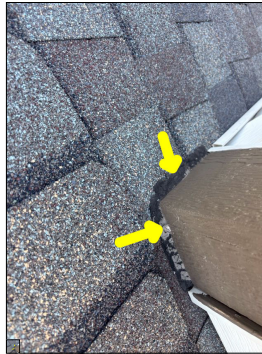
Unconventional application of roof sealant along the base of the chimney. This is considered abnormal and amateur craftsmanship. Amateur craftsmanship is prone to failure and leakage.

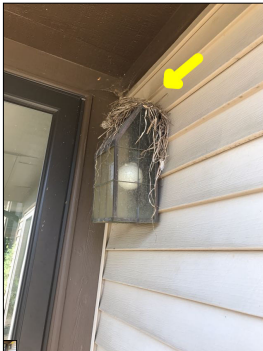
Bird's nest. Wildlife activity can cause property damage.

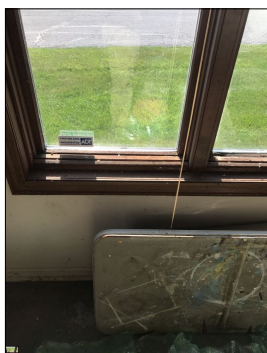
Aged windows.

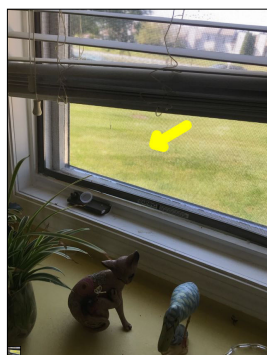
Aged windows.

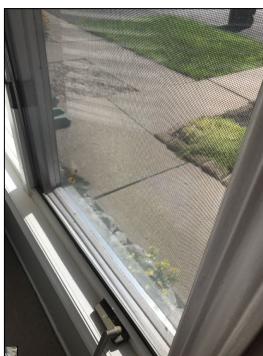
Aged windows.

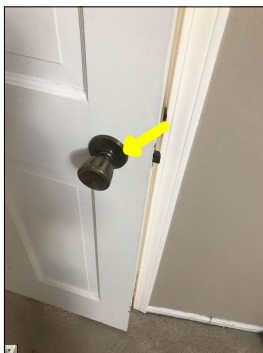
The handle is loose.

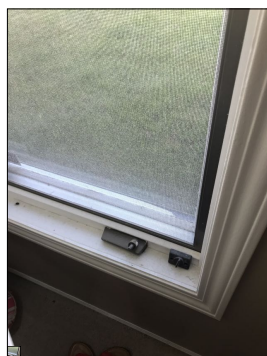
Aged windows.

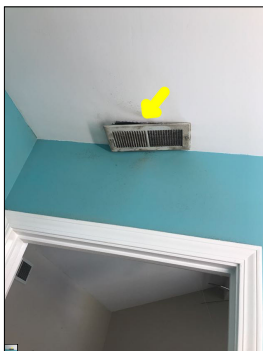
The supply vent is displaced. Also, discoloration around the vent along the wall. This is an indication of dirty HVAC ductwork.

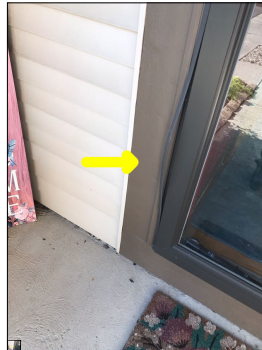
Displaced weatherstrip.

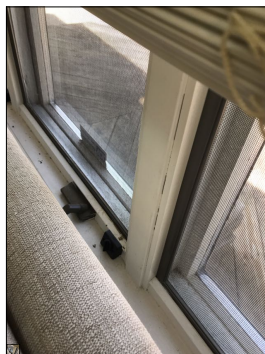
Aged windows.

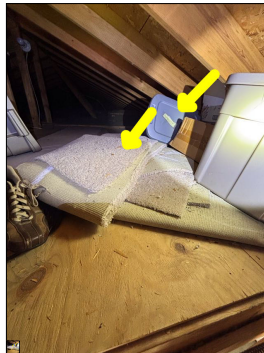
Debris and clutter within the attic. Visibility and accessibility were limited.

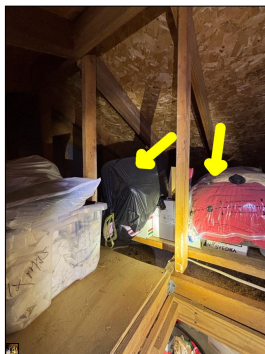
Debris and clutter within the attic. Visibility and accessibility were limited.

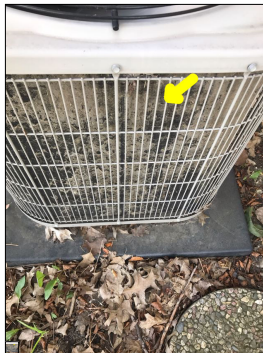
The condenser is dirty and needs cleaning. A dirty condenser can restrict proper airflow along the condenser, thus causing the condenser to work harder, which can shorten the lifespan of the condenser.

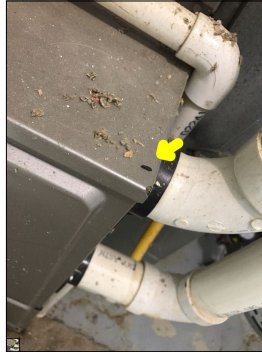
Mice droppings along the furnace.
