# **FAMILYGUARD**

## **HOME INSPECTION REPORT**

**11378 S. State Rd. 13 La Fontaine, IN 46940**  
**Inspection Prepared For: Seller**

**Date of Inspection: 8/5/2026**  
**Age of House: 120+ Years**  
**Weather: Clear**

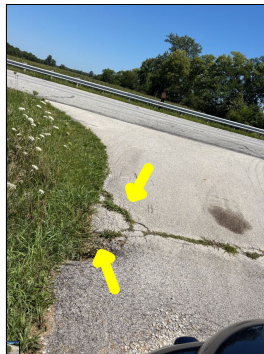
Cracks, deterioration, and a hole along the driveway.

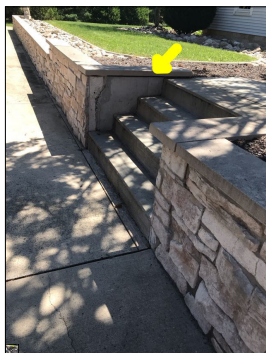
The steps are missing a handrail.

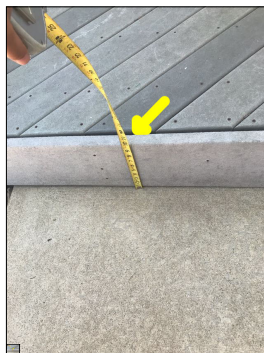
The riser/step is unconventionally high. This is a potential trip hazard. The recommended maximum height for a riser/step is 7 inches.

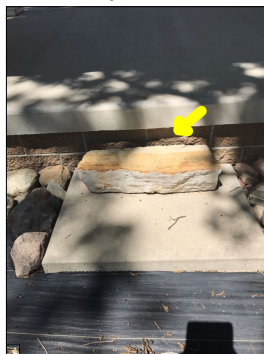
Uneven surfaces along the service walks/steps.

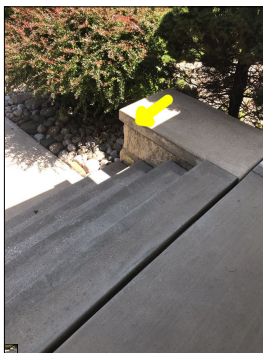
No handrail along the steps.

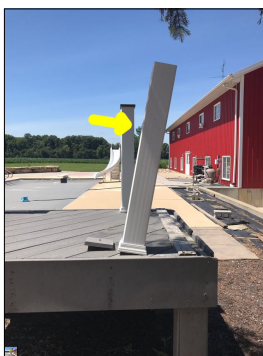
Loose column.

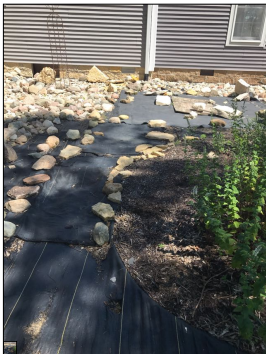
Unfinished landscaping.

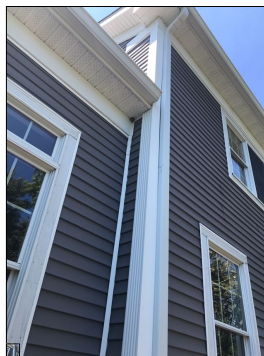
Wasp nest observed. Wasps can cause property damage and potentially sting those dwelling around the house.

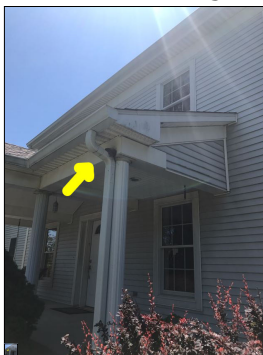
Bird's nest. Wildlife activity can cause property damage.

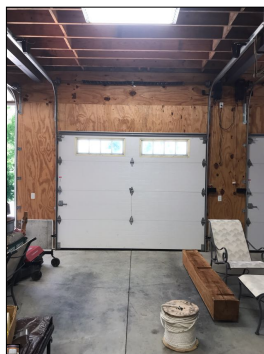
The overhead garage door is inoperable.

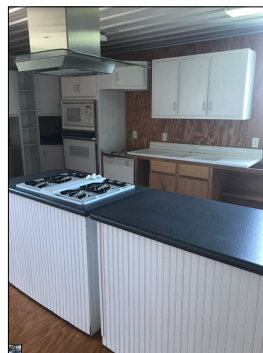
Unfinished kitchen within the garage/pole barn with aged appliances.

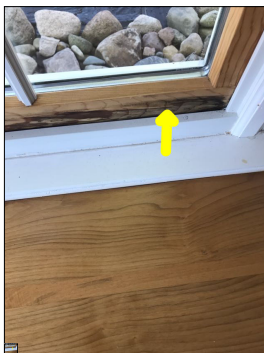
Discoloration along the window. An active or intermittent water source can cause discoloration, mold, and property damage.

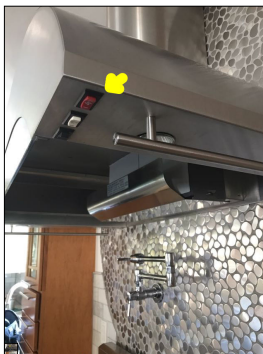
The red button is inoperable.

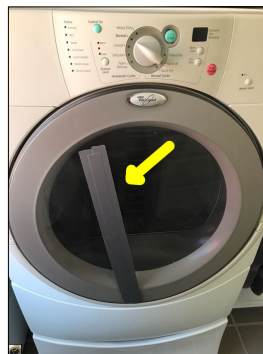
Unconventional tape along the dryer door.

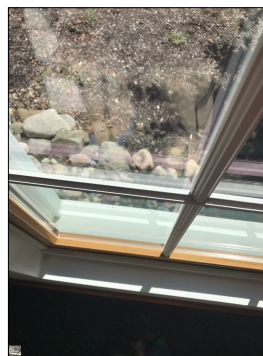
Missing window screens.

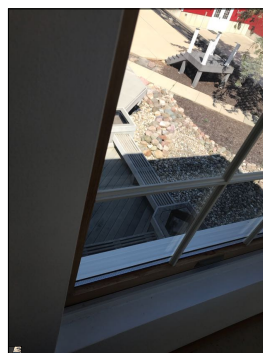
Missing window screens.

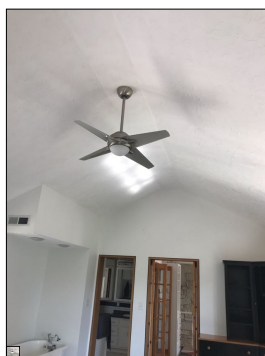
I was unable to operate the ceiling fan. There is no apparent wall switch or remote to the fan. Check with the seller to see if there is a remote that operates the fan.

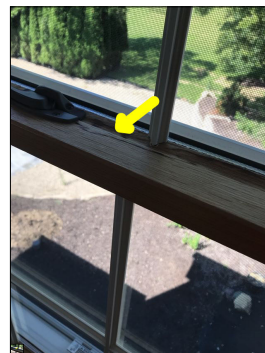
Discoloration along the window. An active or intermittent water source can cause discoloration, mold, and property damage.

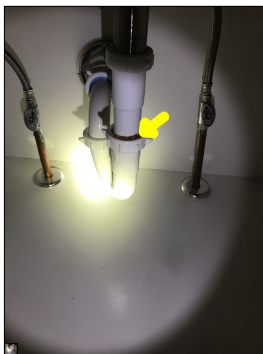
Grime along the **PVC** plumbing pipes. Grime along PVC pipes is considered abnormal and an indication of a developing leak or an intermittent leak.

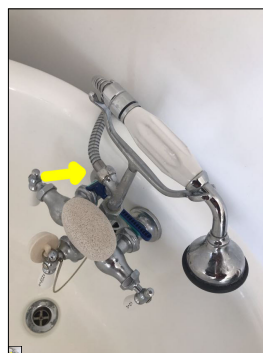
The sprayer leaks during operation.

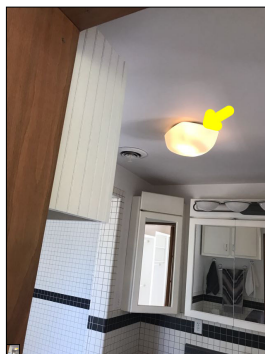
The light is noisy during operation. This is considered a defect.

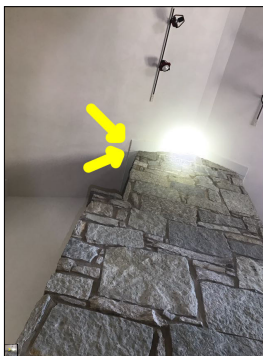
Discoloration along the ceiling and signs of previous water damage. An active or intermittent water source can cause mold growth and property damage.

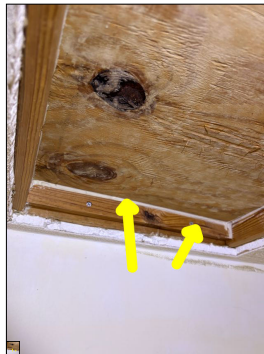
The attic is inaccessible due to the access panel being fastened/secured/glued down. It is beyond the scope of a general home inspection to remove glued/secured panels. Doing so could result in property damage. Attic systems, framing, and components could not be properly inspected.

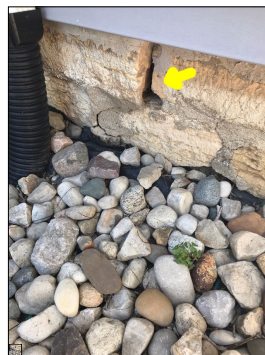
Gaps and deterioration along the foundation.

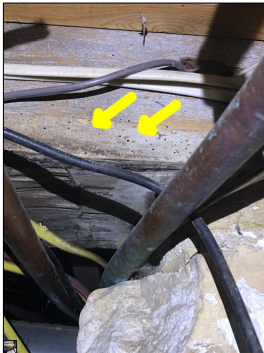
Exit holes observed. Exit holes are an indication of an infestation of powderpost beetles. Powderpost beetles are a wood destroying insect and can cause structural damage and property damage.

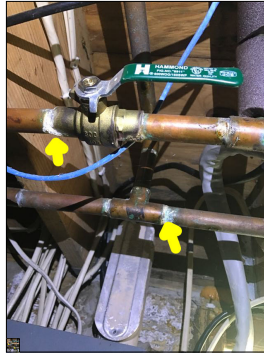
Rust and corrosion along the plumbing pipes.

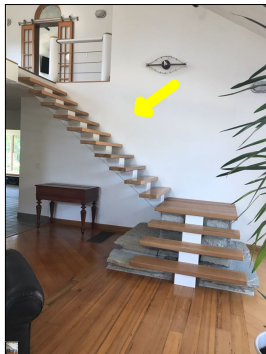
Missing handrail.

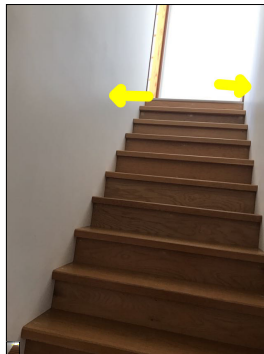
Missing handrail.

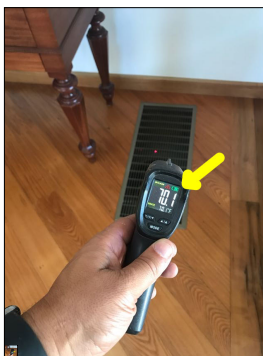
The photo identifies the temperature of the return air while the air conditioner was in operation. The approximate temperature of the return air was 70 degrees Fahrenheit.

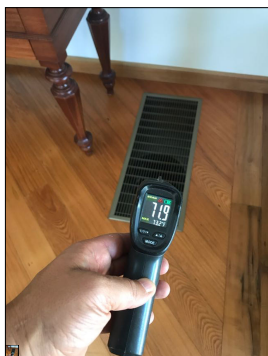
The photo identifies the temperature of the return air while the geothermal was in operation. The approximate temperature of the return air was 71 degrees Fahrenheit.

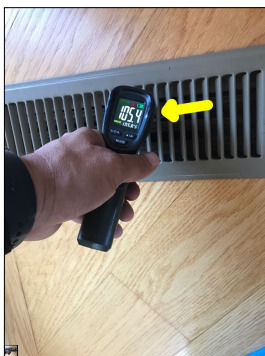
The photo identifies the temperature of the supply air while the emergency heat was in operation. The approximate temperature of the supply air was 105 degrees Fahrenheit.

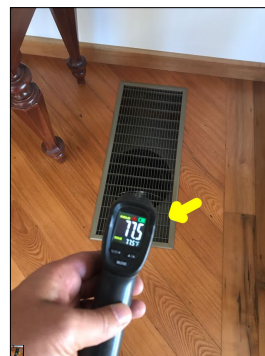
The photo identifies the temperature of the return air while the emergency heat was in operation. The approximate temperature of the return air was 77 degrees Fahrenheit.

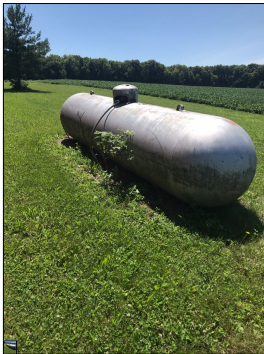
The fuel tank is aged.

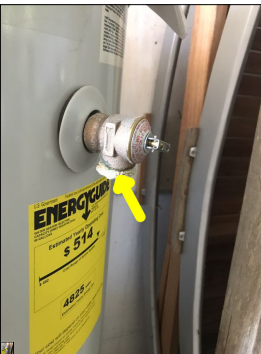
Corrosion along the end of the temperature and pressure relief valve. This is considered a defect and an indication that the water heater might have discharged in the past.

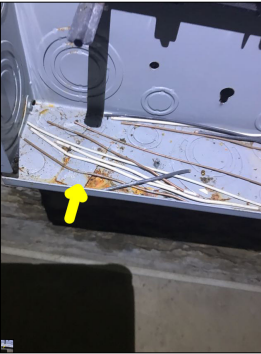
Rust and corrosion within the circuit breaker panel. This is considered abnormal and a potential safety hazard. An active or intermittent water source can cause rust and corrosion.

Rusted/corroded terminals and connections increase resistance in the circuit that can cause overheating, thus causing arcing, spark and/or fire. Some areas of rust and corrosion may not be visible and could be concealed behind breakers, wires, etc.

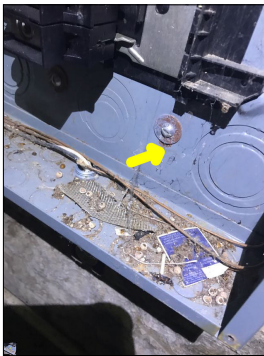
Rust and corrosion within the circuit breaker panel. This is considered abnormal and a potential safety hazard. An active or intermittent water source can cause rust and corrosion. Rust/corroded terminals and connections increase resistance in the circuit that can cause overheating, thus causing arcing, spark and/or fire. Some areas of rust and corrosion may not be visible and could be concealed behind breakers, wires, etc.

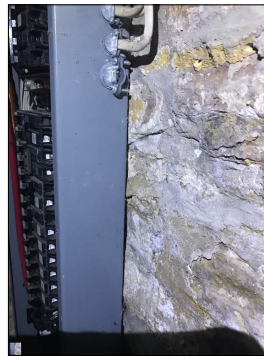
The electrical panel is mounted to the concrete/field stone. This does not meet the industry standard is a potential safety hazard. Concrete/stone can hold moisture. Moisture from the concrete/stone can wick onto the electrical panel. An active or intermittent water source to an electrical component can cause rust, corrosion, property damage and potentially cause bodily harm.

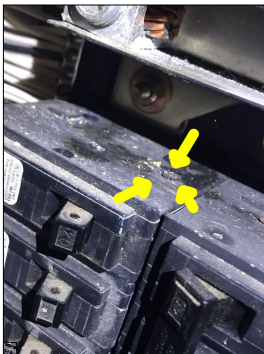
Mice/rodent droppings within the electrical panel. Wildlife activity can cause property damage.
